SIB 64 04 25

**SERVICE ACTION: HARNESS DAMAGE POSSIBLE WHILE CHANGING CABIN NANOFILTER**This Service Information Bulletin (Revision 2) replaces SI B64 04 25 **dated April 2025**.

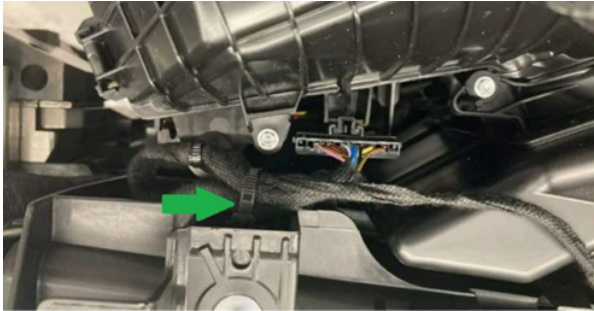
When servicing the cabin air microparticle nanofilter, it is possible to damage the vehicle's wiring harness while re-installing the retaining screws for the cabin air nanofilter's plastic cover.

Use caution when re-installing the plastic cover for the cabin air filter to ensure no damage is done to the vehicle's wiring harness.

Add a retainer to the harness to prevent it being pinched under the air filter plastic cover.

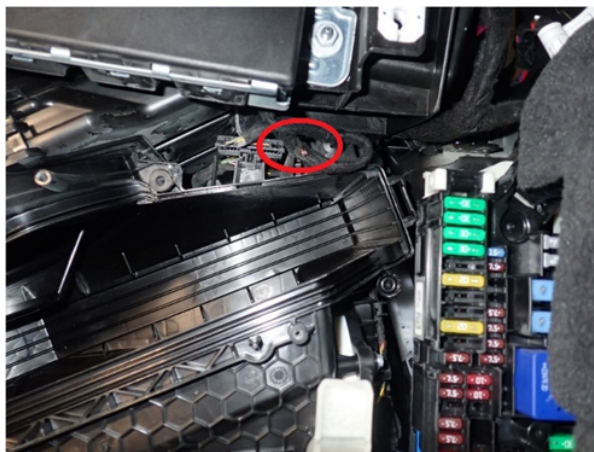
This is where the harness can be damaged when installing the cabin air filter cover screw.

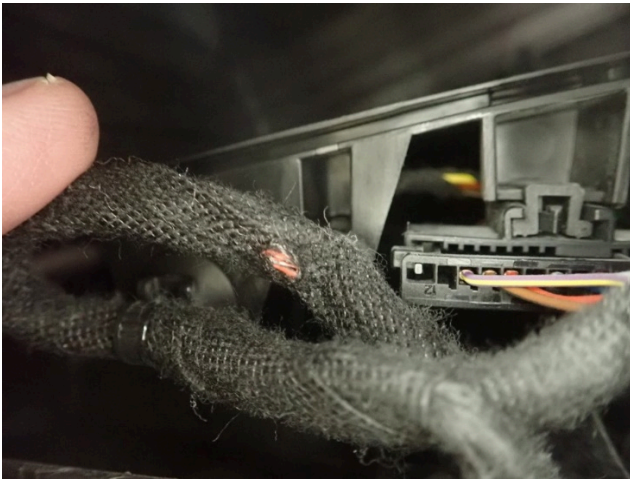
This shows the harness damage; the sheathing has been abraded.

If the wiring harness has already been damaged during the installation of the cabin air filter cover, the damaged section of the wiring harness must be repaired.

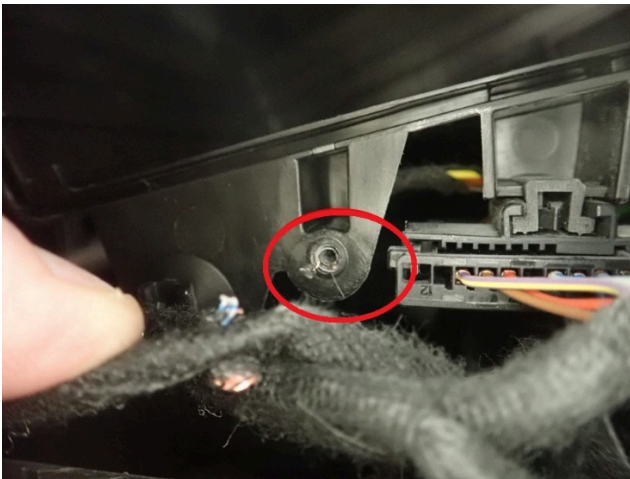
With the harness pulled out of the way, you can see the screw mounting hole for the cabin air filter cover.
