SIB 54 01 25

CONVERTIBLE TOP DOES NOT OPEN AFTER SITTING IN THE SUN FOR A LONG TIME

E-Series	Model Description	Production Date
F91	M8 Convertible	SOP (Start of Production) – September 18, 2023
G14	8 Series Convertible

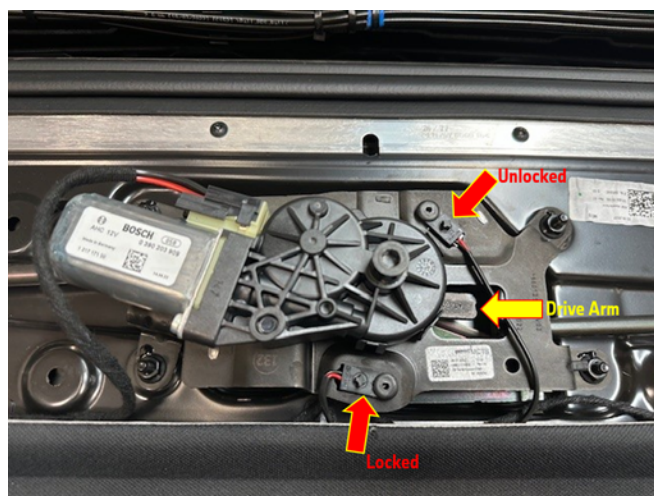
A malfunction of the convertible top is caused by a faulty Hall effect sensor signal (convertible top latch open) when exposed to sunlight.

The gap between the drive arm and the Hall effect sensor is already close to the permissible limit.

When exposed to strong sunlight, the gap between the Hall effect sensor and the motor drive arm expands further and causes a signal change in the Hall effect sensor. It is therefore not possible to open the convertible top.

Measure, and if needed adjust the gap dimension between the Hall effect sensors and the motor drive arm for the latches on the front the bow of the convertible top.

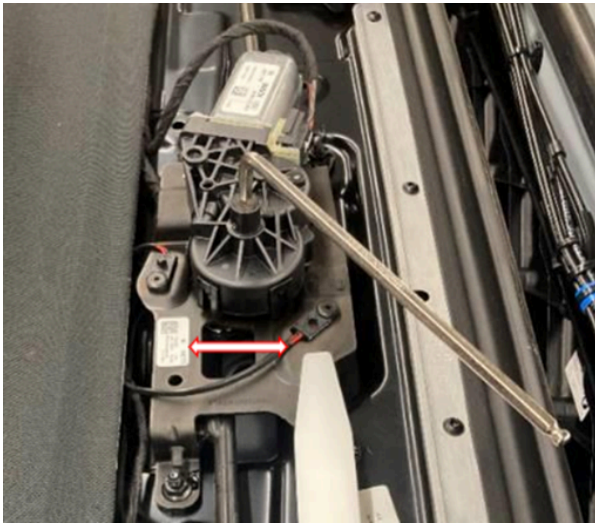
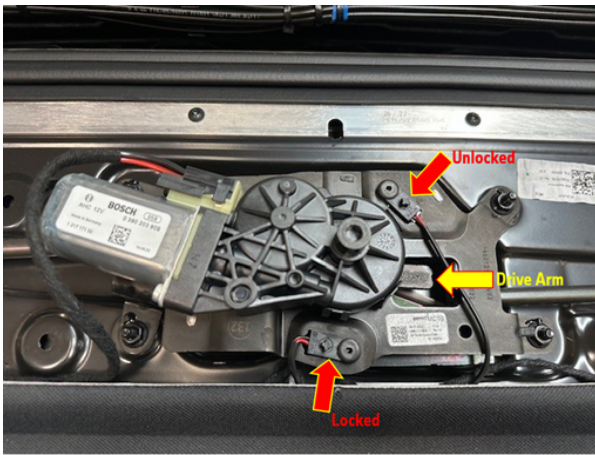
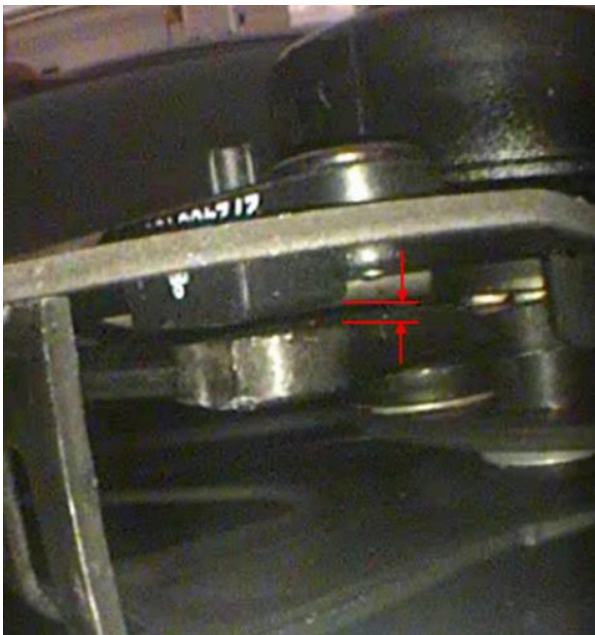
Note: Both values (UNLOCKED and LOCKED) are normally around 1.5 mm. In the event of an operating failure of the convertible top due to exposure to strong sunlight, the value is approximately 3 mm or greater.

5. Using a hex socket, manually rotate the motors drive arm to the **UNLOCKED** position. Using a plastic feeler gauge, measure the gap between the Hall effect sensor and the drive arm and record the value.

6. Using a hex socket, manually rotate the motors drive arm to the **LOCKED** position. Using a plastic feeler gauge, measure the gap

between the Hall effect sensor and the drive arm and record the value.
