<b>Topic</b>	OBC Charging Efficiency MIL HW / SW Update (NAR Only)   Bentayga (Hybrid)   24MY
<b>Market area</b>	United States E05 Bentley USA and rest America (6E05)
<b>Brand</b>	Bentley
<b>Transaction No.</b>	2077790/2
<b>Campaign number</b>	ED44
<b>Note</b>	
<b>Type</b>	
<b>US code</b>

### Hybrid (PHEV) Bentayga 24 Model Year

### Technical background

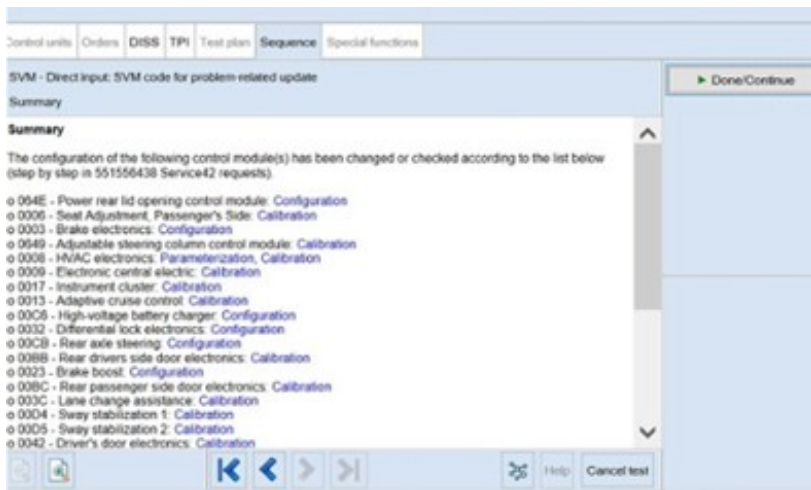
8. If the SVM code completes successfully, ODIS should display as per the image above.

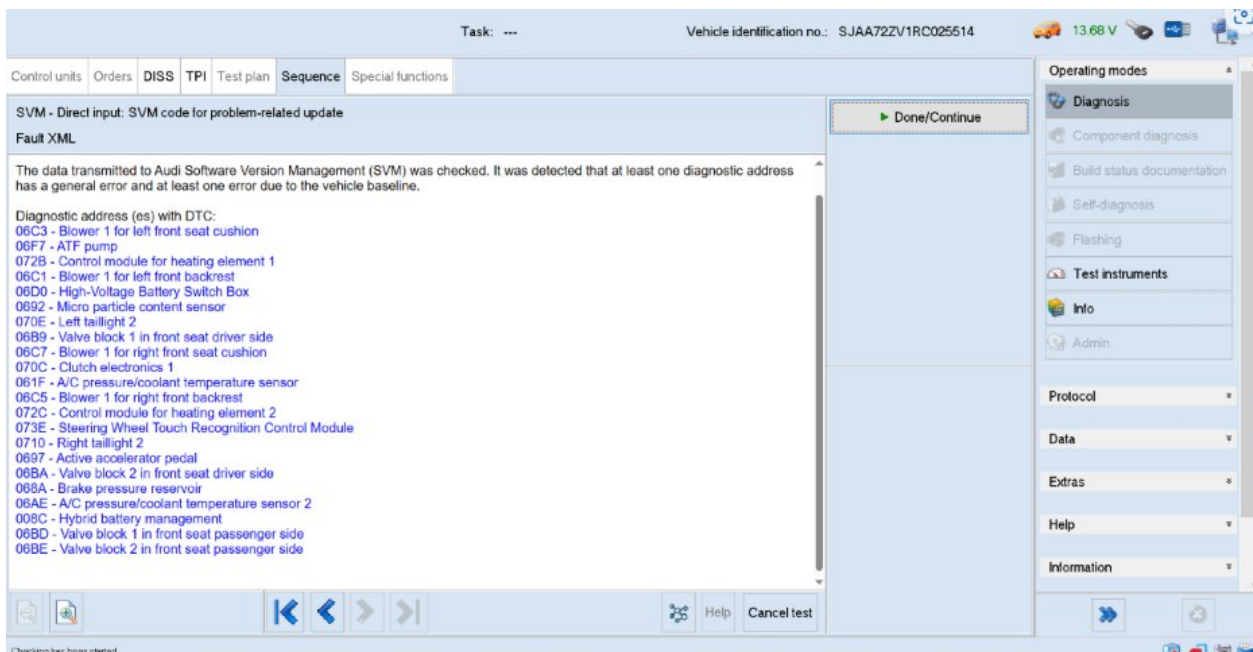
b. If you receive the error '8058' or the screen shown in the image above, please do the following:

c. Locate 00C6 in control unit list

d. Select -> Guided Functions -> Read Identification Data

e. If the software version of 00C6 is now at SW3322 then proceed to step 2.

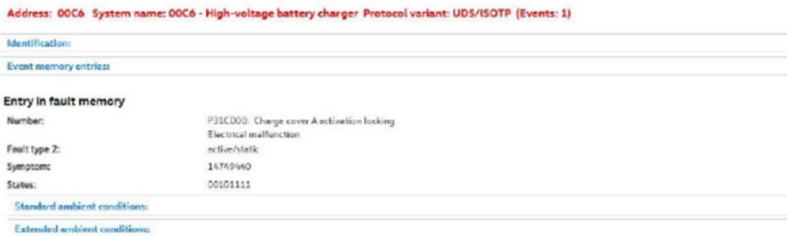
Figure 1

The diagnostic address for the on board charger, 00C6, is storing DTC P31CD00 – Charge cover A activation locking (Figure 1).

The symptom code shown is 14749440.

This DTC is a static fault that can be ignored if the charge flap is functioning normally and there are no warning lights displayed on the driver’s instrument panel.

5. If the DTC shown above is present in 00C6, this can be ignored as per TPI 2076739/-

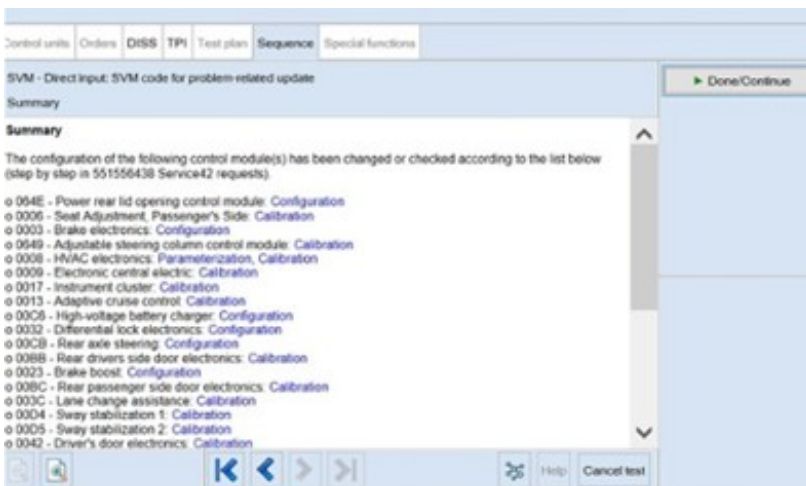
8. If the SVM code completes successfully, ODIS should display as per the image above.
9. After successful completion of the update, perform the following.
  - a. Turn off the ignition.
  - b. Remove all equipment from the car (Diagnostic tester/dongle, battery charger, keys).
  - c. Remove the VCI.
  - d. Close all doors, windows, bonnet and boot lid.

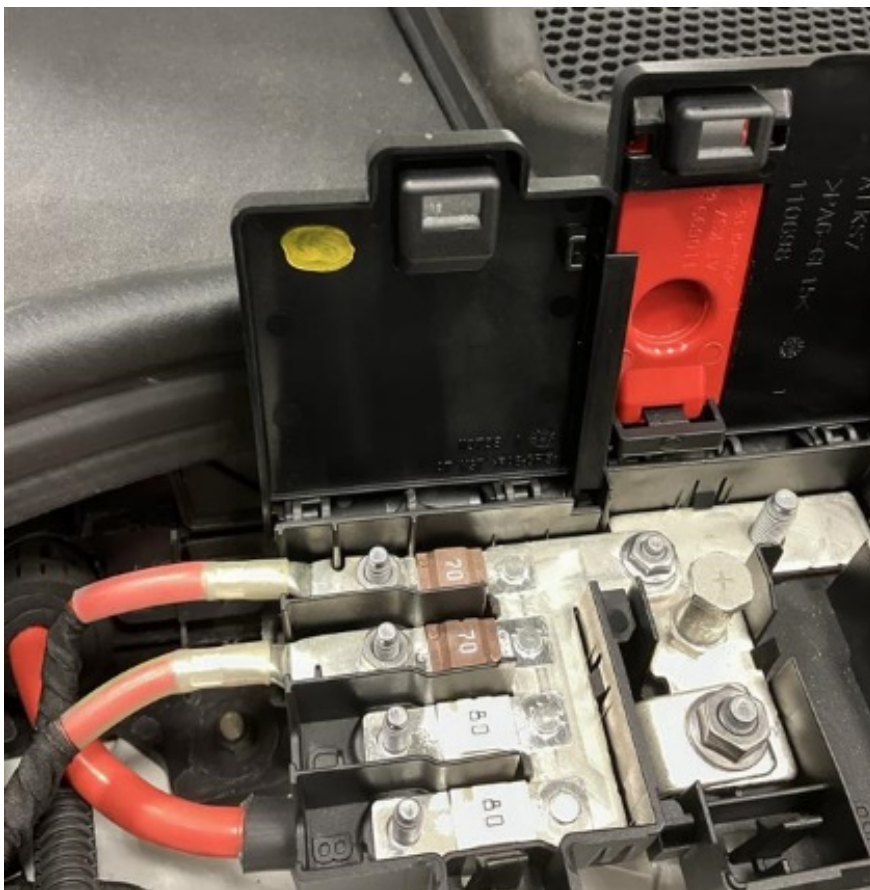
You must also add a paint mark as per the picture below.
