Field campaign

Topic	OBC Charging Efficiency MIL SW Update (NAR Only) Bentayga (Hybrid) 24MY
Market area	United States E05 Bentley USA and rest America (6E05)
Brand	Bentley
Transaction No.	2077846/2
Campaign number	ED45
Note	
Type	
US code

Hybrid (PHEV) Bentayga 24 Model Year

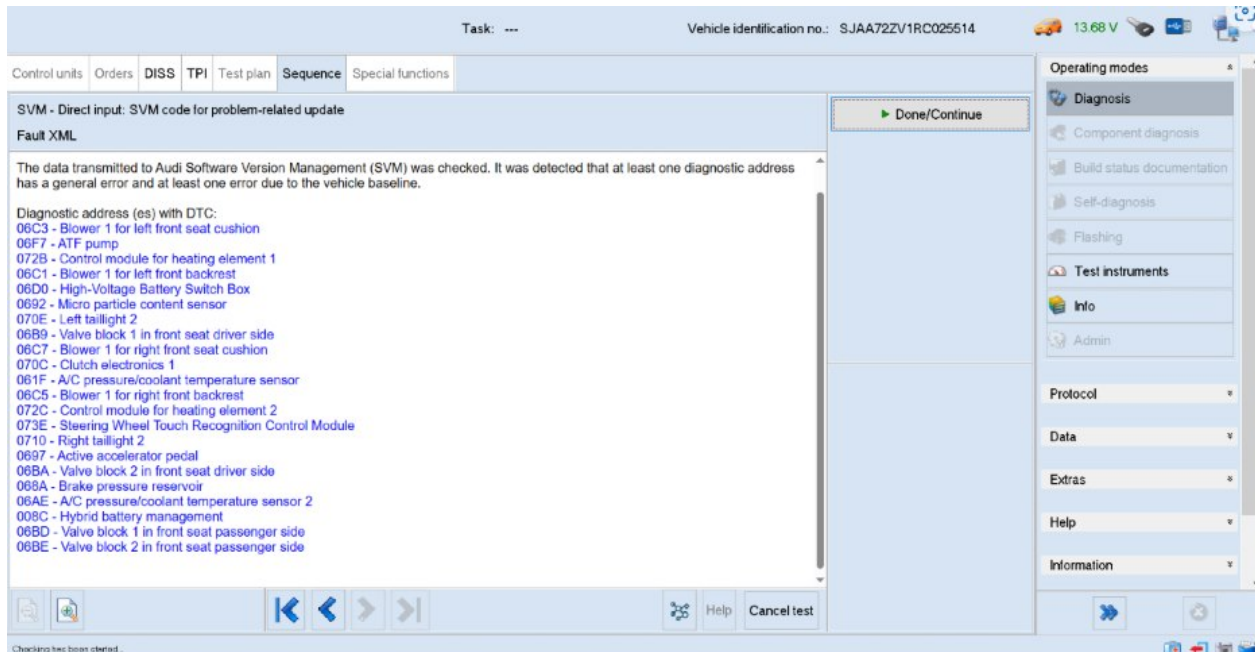
b. If you receive the error '8058' or the screen shown in the image above, please do the following:

c. Locate 00C6 in control unit list

d. Select -> Guided Functions -> Read Identification Data

e. If the software version of 00C6 is now at SW3322 then proceed to step 2.
