## Field campaign

<b>Topic</b>	OBC Charging Efficiency MIL SW Update (NAR Only)   Bentayga (Hybrid)   25MY
<b>Market area</b>	United States E05 Bentley USA and rest America (6E05)
<b>Brand</b>	Bentley
<b>Transaction No.</b>	2077847/2
<b>Campaign number</b>	ED46
<b>Note</b>	
<b>Type</b>	
<b>US code</b>

### Hybrid (PHEV) Bentayga 25 Model Year

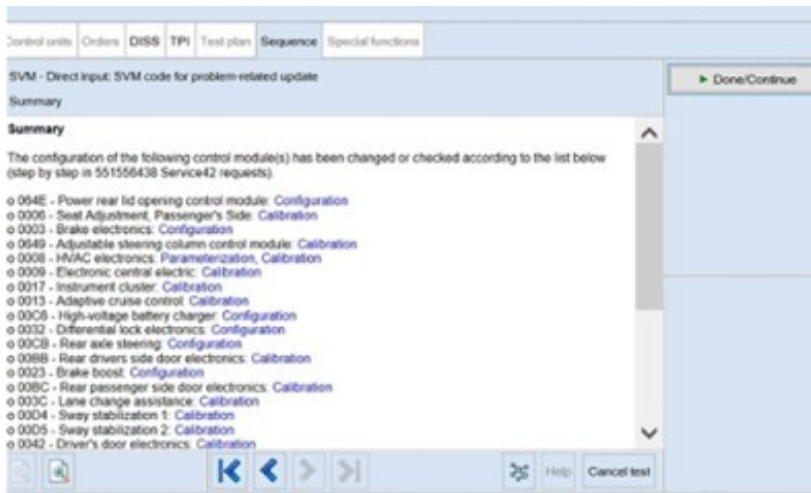
9. If the SVM code completes successfully, ODIS should display as per the image above.

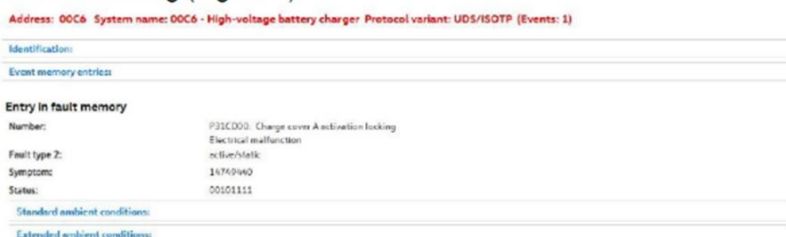
Figure 1

The diagnostic address for the on board charger, 00C6, is storing DTC P31CD00 – Charge cover A activation locking (Figure 1).

The symptom code shown is 14749440.

This DTC is a static fault that can be ignored if the charge flap is functioning normally and there are no warning lights displayed on the driver's instrument panel.

13. If the DTC shown above is present in 00C6, this can be ignored as per TPI 2076739/-
