HYUNDAI Technical Service Bulletin

NUMBER
25-EV-003H

SUBJECT: DC PIN CAPS REPLACEMENT

Description: Certain IONIQ 5 (NE EV), IONIQ 6 (CE EV), and IONIQ 5 N (NE EV N) vehicles may have missing Inlet 5-Pin Combo DC insulation caps (DC pin caps) which may lead to damage to the charge port if not replaced. This bulletin provides instructions to replace the DC pin cap(s).

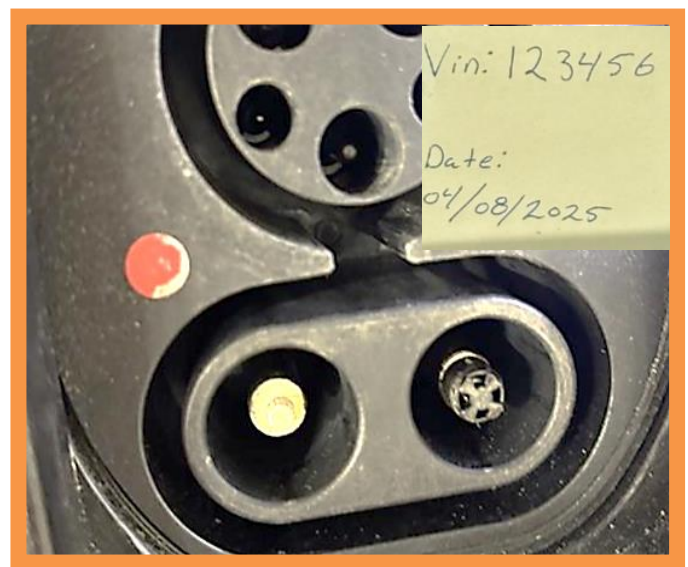
3.

Using STUI, take a photo of the missing DC pin cap(s) with the last 6 digits of the VIN and the date of repair on a piece of paper.
