Technical Service Bulletin

GROUP EV SYSTEMS	NUMBER 25-EV-003G
DATE JULY 2025	MODEL(S) SEE BELOW

SUBJECT: DC PIN CAPS REPLACEMENT

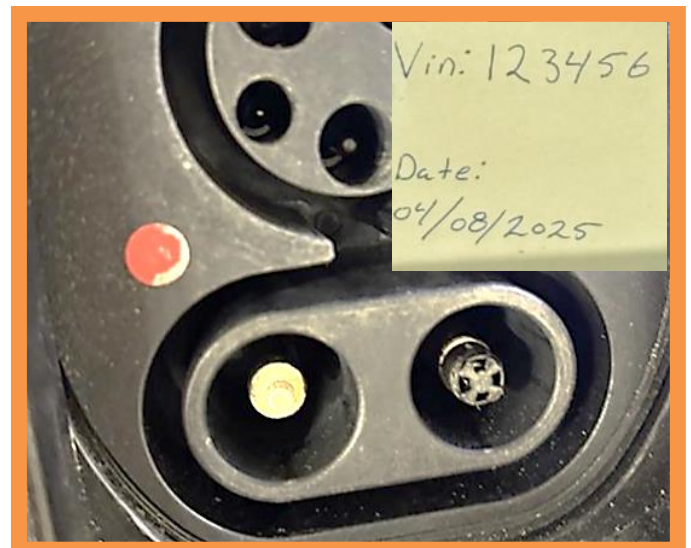
1. Open the charging door.
2. Check the charge port for missing DC pin caps (A).

3. **Using STUI, take a photo of the missing DC pin cap(s) with the last 6 digits of the VIN and the date of repair on a piece of paper.**
