Technical Service Bulletin

Transaction No.:
2062261/6

Bentayga - Air suspension warning light within the DIP - DTC's P089200 - C104707 - C103B13
- Evident within Address 74

Release date: Jun 30,
2025

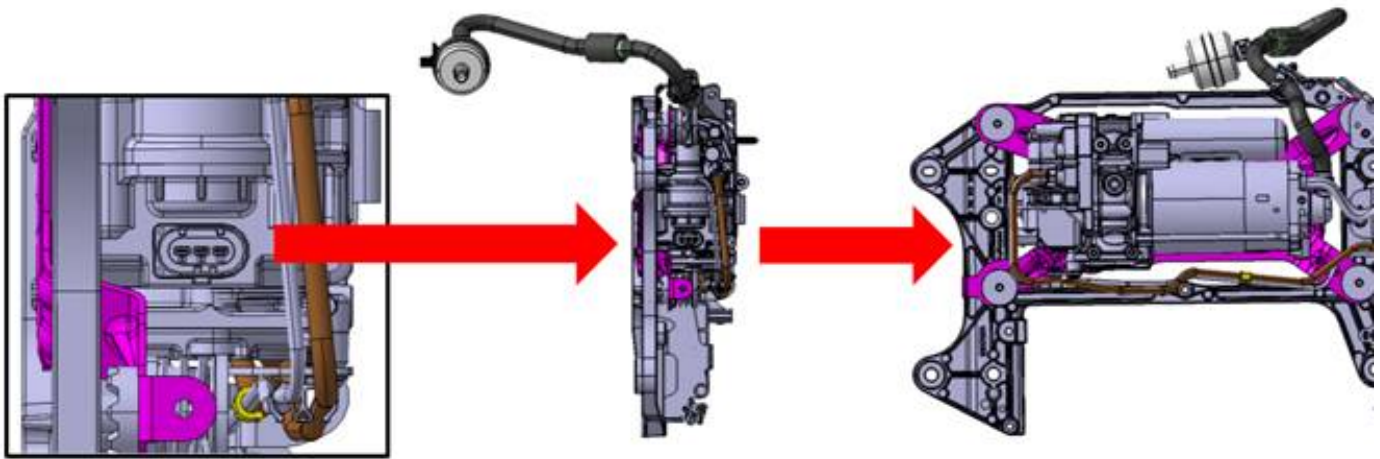
NOTE: NX7 is located as shown in Figure 1 (On the air supply unit/opposite side to the valve block)

1) Conduct a wiring integrity check between the valve block for adaptive suspension control unit (NX7) and the Running gear control unit (J775)

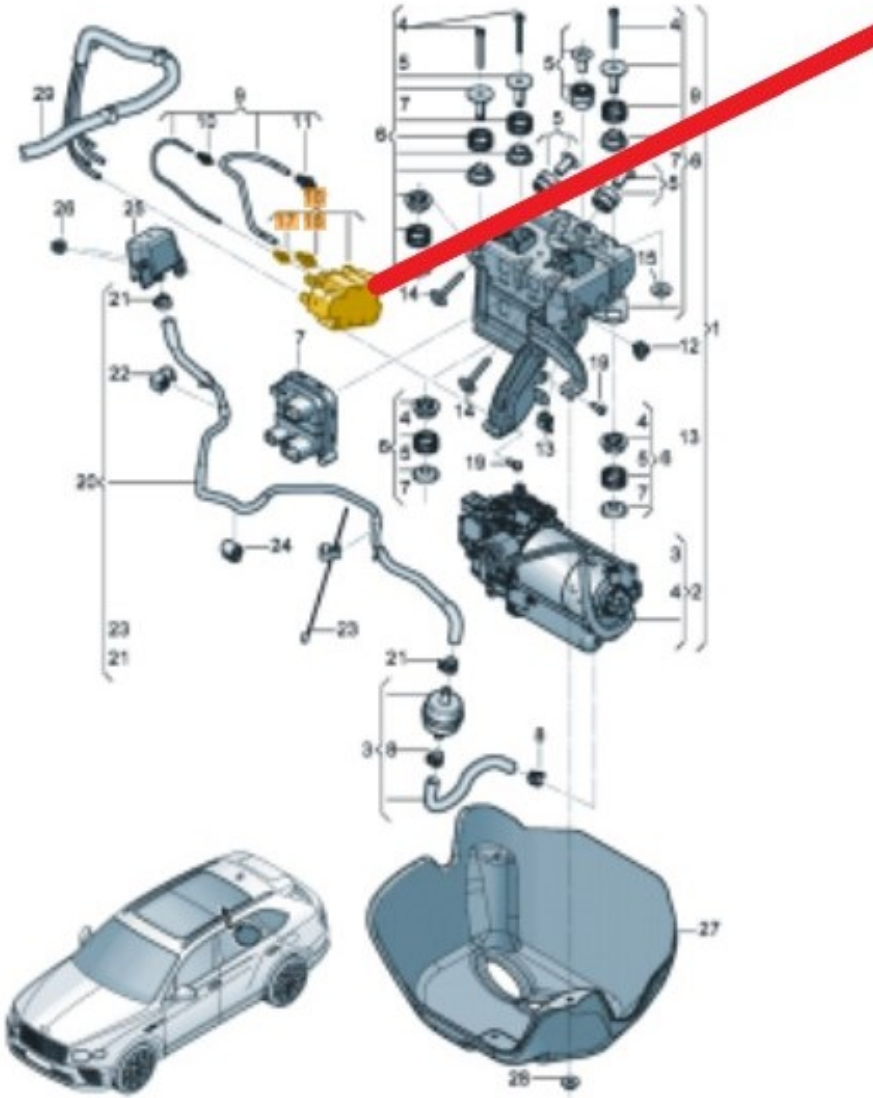
Figure 2

Hint: The solenoid valve block can be replaced without the need to remove the air supply unit assembly from the vehicle

| <ul style="list-style-type: none">• Should none of the afore mentioned issues be evident - Replace the solenoid valve block (Figure 2) |

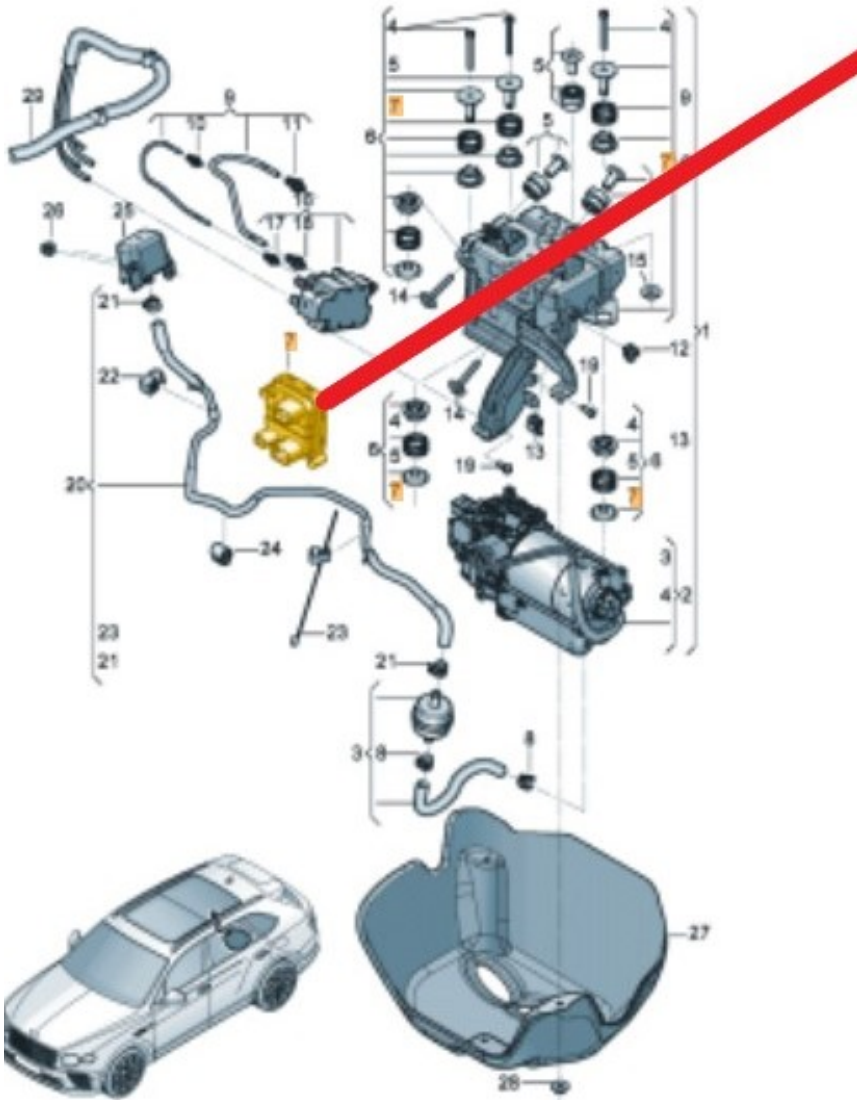
Hint: The compressor control unit can be replaced without the need to remove the air supply assembly unit from the vehicle

- Replace the compressor control unit - Figure 3

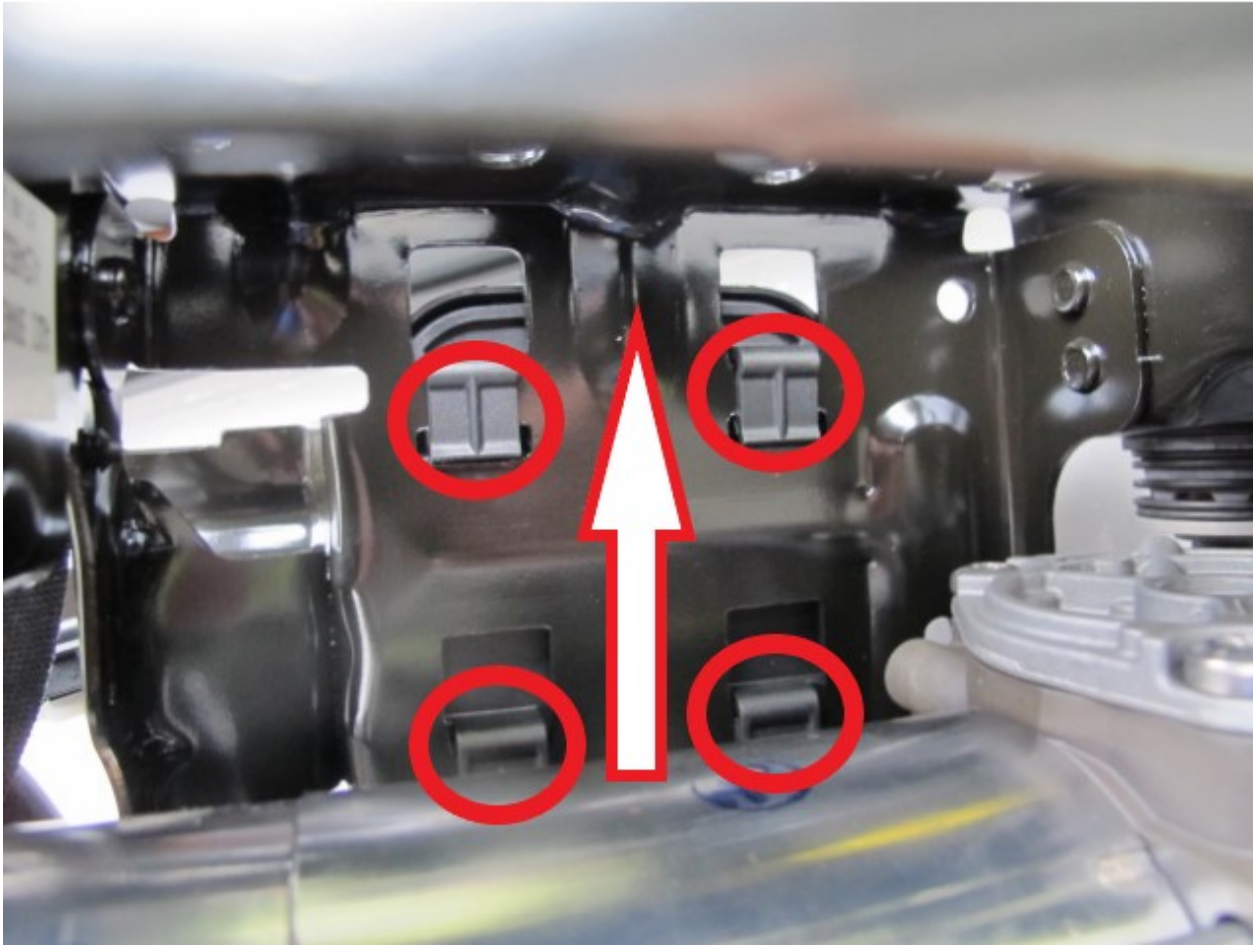
Figure 4

TIP: The clips can easily snap - Take care when refitting the new control unit

Hint: The control unit is secured to the air supply unit bracket using (x4) clips - To remove the control unit disengage the clips using a non metallic tool then slide/remove the control unit from the bracket (Figure 4)
