Field campaign

Topic	Software Update Window Short Drop Deletion Continental GT/GTC 26MY (SC25 /31)
Market area	Bentley: worldwide (2WBE),China 796 VW Import Comp. Ltd (Vico), Beijing (6796)
Brand	Bentley
Transaction No.	2078277/1
Campaign number	ED59
Note	
Type	
US code

26MY Continental GT / GTC

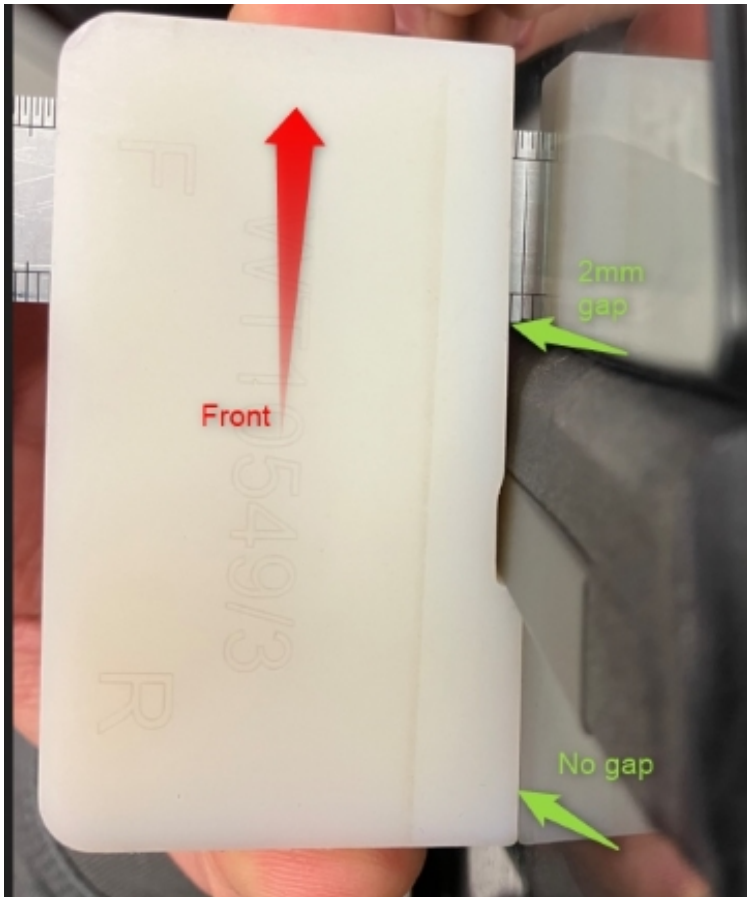
Figure 1

Window Parallel

When the window is parallel take the 2mm step from the tool and minus the 2mm gap between front window and tool = -0mm (as shown in figure 1)

When the rear window is 0mm inboard from the front glass and the windows are parallel, the measurement written as 0mm (figure 2)

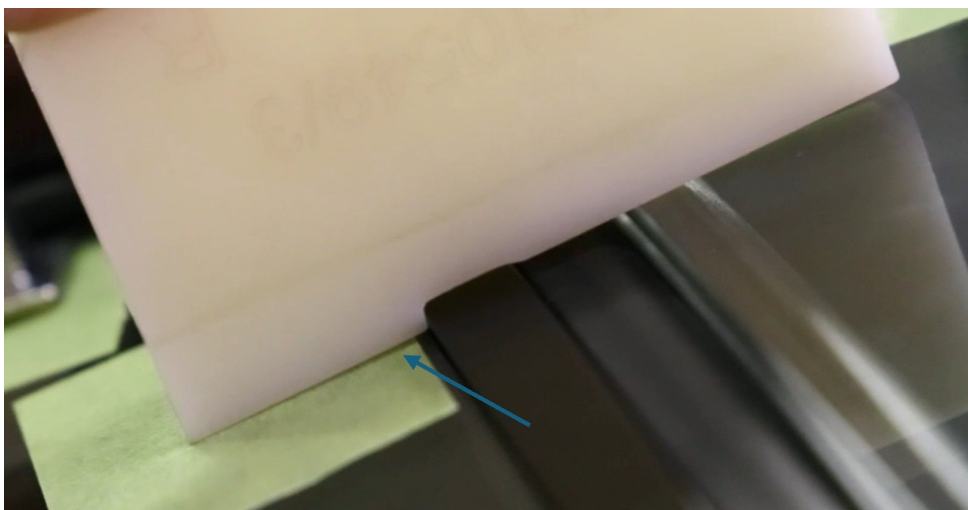
Figure 7

If the tool (WT10549/3) does not sit flush against the rear window then this shows rear window is more than 2mm inboard (more than -2mm), check this by holding the tool on the front window and measuring gap between the rear glass and the tool (as shown in figure 7)

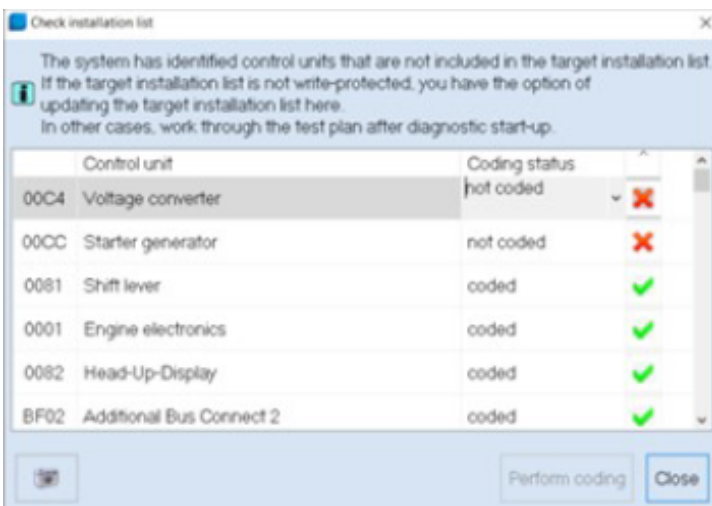
Figure 9

If a ‘Check installation list’ pop-up appears, select ‘close’ (Figure 9)

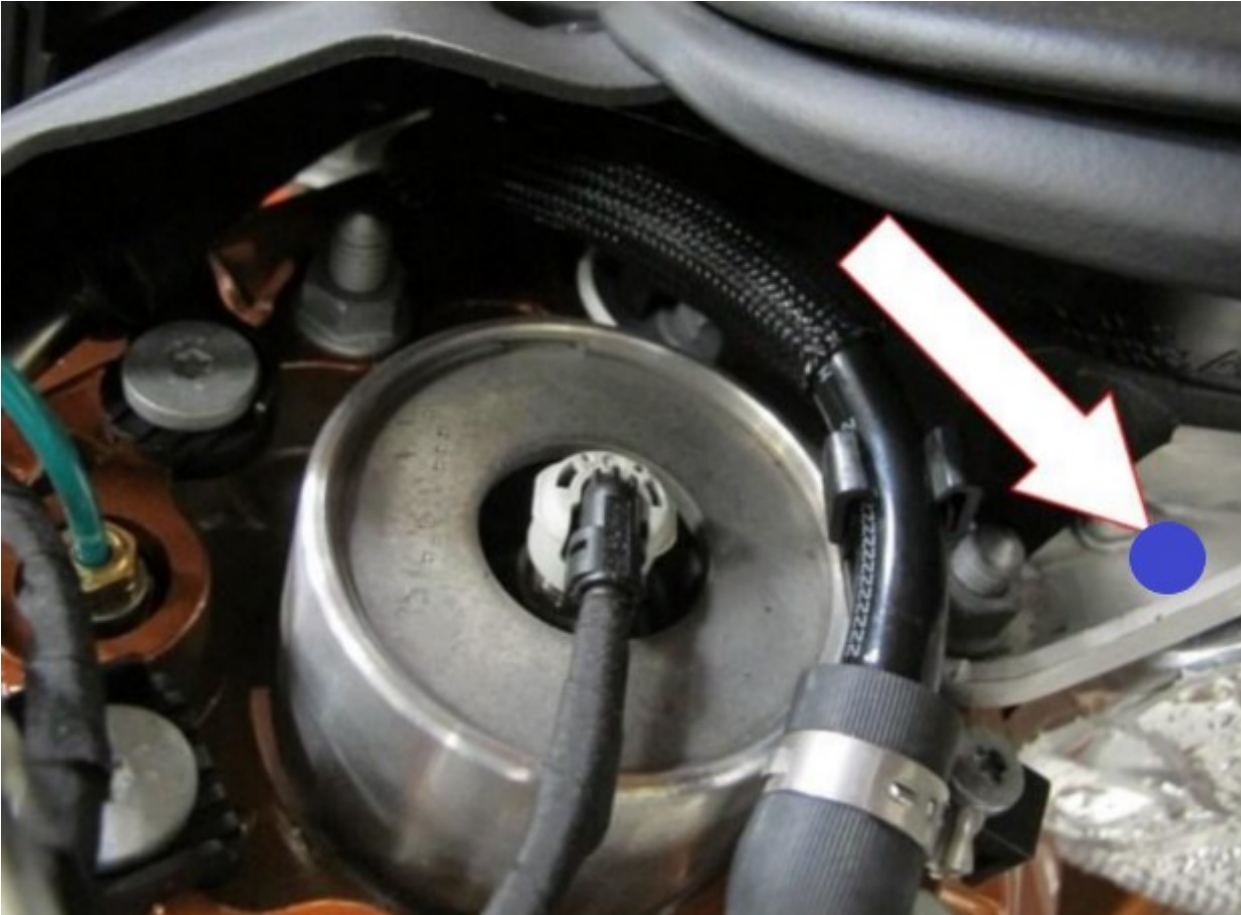
Figure 12

Blue paint completion mark on the engine partition brace

13) Referring to the Identification section - Apply a blue paint completion mark on the engine partition brace (Figure 12)
