SIB 66 10 25

DIAGNOSTIC HINT: LANE STEERING ASSISTANCE DEACTIVATES FAULT CODE FRSF 7E01AA

E-Series	Model Description
i20	iX Sports Activity Vehicle

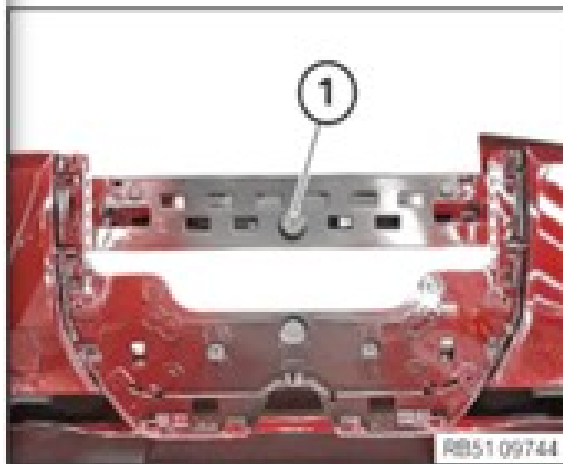
Trimming front bumper cover

New front bumper covers required preliminary repair step to trim material away in center section and if not performed the FRSF front radar will be blocked by the bumper cover after installation.

Preliminary instructions illustrating the required steps for trimming new front bumper cover during installation.

Carry out the step only after painting the bumper cover.

- Cut the section (1) in the area of the dotted lines using a suitable tool and dispose of it.

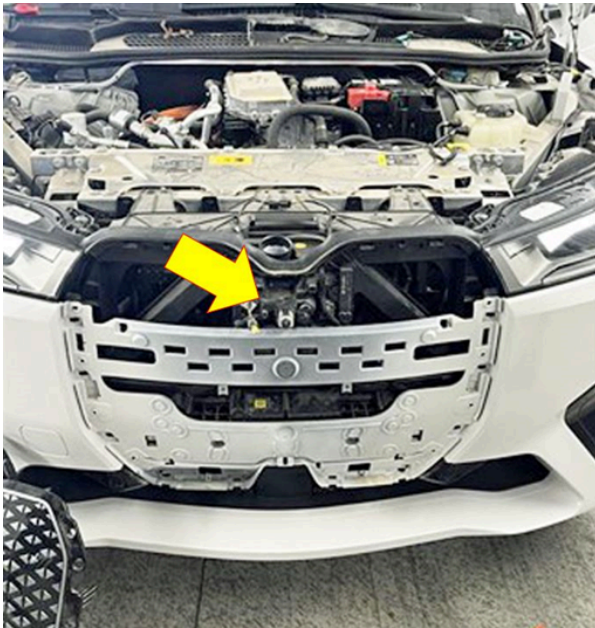
The FRSF front radar is blocked, which causes degradation in the system. The system will shut down into standby mode when fault is detected. FRSF front radar can be blocked due to a previous body repair that involved the replacement of the new front bumper cover.

Photo shows the new front bumper cover installed without the preliminary trimming procedure being performed. The FRSF front radar (arrow) is mounted behind the center section.

- Review repair instructions under “Replace **bumper cover, front**” 51 11 157 | REP-REP-P-5111157-I20 - V.6 to verify repair.
- If needed perform trimming procedure “**Trimming front bumper cover**” REP-TAT-P-5111-26-I20

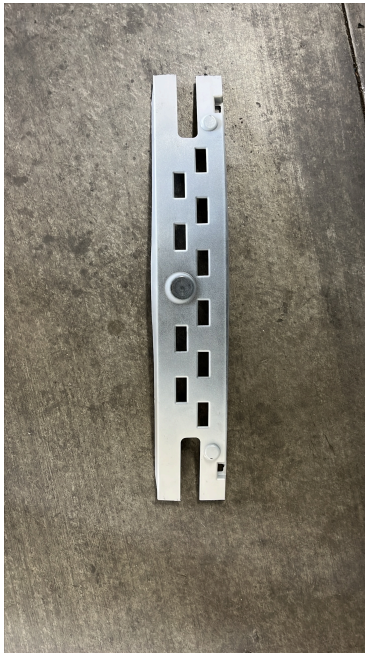
Photo shows the center section of the new front bumper cover that will be removed during installation. This section, if not removed, blocks the FRSF front radar reducing the functionality and causing erroneous behavior.
