Service Instructions

SI10-800-160 – Frame Web Cracks, 217” WB Flat Floor

Suspect Population: Certain 2021 through 2026 Blue Bird BBCV buses, equipped with a 217” WB flat floor & Ford 7.3L powered engine.

Condition: Chassis web fractures in or around the vicinity of the LF shock mount

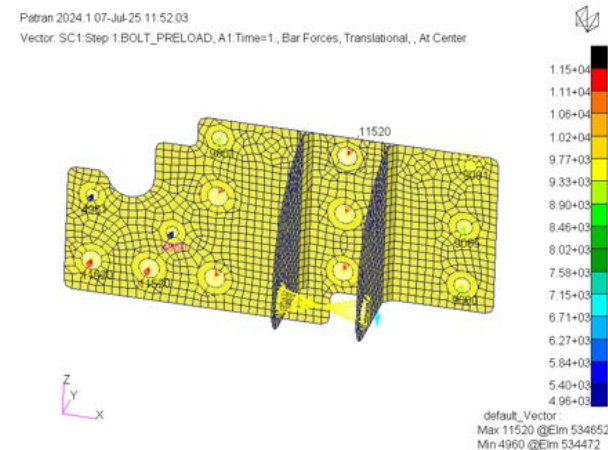
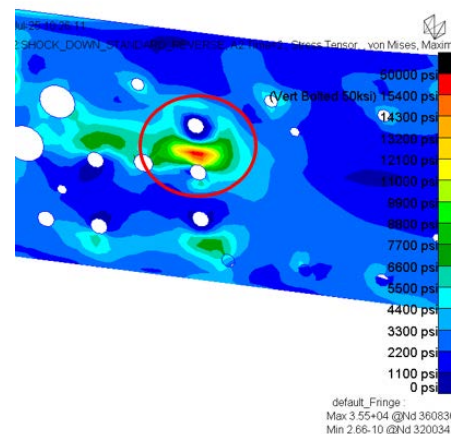
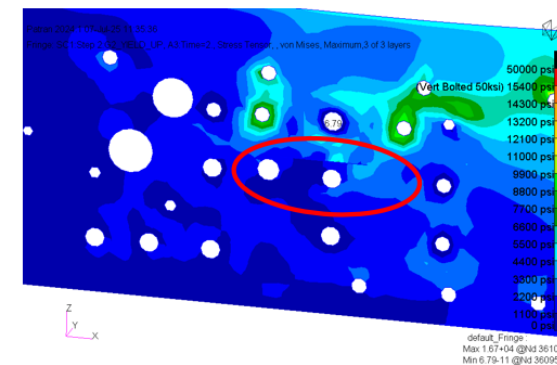
- FEA modeling shows elevated regions of stress in proximity of the upper fastener hole for the LH shock mount resulting from several external influences. The highest stress stemming from shock extension forces in curb hop scenarios.

- Bearing in mind the absence of this failure mode on standard floor chassis designs with substantially higher usage, the projected stress in this region of 4582 PSI is used as an objective bench mark of the acceptable upper limit.

- Two corrective solutions are being executed as pragmatic countermeasures to correct this failure mode, based on the severity and frequency of the crack, if present. Repair plate 1 being the latest evolution. FEA analysis & ref chart below

- Installation of this repair plate decreases the stress in this region to less than the standard floor chassis baseline allowing us to predict this solution to last the expected life of the chassis.

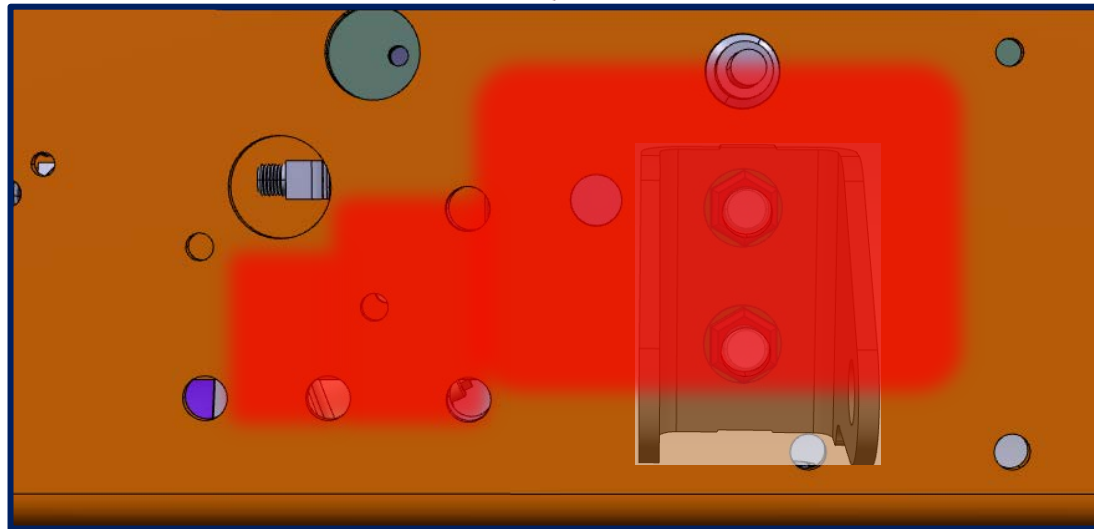
Region A

Repair Criteria		
	Repair Plate 1	Repair Plate 2
Crack Length	<100mm(4 inches)	>101mm(4 inches)
Number of Cracks	1	1 or More
Region of Crack	A	B

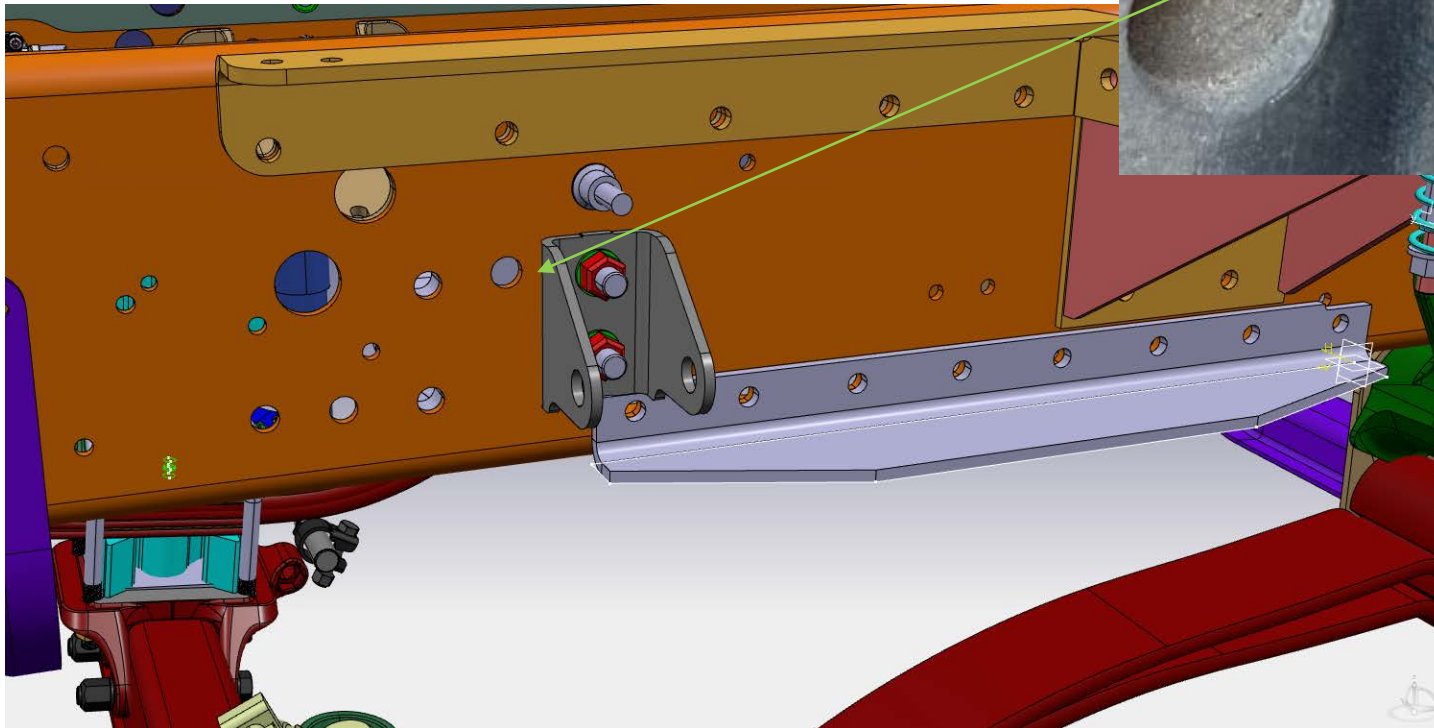
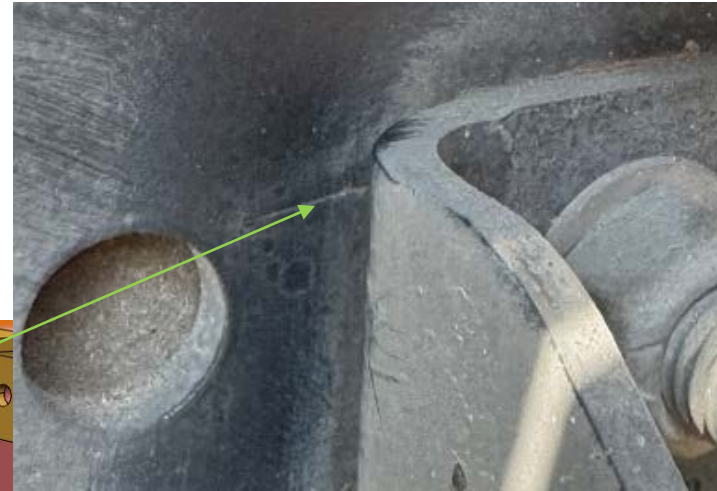
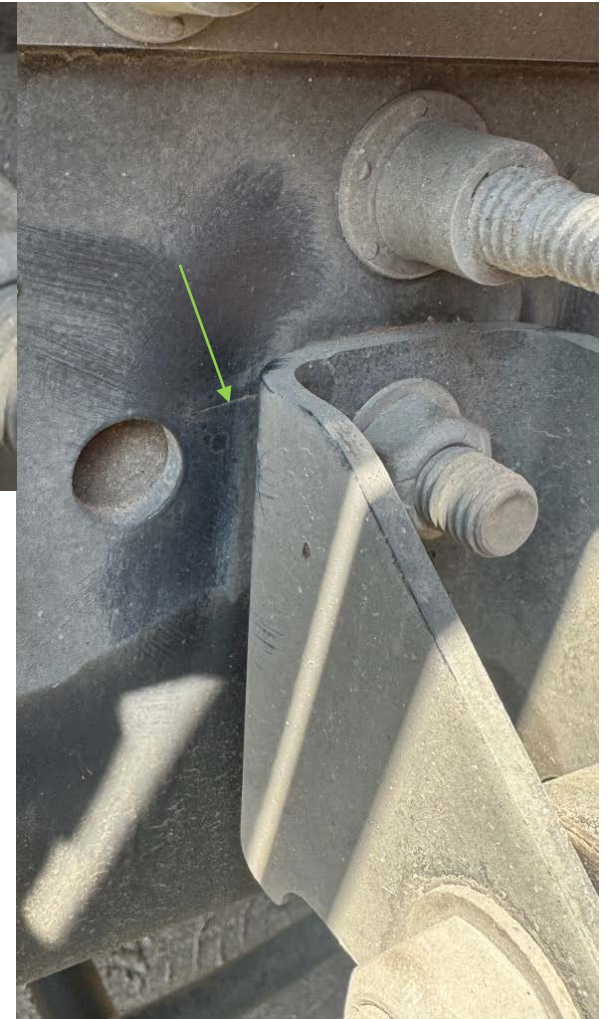
Severity Detection Example

Crank Length- 45mm

Crack Quantity- 1

Solution- Repair Plate 1

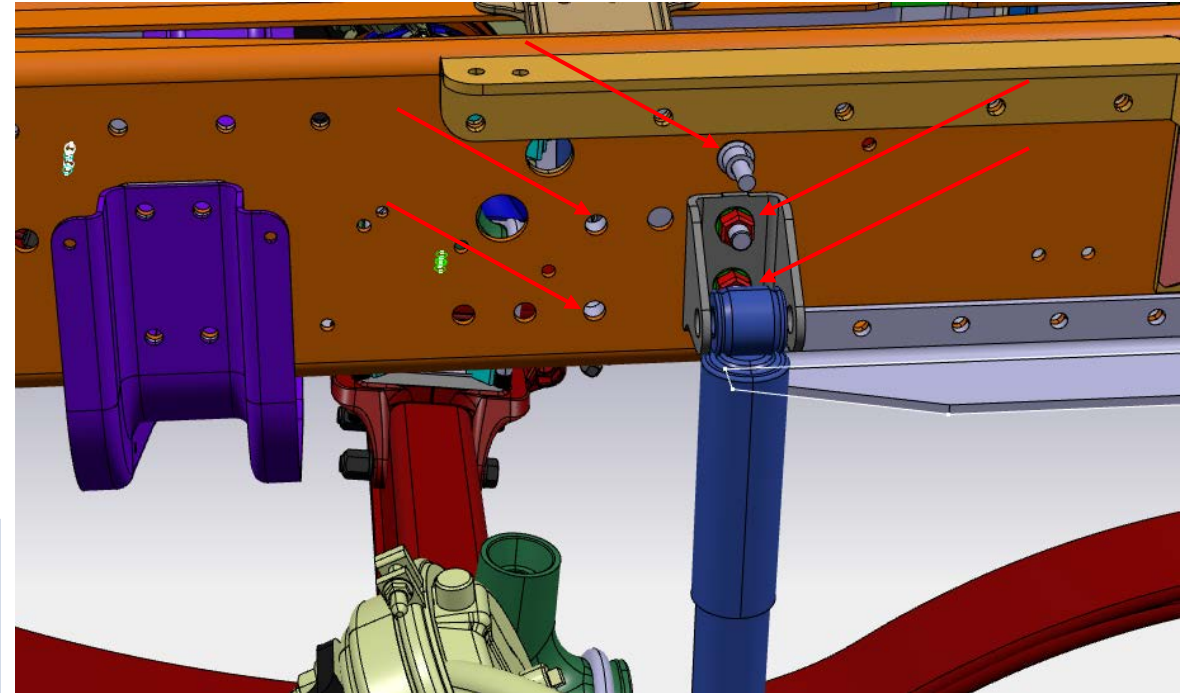
Photo of crack stop drill

Photo of Transfer Punch

5. Remove all fasteners as described in FIG1
6. Identify and center punch the end(s) of existing crack(s). Stop drill with #30 drill bit.
7. Temp up the relevant repair plate, and using the proper transfer punch, mark the holes required for drilling

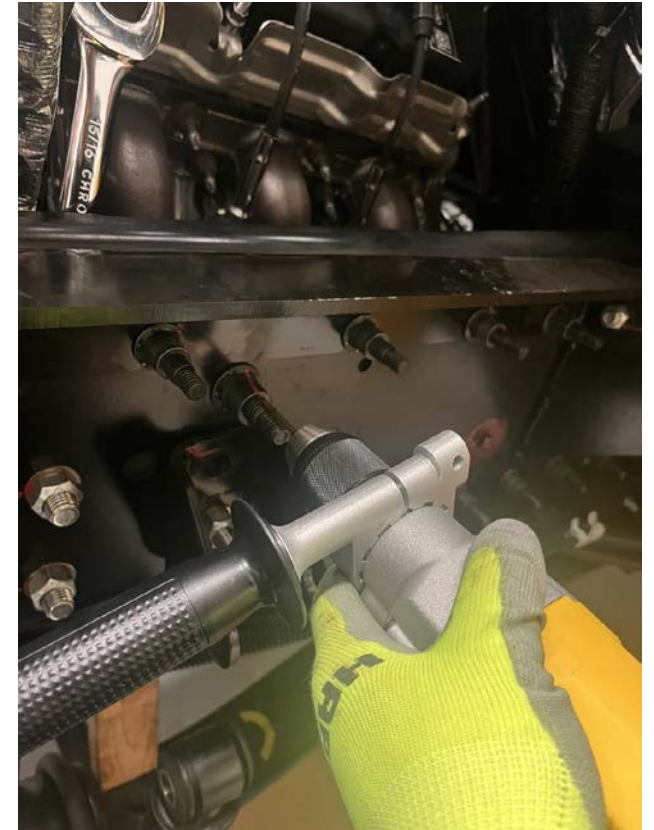
Photo of marking holes

Photo of Mag Drill

8. Setup Mag Drill with 9/16” annular Cutter, engage pilot into marks made from transfer punch
9. Bore 3 holes, going slow with proper oil.
10. Cut & remove Huckspin™ collar and remove bolt.
