Subject: RV Door Latch may experience a lock-out condition

This letter serves to notify Dynamax Corporation that TriMark is intending to issue a Technical Service Bulletin and conduct a Field Retrofit for the PTL Entrance Door Model 3000 that uses a TriMark 030-0900 Motor Home Entrance Door System with a 21396-05 Inside Release.

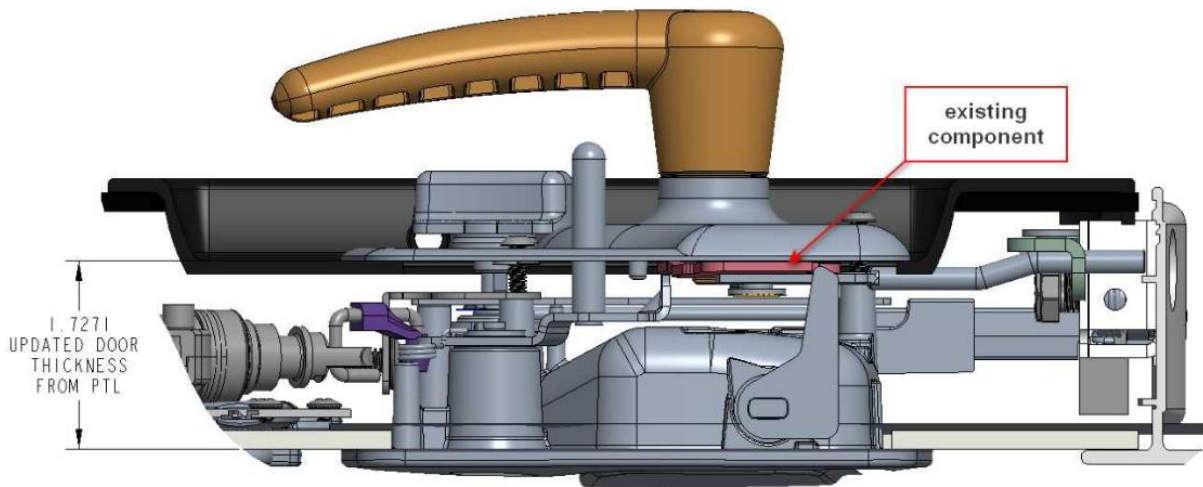
21396-05 / 36285-02 IN 1.7271" PTL DOOR

Description of the defect: TriMark manufactured and sold to PTL, a complete RV door hardware system consisting of a 030-0900 Exterior Paddle Handle (P/N's 36285-02 and 36285-04), Inside Release (P/N 21396-05) and Rotary Latch (P/N 17999-01). PTL Engineering has reported that several Motor Coach Manufacturers have encountered issues with motorhome lockouts at their manufacturing facilities. Additionally, there have been several reported lockouts affecting coach owners on sold units. It was found that the pivot arm on the outside handle may pass underneath the release arm of the inside handle, due to multiple potential root causes preventing the door from opening from the outside handle. However, the interior handle is still operational from inside of the motor home.

Description of the safety risk: a small percentage of doors exhibit a condition where the exterior paddle handle can bypass the inside release pivot causing a lock-out situation, but the door can still be opened from the inside.

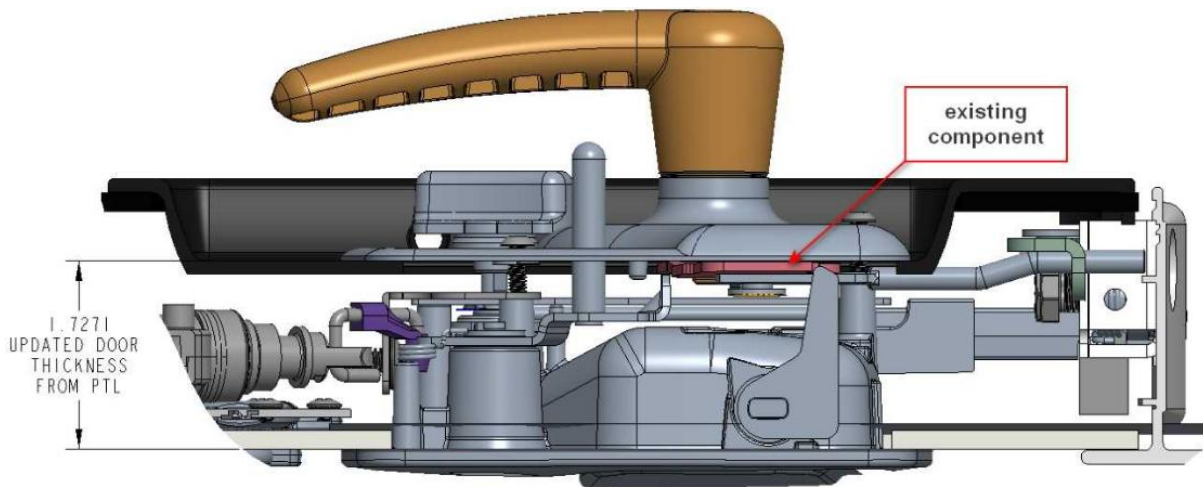
21396-05 / 36285-02 IN 1.7271" PTL DOOR

Description of the defect: TriMark manufactured and sold to PTL, a complete RV door hardware system consisting of a 030-0900 Exterior Paddle Handle (P/N's 36285-02 and 36285-04), Inside Release (P/N 21396-05) and Rotary Latch (P/N 17999-01). PTL Engineering has reported that several Motor Coach Manufacturers have encountered issues with motorhome lockouts at their manufacturing facilities. Additionally, there have been several reported lockouts affecting coach owners on sold units. It was found that the pivot arm on the outside handle may pass underneath the release arm of the inside handle, due to multiple potential root causes preventing the door from opening from the outside handle. However, the interior handle is still operational from inside of the motor home.

Description of the safety risk: a small percentage of doors exhibit a condition where the exterior paddle handle can bypass the inside release pivot causing a lock-out situation, but the door can still be opened from the inside.
