Technical Service Bulletin

| Topic | New Continental GT/C & New Flying Spur - Air suspension warning light in the DIP |
| Transaction No. | 2070768/2 |

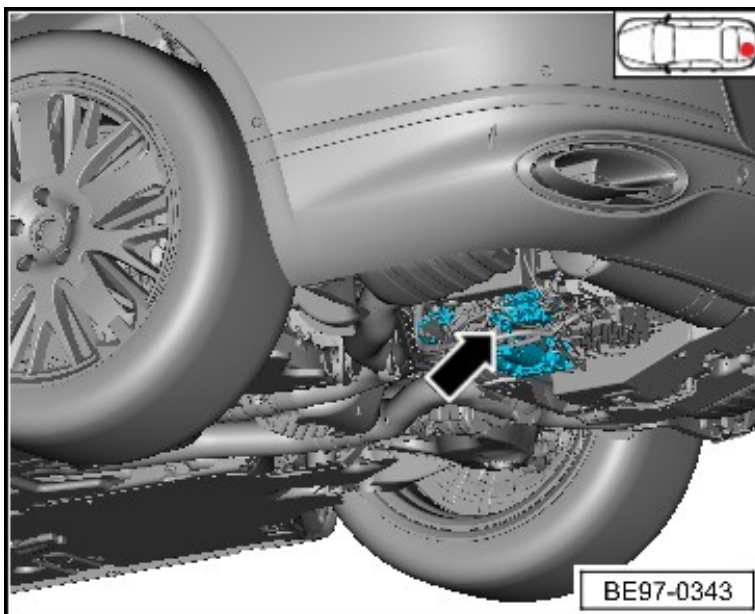
NOTE: NX7 is located as shown in Figure 1

- Perform visual inspections of the connectors/pins, checking for damage and water ingress

TIP: Previous instances have highlighted the following after inspection:

- Broken wires
- Kinked wiring
- Pin/s missing
- Pin's broken
- Pin's loose

1) Referring to the applicable wiring diagram - Conduct a wiring integrity of the applicable air suspension circuits from NX7

2) Repair any broken or damaged wires as per Rep.Gr 97

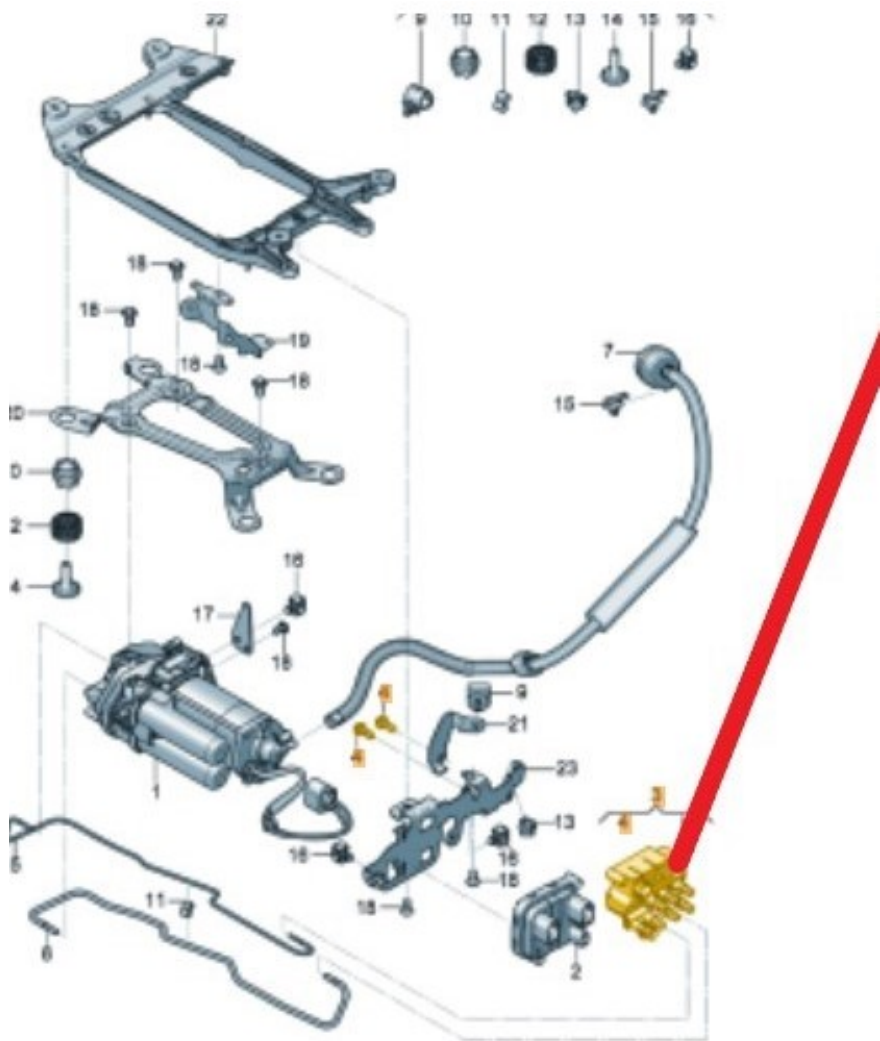
Figure 2

- Check for water ingress within the air supply unit/valve block
- Check for water ingress within the air supply hoses
- Check the air filter is not blocked
- Should none of the afore mentioned issues be evident - Replace the solenoid valve block (Figure 2) as detailed within Rep.Gr 43

Hint: The solenoid valve block can be replaced without the need to remove the air supply unit from the vehicle

- Check to confirm the issue is now resolved and no DTC's are evident

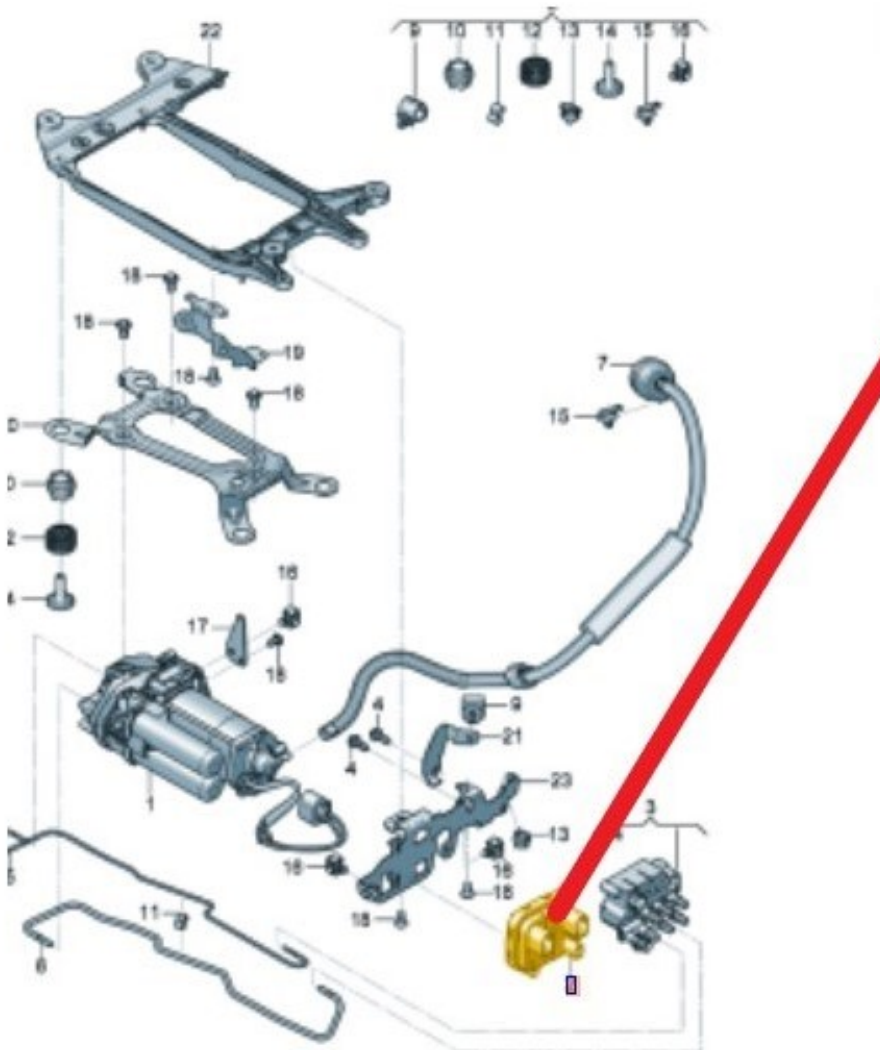
Figure 3

Should an electrical issue be evident issue and the wiring integrity checks were to specification, the operative should continue as follows:

- Referring to Rep.Gr43 (Air suspension compressor to remove and fit) - Replace the compressor control unit (Figure 3)

Hint: The compressor control unit can be replaced without the need to remove the air supply unit from the vehicle

The control unit is secured to the air supply unit bracket using (x4) clips - To remove the control unit disengage the clips using a non metallic tool then slide/remove the control unit from the bracket

TIP: The clips can easily snap - Take care when refitting the new control unit
