Technical Service Bulletin

Topic	Rear Door Blind Inoperative Bentayga Series
Market area	Bentley: worldwide (2WBE),China 796 VW Import Comp. Ltd (Vico), Beijing (6796)
Brand	Bentley
Transaction No.	2077256/2
Level	EH
Status	Released for publishing
Release date	Jul 7, 2025

Rear door blind is inoperative.

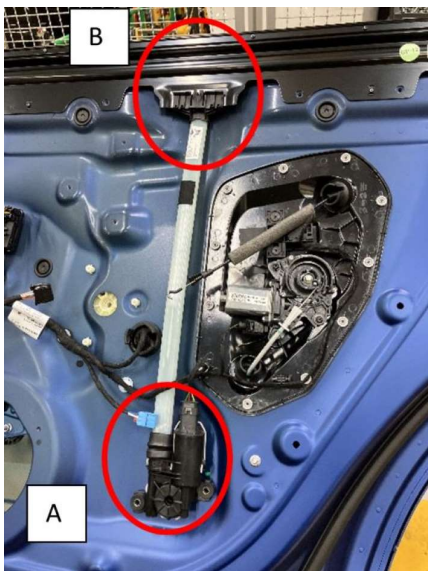
Figure 1

- 1) Check if any external influence is blocking the blind to actuate and provide relevant images and videos.
- 2) Check for DTC's in the rear door ECU's (diagnostic address 00BB or 00BC) and submit the log via a full technical DISS query.
- 3) Disconnect the roller blind motor and actuate the motor to check if it is working and send the videos via a full technical DISS query.

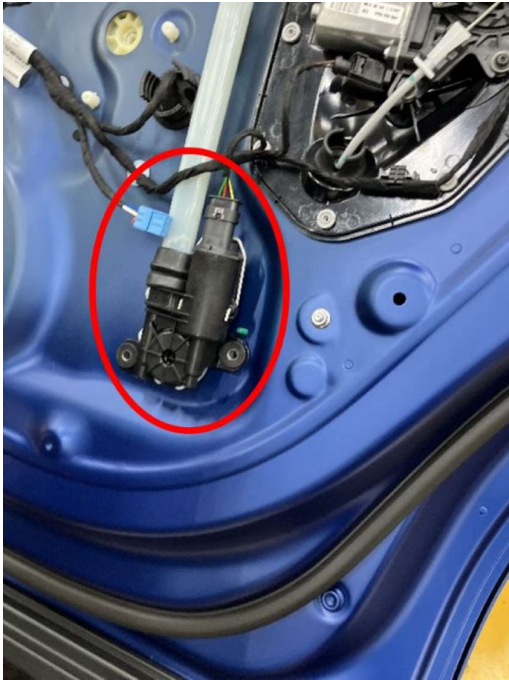
Figure 2 – A close up of detail A from figure 1

- To disconnect the motor, first unplug the connector and unscrew the fixings from the motor (Figure 2)

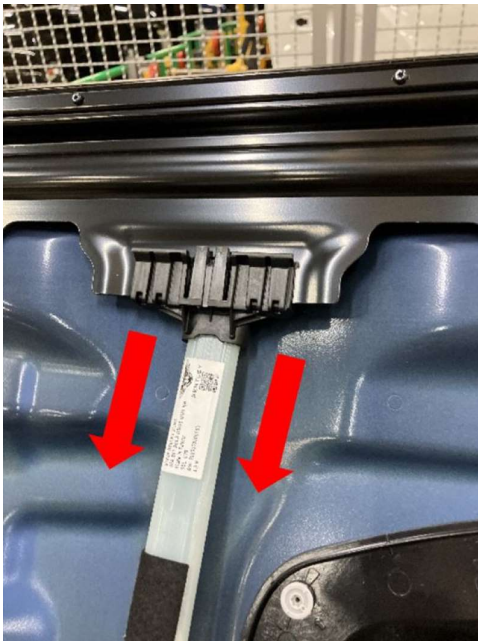
Figure 3 – A close up of detail B from figure 1

4) Remove the motor only (Figure 3) and actuate the rear door blinds through the switch and through ODIS.
