Technical Service Bulletin

Topic	Air Suspension Warnings - EFP does not communicate with ODIS Continental GT/GTC /Flying Spur 25MY
Market area	Bentley: worldwide (2WBE),China 796 VW Import Comp. Ltd (Vico), Beijing (6796)
Brand	Bentley
Transaction No.	2078265/1
Level	EH
Status	Released for publishing
Release date	Jul 9, 2025

25MY Continental GT/GTC and Flying Spur

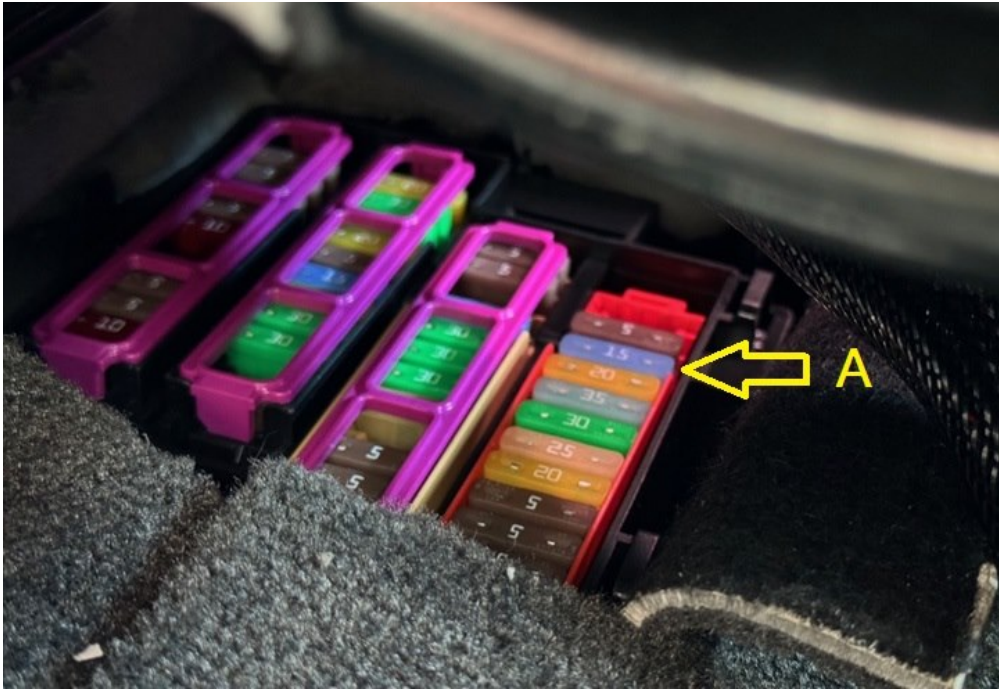
Figure 2. Fuse control panel

- Fuse carrier 2 (ST4 RED – LHS Font Seat, floor) (Figure 2, A)

Tip: You must consult the applicable wire diagram for the vehicle you are working on if there is no fuse in position F4, or the fuse in position F4 is not 15A.

3. Perform a reset of the suspension control module supply fuse (address word 0074) by removing the KL30 15A fuse - location 4 located on the red fuse holder N (rearmost of all 4) for 10 seconds.

4. Reinstall fuse board lid.

5. Re-run guided fault finding and clear DTCs if any faults are present. If faults are still present, please raise a full DISS query with a full GFF log uploaded online stating the error encountered.
