MAS004773 RU 25-20

Rapid Update 793 GranTurismo – Check right side window

DATE: July 18, 2025

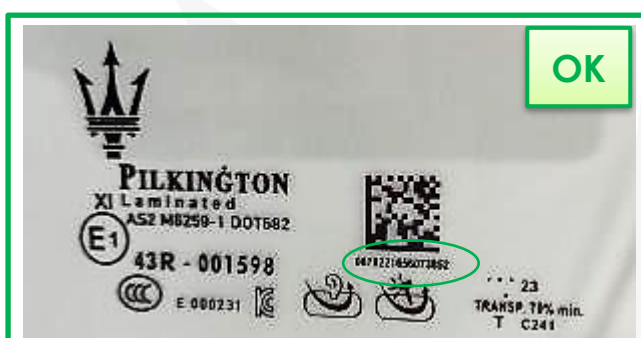
Figure 2: Right Side OK 6702216560xxxxx

→ If the **code** shown is **compliant**, no further action is required.

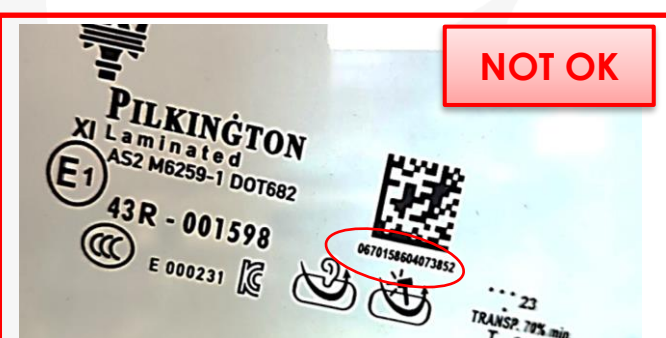
Some vehicles may have been fitted with a glass lacking the moisture protection on the edge. This condition does not affect vehicle safety, but over time, it may cause visible halos or moisture infiltration, resulting in an aesthetic issue not compliant with Maserati standards.

Figure 2: Right Side NOT OK 6701586040xxxxx

→ If the **code is not compliant**, proceed with **replacing the glass (Step 4)**.

4. Follow the procedure provided in the workshop manual to replace the glass:
 - **9.34.005 FRONT WINDOW GLASS - PASSENGER SIDE Removal-Refitting or Replacement**
5. Reinstall all removed parts in reverse order.
6. Complete the inspection and release the vehicle.

Description	Part number	Amount
FRONT RIGHT DOOR GLASS	670221656	1

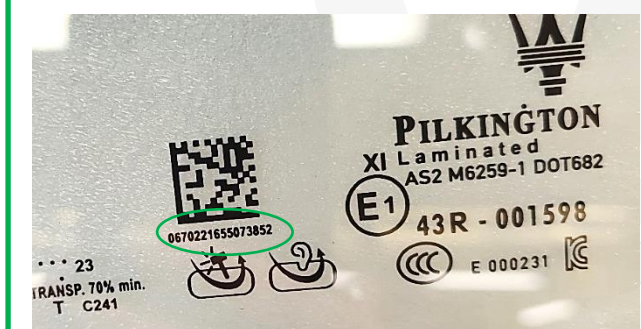
Figure 3: Left Side OK 6702216550xxxxx

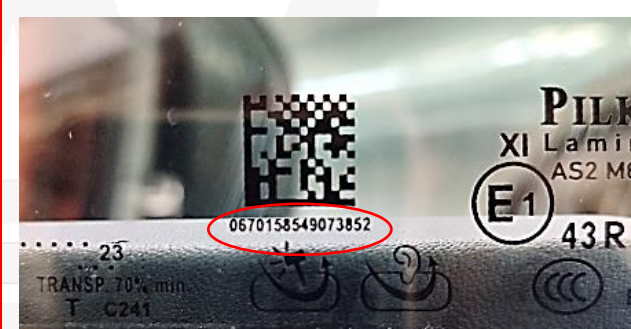
Important note: The inspection of the left side is a formality. No issues are expected. However, if a non-conformity is found on this side, open a BOL as "support request" and wait for further instructions.

Figure 4: Left Side NOT OK 6701585490XXXXX
