# Technical Service Bulletin

<b>Topic</b>	EPB Warning light in DIP - Front door/s power latch system intermittent - DTC U112300 within Address 03 and Address 46
<b>Market area</b>	Bentley: worldwide (2WBE),China 796 VW Import Comp. Ltd (Vico), Beijing (6796)
<b>Brand</b>	Bentley
<b>Transaction No.</b>	2075034/3
<b>Level</b>	EH
<b>Status</b>	Released for publishing
<b>Release date</b>	Jul 18, 2025

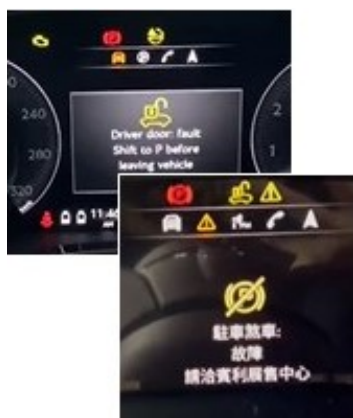
Figure 1

One or a combination of the following is evident within the DIP (Figure 1)

- Electronic parking brake warning

- Drivers door power latch intermittent operation warning

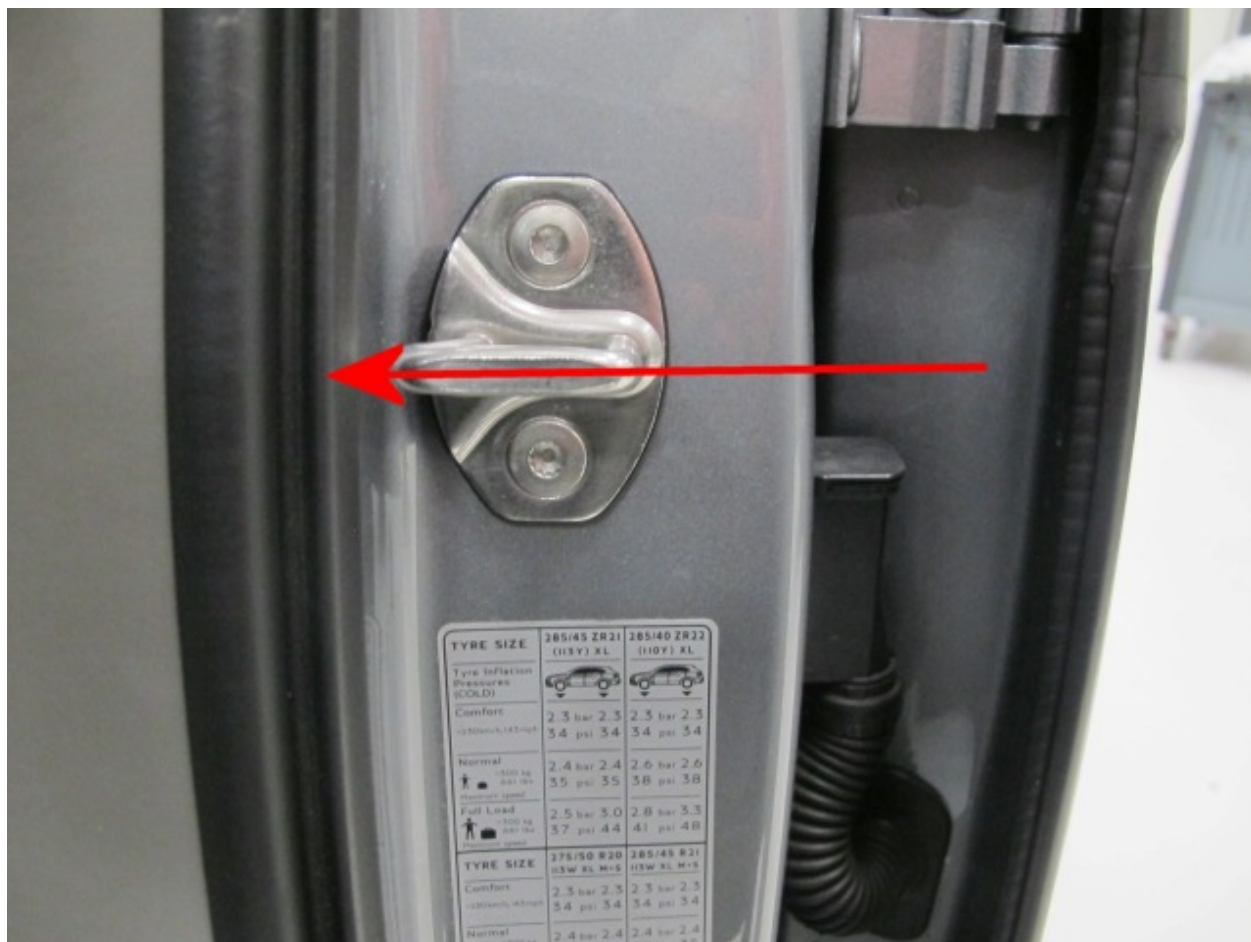
Figure 2

Insufficient back pressure of door (door closing loads / seal load) results in the pawl microswitch signal becoming too short. This short signal is then calculated as an error state by address 0003 -Brake electronics

In addition, adjust the striker as far as possible (at least 0.5 mm) further inwards (Figure 2)
