TECHNICAL SERVICE BULLETIN

Instrument Panel Upper Section Speaker Grille Is Lifting, Warped, Or Not Seated Flush With The Instrument Panel

25-2345

Lincoln 2019-2024 Navigator

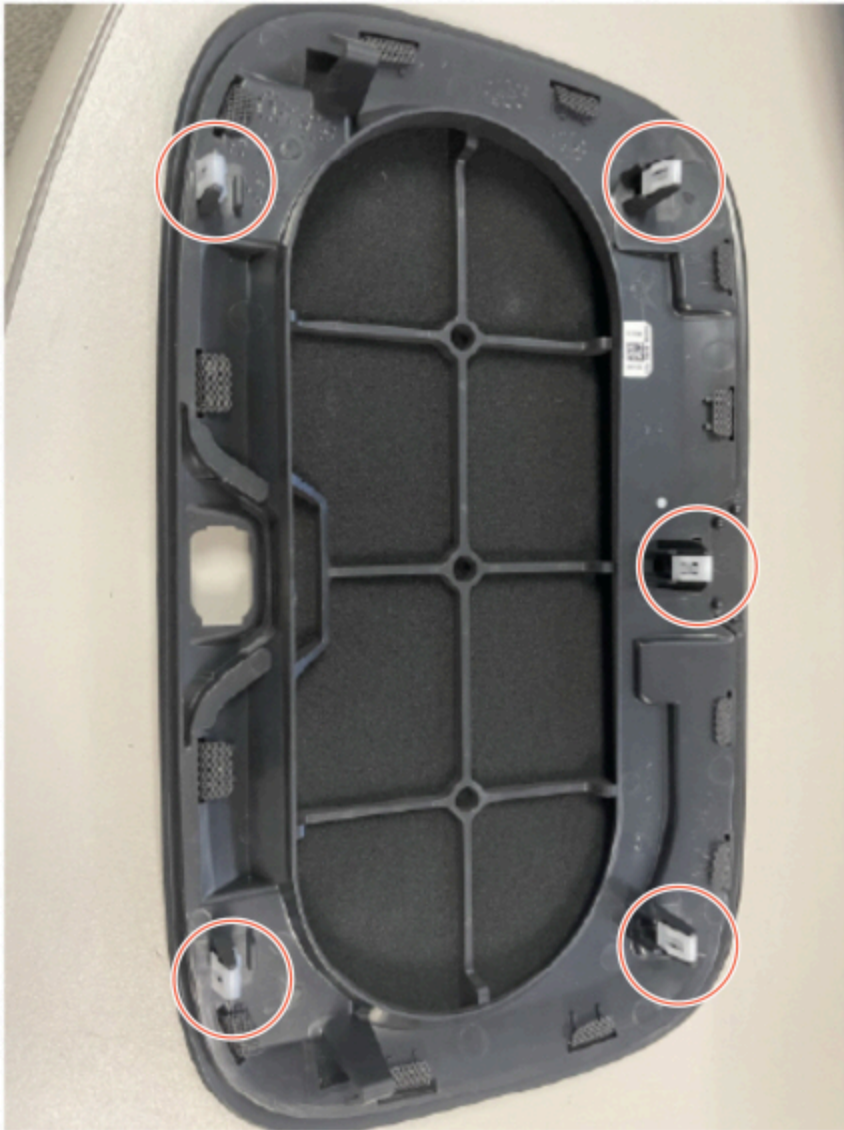
Figure 1

Issue: Some of the vehicles listed in the Model statement above may exhibit an instrument panel upper section speaker grille that is lifted, warped, or not seated flush with the instrument panel. This may be due to upper section speaker grille clips that are not seating.

2. Replace the clips on the instrument panel speaker grille with the new clips. (Figure 1)
