Technical Information

Quattroporte Ghibli Levante - Sunroof Anomalies

DATE: July 23, 2025

MODELS: Levante M161, Ghibli M157, Quattroporte M156 (All MY).

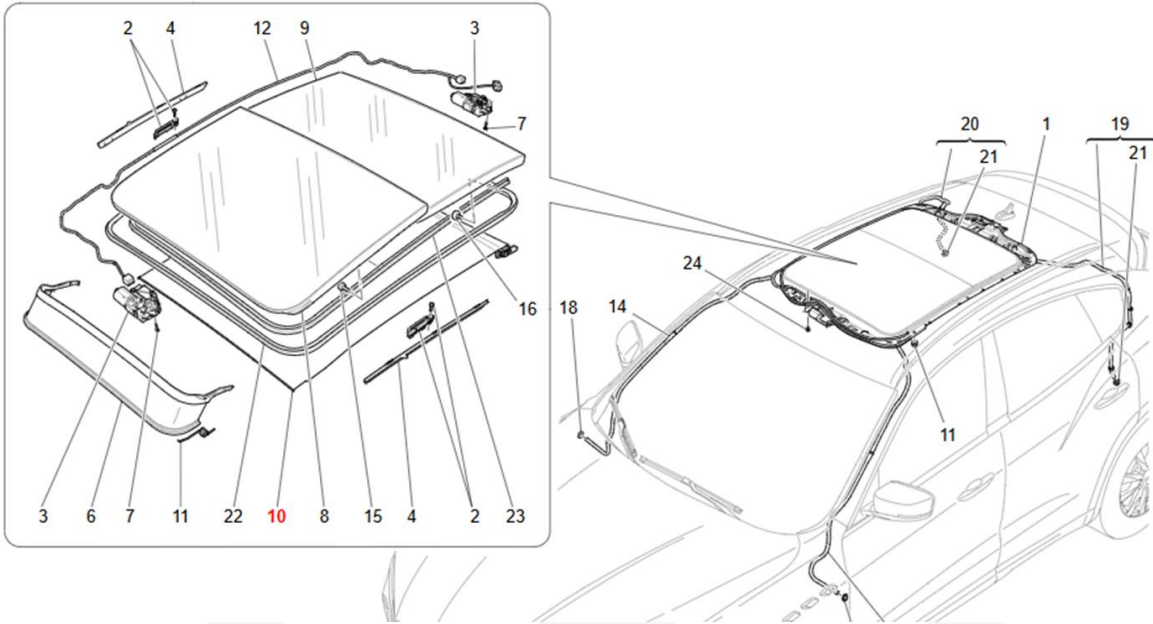
LEVANTE

Common root causes:

1. Detached wiring that vibrates and causes noise
2. Curtain displaced from guide tracks
3. Loose screws or components within the guide system
4. Friction between moving components (sticking/slipping surfaces)

NOTE: The area/position of the detached wiring clip and/or area where the curtain exits from the guides must be drawn on the image below. Take a photo of the fault. The drawn image and the photos must be attached to the Service Entry.

For item 3), the source cause (e.g., loss of screw torque) must be identified, providing indications on the image below of the area/where screw lost torque. Then:

- a) Measure the residual torque of the fastening
- b) Tighten to torque according to the workshop manual and check that the problem has been solved

For item 4), draw on the image below the contact zone that generates the noise and make detailed videos of the noisy zone before and after the operation (to objectify that the adopted solution has solved the problem). The image drawn and the videos must be attached to the Service Entry.
