**TECHNICAL SERVICE BULLETIN****25-2350****"Steering Assist Fault Service Required" Message In The IPC And Reduced Steering Assist With DTCs U3008 And/Or U3009 Stored In The PSCM**

25 July 2025

Ford 2025 Explorer
Lincoln 2025 Aviator

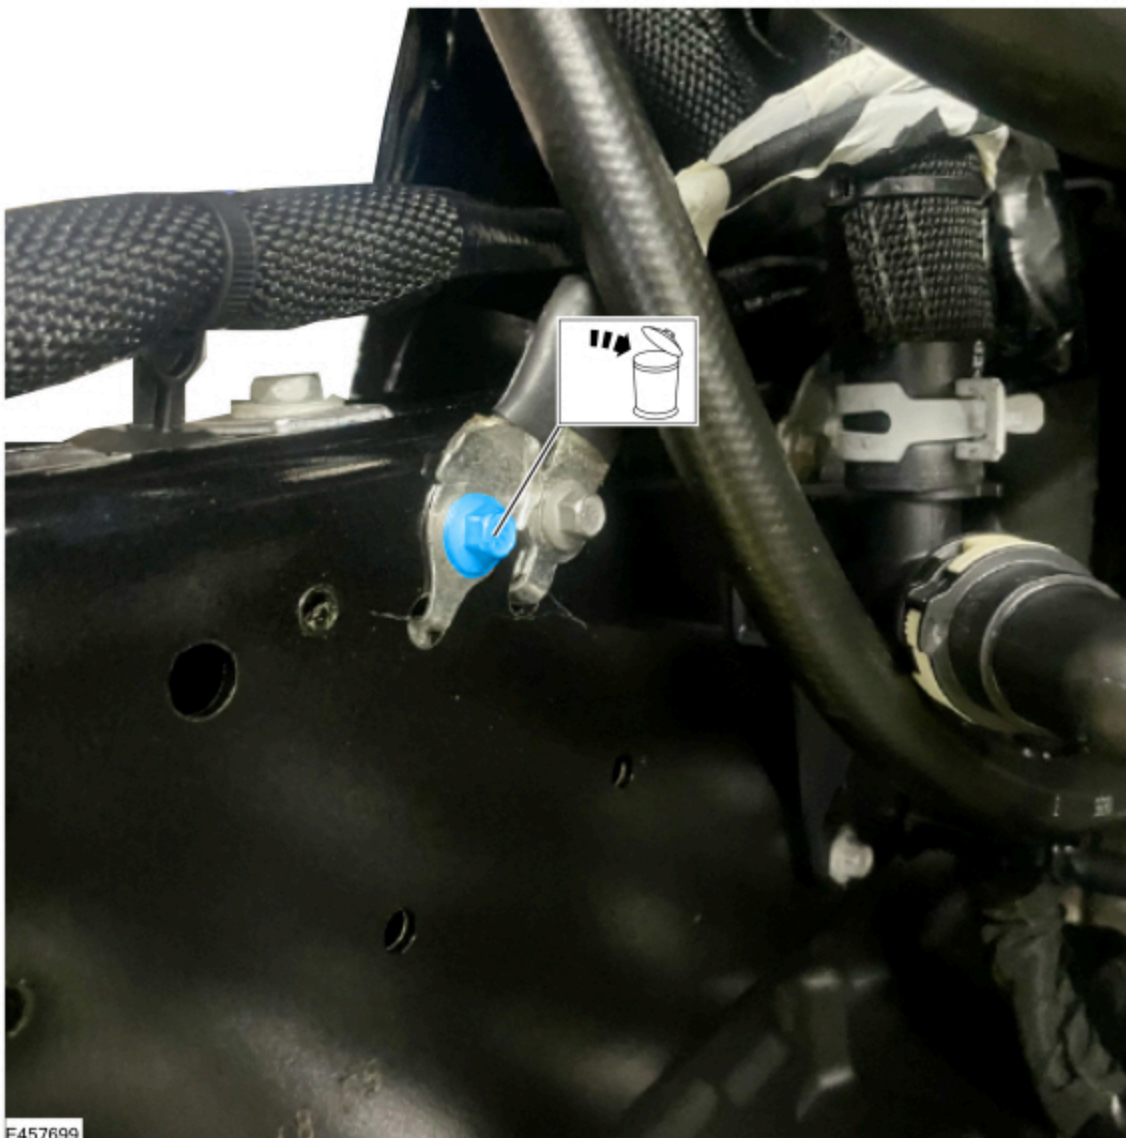
Figure 1

- Using the latest version of the FDRS scan tool, download and run the "Self-Test" application and select "Run ALL CMDTCs". Is DTC U3008 present in the PSCM?
 - Yes - proceed to Step 2.
 - No - proceed to Step 7.
- Remove the engine front undershield. Refer to WSM, Section 501-02 > Removal and Installation > Engine Front Undershield.
- Remove and discard the M6 fastener from ground G104 (Explorer) or G116 (Aviator) on the passenger side frame rail. Refer to Wiring Diagram Cell 151 for connection locations. (Figure 1)

4. Carefully enlarge the existing holes in the frame rail sheet metal and the harness eyelet by drilling with a 7 mm (9/32 in.) drill bit.
5. Reinstall ground G104 (Explorer) or G116 (Aviator) using the new self-tapping M8 fastener. Make sure the ground eyelet locating tab is properly aligned with the alignment hole in the frame. Tighten to 71+/-11 lb.in (8.0+/-1.2 Nm).
6. Install the engine front undershield. Refer to WSM, Section 501-02 > Removal and Installation > Engine Front Undershield.
7. Using FDRS, download and run the "Self-Test" application and select "Run ALL CMDTCs". Is DTC U3009 present in the PSCM?
 - (1). Yes - proceed to Step 8.
 - (2). No - repair is complete. If further diagnosis is necessary, refer to WSM, Section 211-02 > Diagnosis and Testing.
8. On Aviator vehicles, remove the wiring harness retainer from the ground G119 stud bolt to access the bolt. (Figure 2)
