TECHNICAL SERVICE BULLETIN

Chatter/Shudder During Low Speed Turning Events

25-2351

25 July 2025

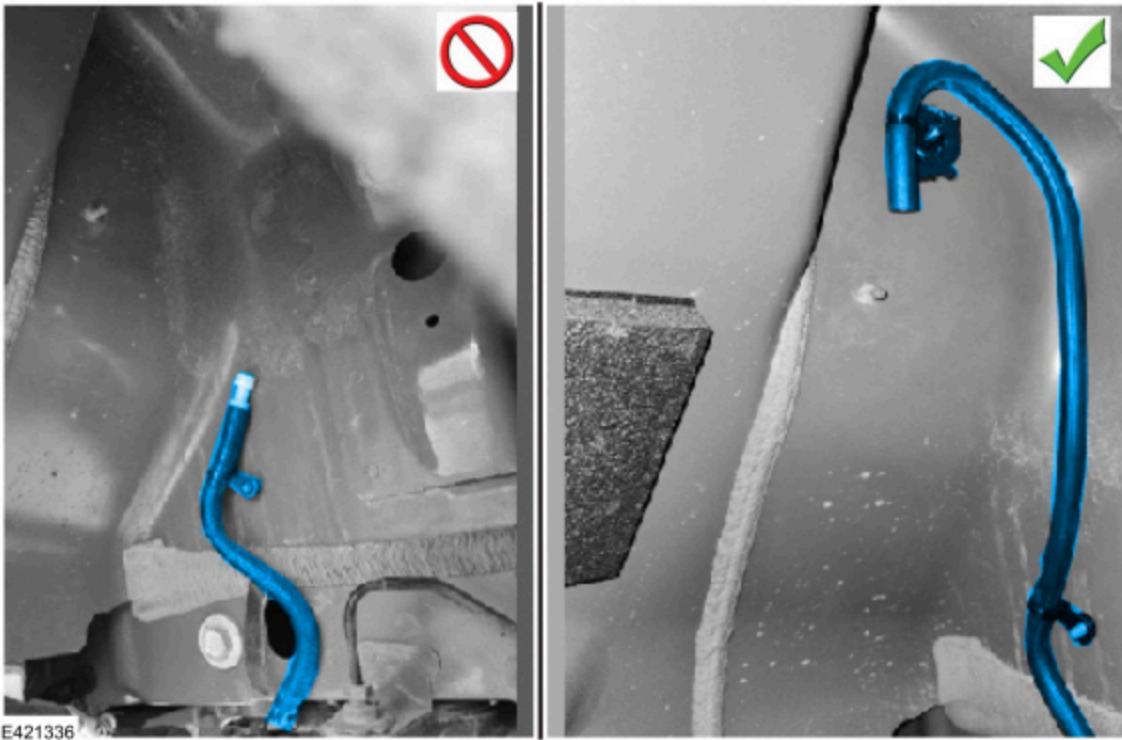
Figure 3

2. Inspect the RDU vent hose mounted behind the right rear fender splash shield. Is the vehicle equipped with the updated RDU vent hose as shown in the image with the green check mark in Figure 3?

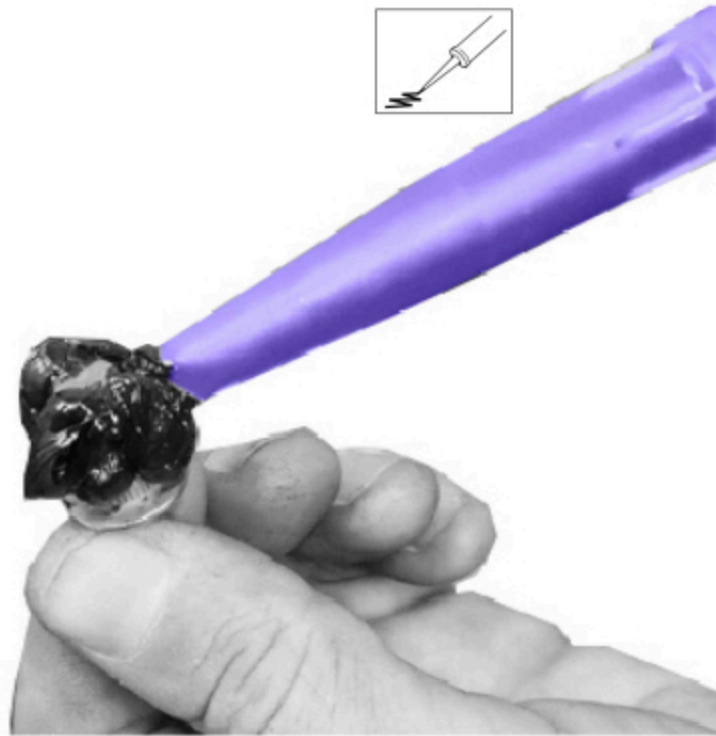
Figure 12

CAUTION: Failure to properly seal the stud rivet could lead to water entry into the passenger area.

22. Apply a generous amount of sealant to the body side of the stud rivet. (Figure 12)
