Technical Service Bulletin

Topic	Window Drop Glass Operation Continental GT/GTC 25-26MY
Market area	Bentley: worldwide (2WBE),China 796 VW Import Comp. Ltd (Vico), Beijing (6796)
Brand	Bentley
Transaction No.	2075821/3
Level	EH
Status	Released for publishing
Release date	Jul 18, 2025

Retailer glass reset procedure for New GT/GTC

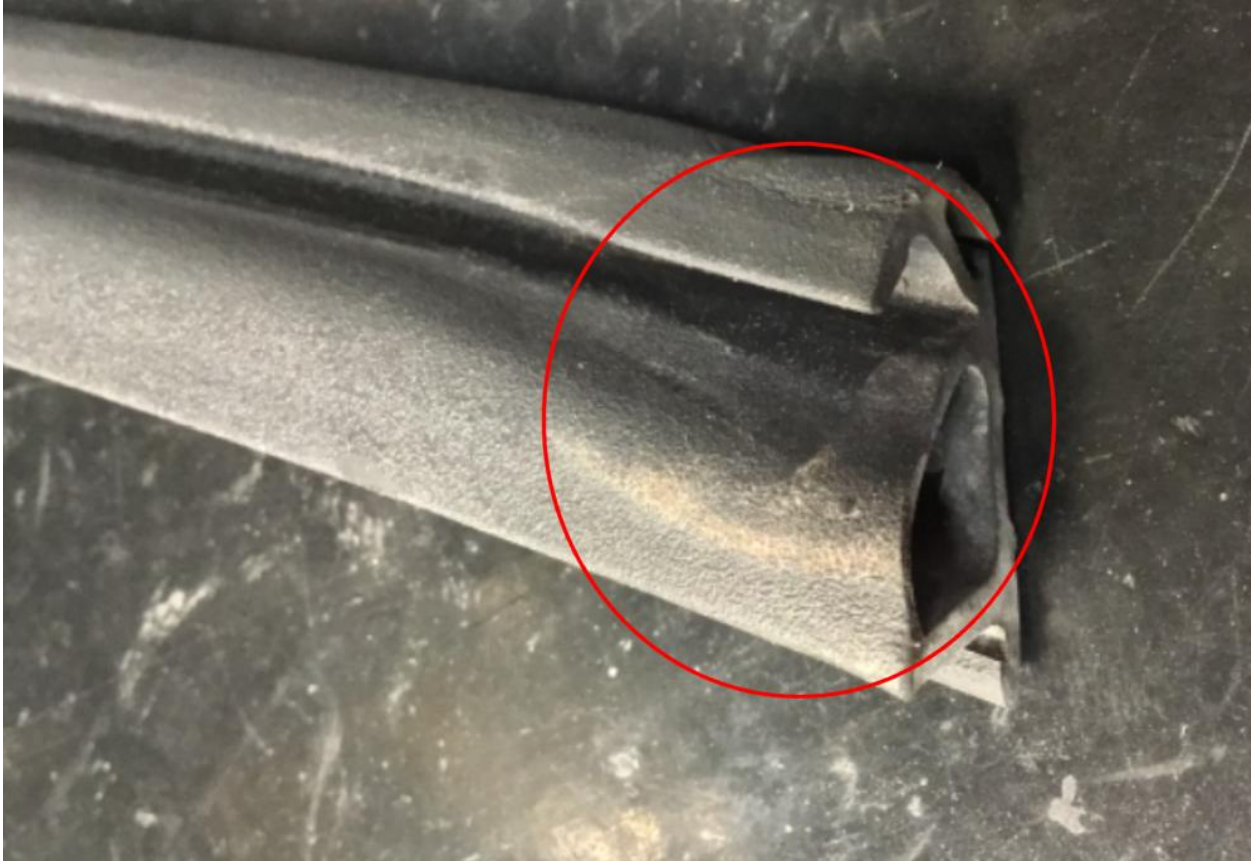
Figure 1

- Splits
- Tears
- Misalignment
- Incorrectly fitted / located
- Drop glass seal deformation (see Figures 1 and 2 as examples)

NOTE: Any issues found with the window seals must be rectified before conducting the remaining steps

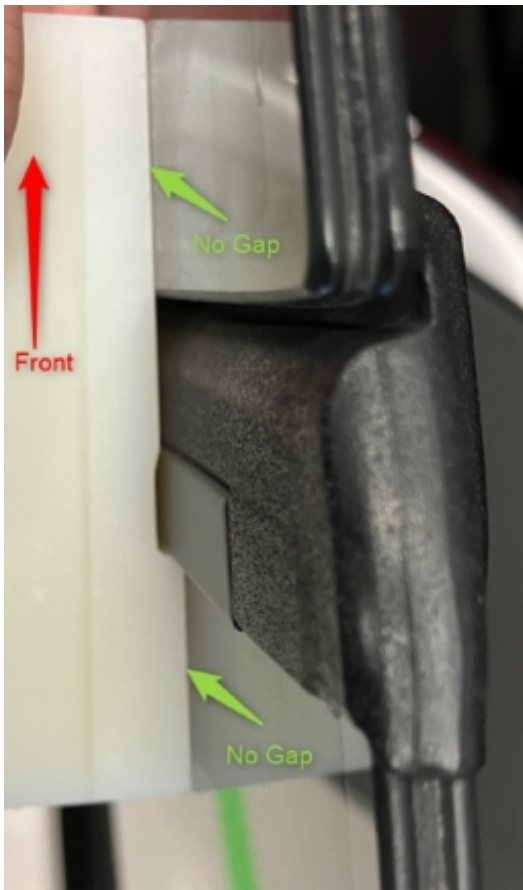
Figure 6

When the rear window is inboard and there is a 2mm step from the tool, when there is no gap between either window and tool (figure 6), the recorded measurement should be -2mm (figure 7)

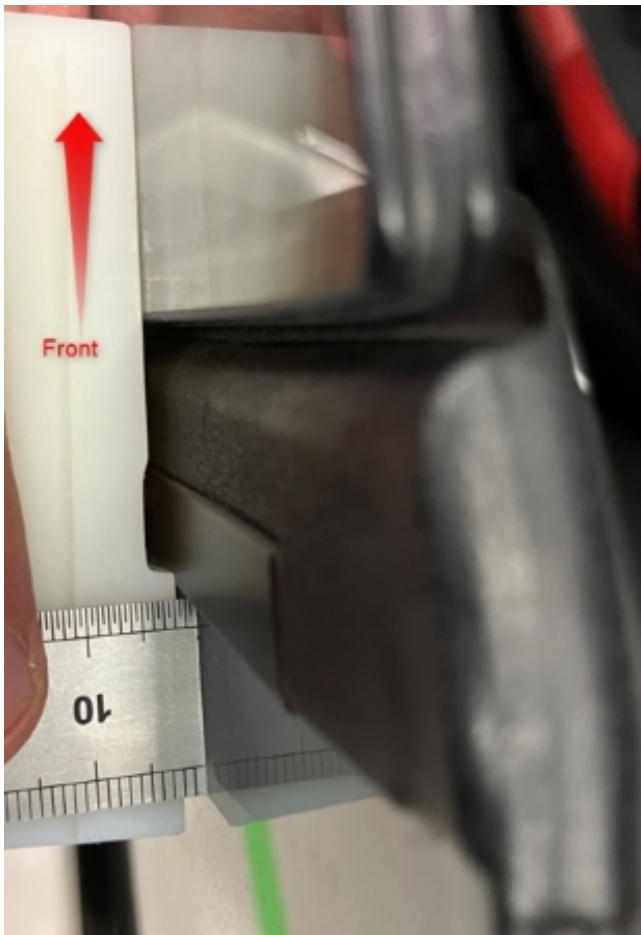
Figure 8

When the rear window is inboard and there is a 2mm step from the tool as well as an additional 1.5mm gap to the window (figure 8), the recorded measurement should be -3.5mm (figure 9).

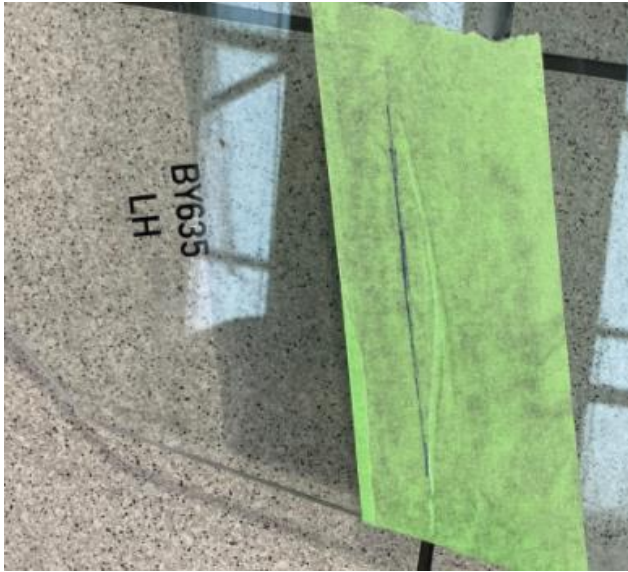
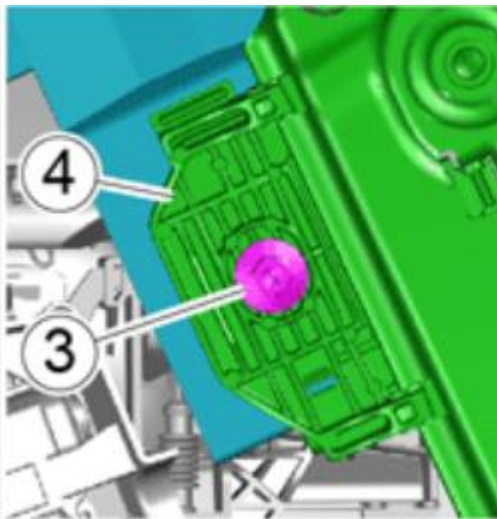
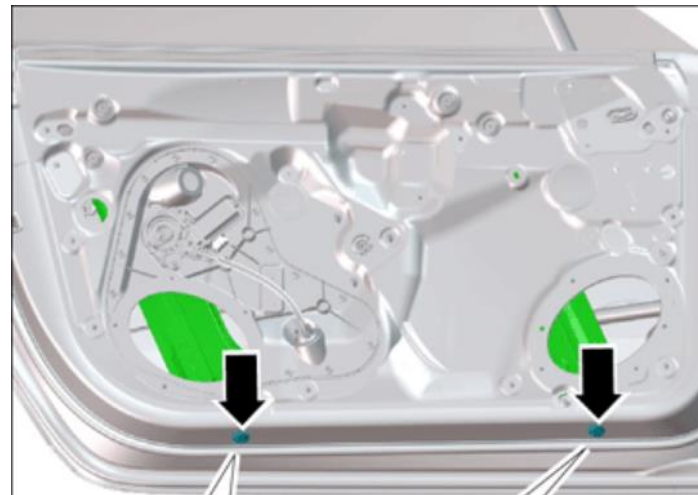
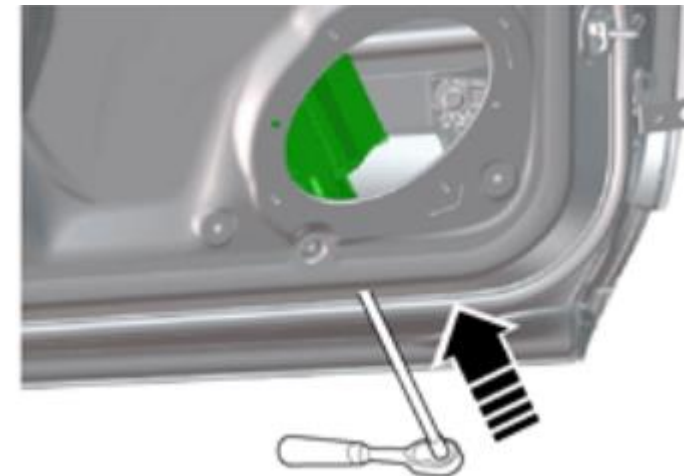
Example: Front drop glass Z axis not adjusted correctly. Bottom of tape was level with waist rail seal, after slackening pinch bolt (3 in bottom left image) front drop glass lowered 14mm to where pen marked line is.

Z-axis adjusters (bottom middle and right images) had not been used, pinch bolt had been slacked and glass lifted out of the regulator to achieve specification. This has a knock on effect of altering the 10mm division bar intrusion seen in previous slide as glass is loose and can be accidentally moved in X-axis.

This also creates a risk that the window will bottom out on the cant rail seals rather than the regulator bump stops meaning that the glass can raise further as the seals soften over time and affect end stop learning.

Z-Axis height should only be adjusted by the 4mm Allen key adjusters as per ELSAPRO

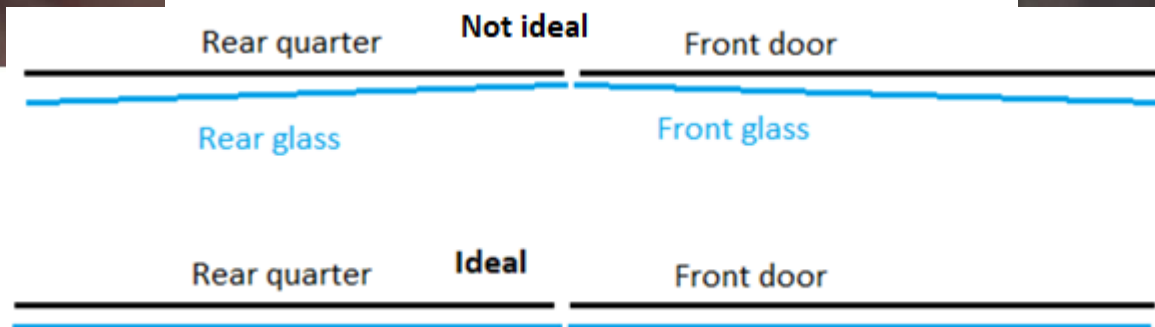
Images show a poor setting.
Circa 6mm at front edge (near wing mirror)
closing up to 2mm at the rear edge.

2mm at rear edge would have been set to achieve specified flush/2mm underflush profile condition between front and rear glasses, the rear quarter glass mirrors this taper condition. This potentially increases the risk of false anti trap as rear window/seal does not engage with front window at the correct angle. Suggested to set to specification on problem vehicles as per next slide. If both windows are set between 4-6mm then the flush/2mm underflush profile can be easily achieved.

Set waist rail gapping to between 4-6mm as mentioned in Glass setting guide videos on E-Academy and also check for parallelism along front and rear windows to door/quarter. 50mm from edge of Wastrail seal, roughly underneath the Bentley wings.

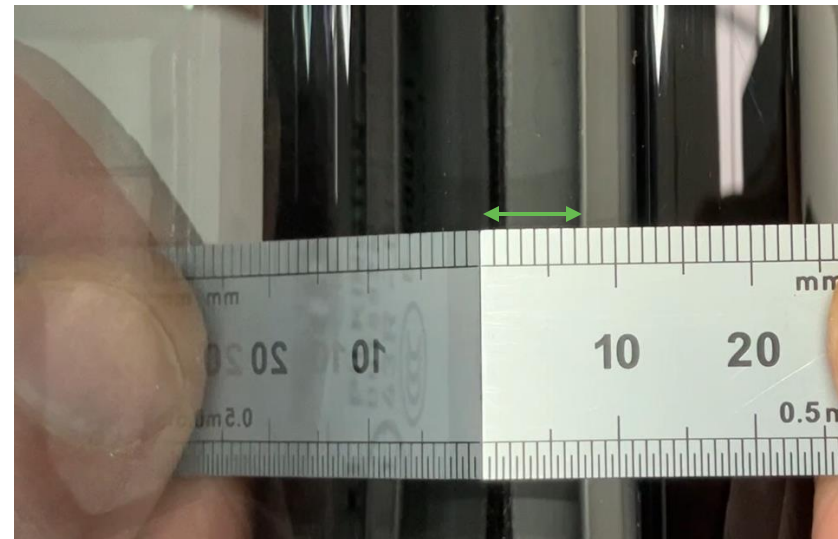
RHF window, front window closed, rear window closed. Note gap, over 0.25mm outboard movement, this is incorrect

If more tension is required to resolve a wind noise or water ingress then aim for no more than 0.25mm of outboard movement.
