REFERENCE:	TSB: 08-221-25 GROUP: 08 - Electrical	Date:	July 22, 2025	REVISION:	—
VEHICLES AFFECTED:	<p>2019 - 2025 (D2) RAM 3500 Pickup 2025 (DD) RAM 3500 Cab Chassis 2019 - 2025 (DJ) RAM 2500 Pickup 2025 (DP) RAM 4500/5500 Pickup 2019 - 2025 (DT) RAM 1500 Pickup</p> <p>This bulletin applies to the following:</p> <ul style="list-style-type: none"> • 2021 - 2024 DT equipped with RamBox Cargo Management System (Sales Code XB9). • 2025 DT vehicles built on or before April 30, 2025 (MDH 0430XX) equipped with RamBox Cargo Management System (Sales Code XB9) and Exterior 115V AC Outlet (Sales Code XBE). • DD and DP vehicles built on or before April 30, 2025 (MDH 0430XX) equipped with On-Board Power System - Low Power (XBH). • 2019 - 2020 D2 and DJ equipped with RamBox Cargo Management System (Sales Code XB9). • 2021 - 2025 D2 vehicles built on or before April 30, 2025 (MDH 0430XX) equipped with RamBox Cargo Management System (Sales Code XB9) and Exterior 115V AC Outlet (Sales Code XBE). • 2021 - 2025 DJ vehicles built on or before April 30, 2025 (MDH 0430XX) equipped with RamBox Cargo Management System (Sales Code XB9) and Exterior 115V AC Outlet (Sales Code XBE) or On-Board Power System

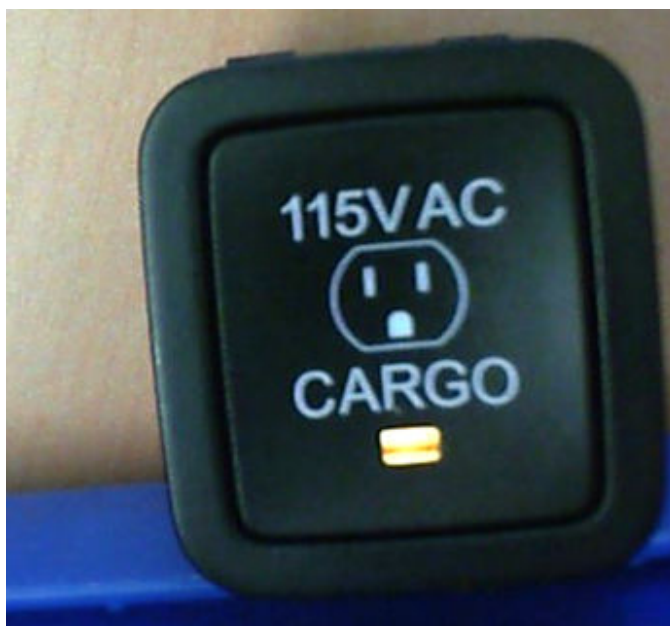
Fig. 1
115V Inverter Switch

CUSTOMER SYMPTOM:	<p>Customers may experience the following:</p> <ul style="list-style-type: none"> • The amber LED remains continuously illuminated, regardless of whether the switch button is activated. 				
CAUSE:	Manufacturing issue

1. Replace the 115V inverter switch [Fig. 1](#). Refer to the detailed service procedures available in DealerCONNECT/Service Library under: Service Info> 08 - Electrical / 8W - Power Distribution / Outlet, Power / Removal and Installation.
