<b>REFERENCE:</b>	<b>TSB:</b> 18-011-25 REV. A <b>GROUP:</b> 18 - Vehicle Performance	<b>Date:</b>	July 25, 2025	<b>REVISION:</b>	18-011-25
<b>VEHICLES AFFECTED:</b>	<b>2024 (JL) Jeep Wrangler</b> This bulletin applies to vehicles equipped with the 2.0L I4 DOHC DI Turbo Engine W/ESS (Sales Code EC1).	<b>MARKET APPLICABILITY:</b>			
		<input checked="" type="checkbox"/> NA <input checked="" type="checkbox"/> <b>**IAP**</b> <input checked="" type="checkbox"/> <b>**SA**</b> <input type="checkbox"/> <b>**CH**</b> <input type="checkbox"/> EE <input checked="" type="checkbox"/> <b>**MEA**</b> <b>NOTE: **This bulletin applies to the North and South America, India &amp; Asia Pacific, Middle East and Africa and China markets.**</b>			
<b>CUSTOMER SYMPTOM:</b>	<p><b>Customers must experience a Malfunction Indicator Lamp (MIL) illumination and the vehicle must exhibit/set one or more of the following Diagnostic Trouble Codes (DTCs):</b></p> <ul style="list-style-type: none"> <li>• <b>**P0133</b> - O2 Sensor 1/1 Slow response.</li> <li>• P2453 - Particulate Filter Pressure Sensor "A" Circuit Range/Performance.</li> <li>• P245F - Particulate Filter Pressure Sensor "B" Circuit Range/Performance.

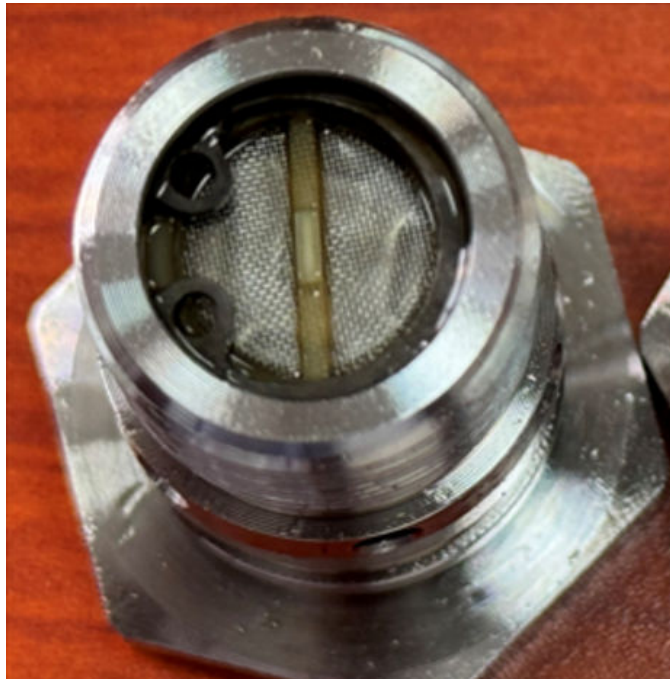
**Fig. 1**  
OCV Filter OK

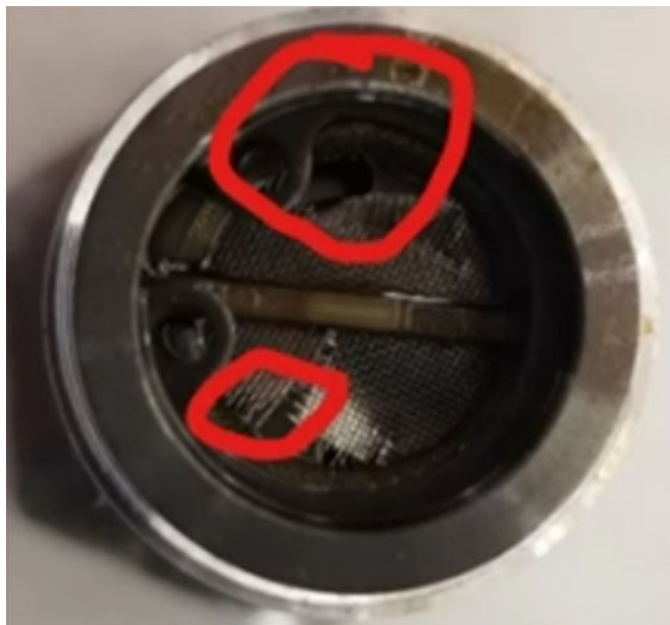
**Fig. 2**  
OCV Filter Torn

5. Are the OCV filter screen(s) torn?

- YES>>> Replace the OCV(s) and change the engine oil and filter. Refer to the detailed service procedures listed in DealerCONNECT>Service Library>Service Info>under: 09 - Engine, 2.0L / Lubrication / Standard Procedure Engine oil and filter change. Use LOPs (09-05-37-91) and (26-99-00-10). Proceed to [Step 11](#).
- NO>>> Proceed to [Step 6](#).

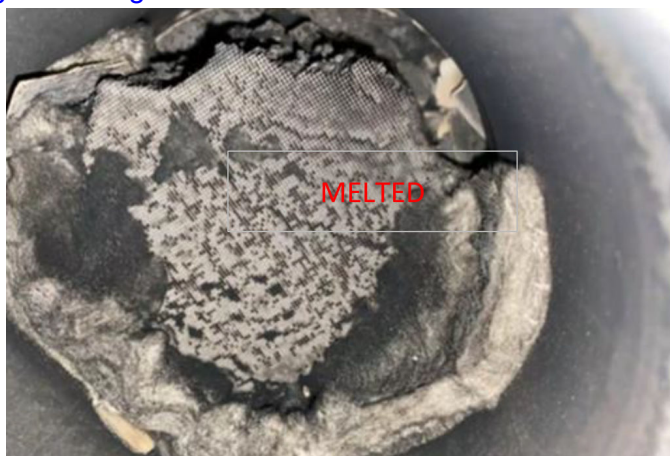
10. Remove the Upstream Oxygen Sensor and using a borescope, is the catalytic converter internally melted/ cracked or brain pattern [Fig. 3](#) and [Fig. 4](#) ?

**Fig. 3**  
Melted Catalyst

- YES>>> Replace the catalytic converter. Refer to the detailed service procedures listed in DealerCONNECT>Service Library>Service Info>under: 11 - Exhaust System / Converter, Catalytic / Removal and Installation. Use LOP (11-50-01-91). Proceed to [Step 11](#).
- NO>>> Use Inspect LOP (11-50-01-90). Proceed to [Step 11](#).
