STAR ONLINE PUBLICATION

Case Number: S2523000071

Symptom/Vehicle Issue: 1st Or 2nd Row Center Console Armrest Door Difficult To Slide Open And Or Closed.

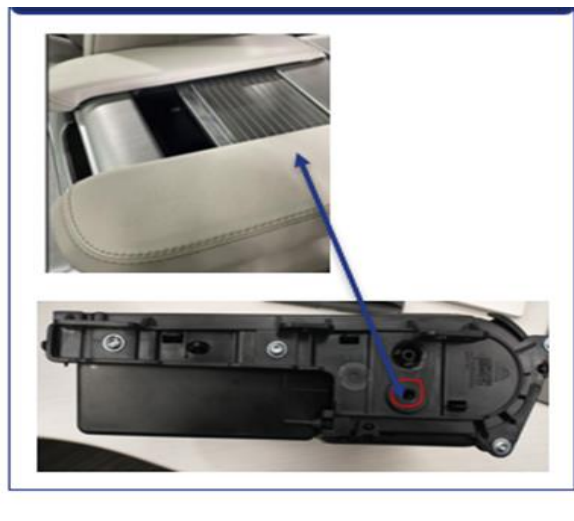
Customer Complaint/Technician Observation: Customer states cannot access armrest storage bin due to cover jamming.

1. Refer to Service Library Service Information 23 - Body / Interior / ARMREST, Console / Disassembly and Assembly FRONT FLOOR CONSOLE ARMREST to remove the bin. Follow the steps up to step 5.
2. With the bin removed. Locate the driver's side silver colored screws on the bin. Using a T20 screwdriver or socket, remove the 3rd screw (from rear to front) shown in the image below. Leave the screw- do not reinstall the screw.
3. Assemble the armrest.
4. Verify the operation of the tambor door on the armrest.
