STAR ONLINE PUBLICATION

Case Number: S2523000072

Symptom/Vehicle Issue: Central ADAS Decision Module (CADM), Long Range Camera Front (LRCF), Advanced Driver Assist System (ADAS). AEB ACC FCW Message On Cluster.

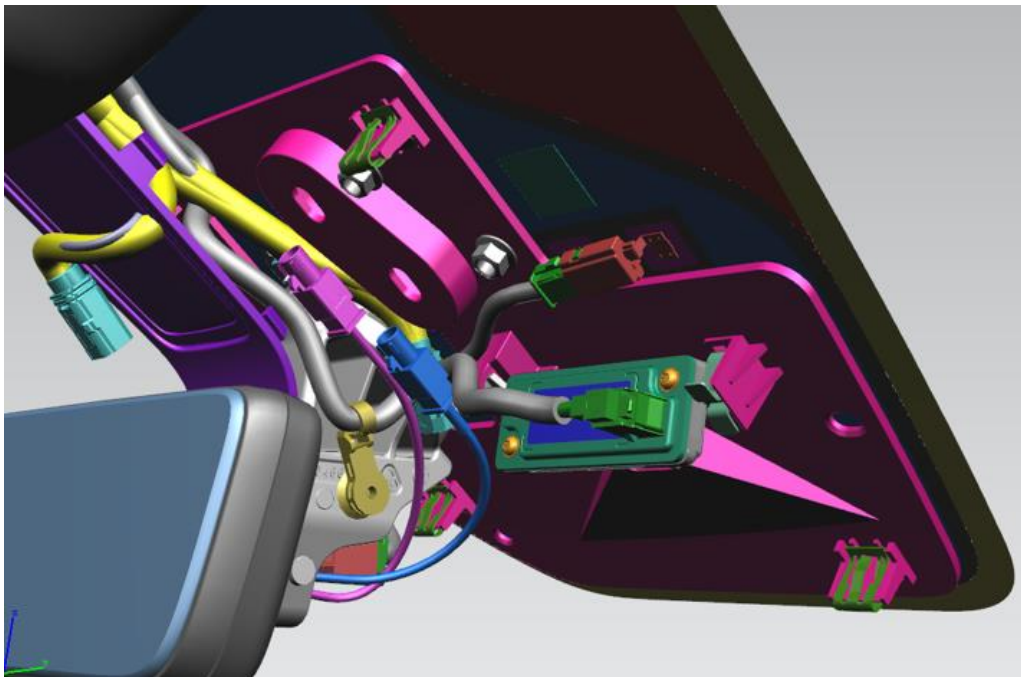
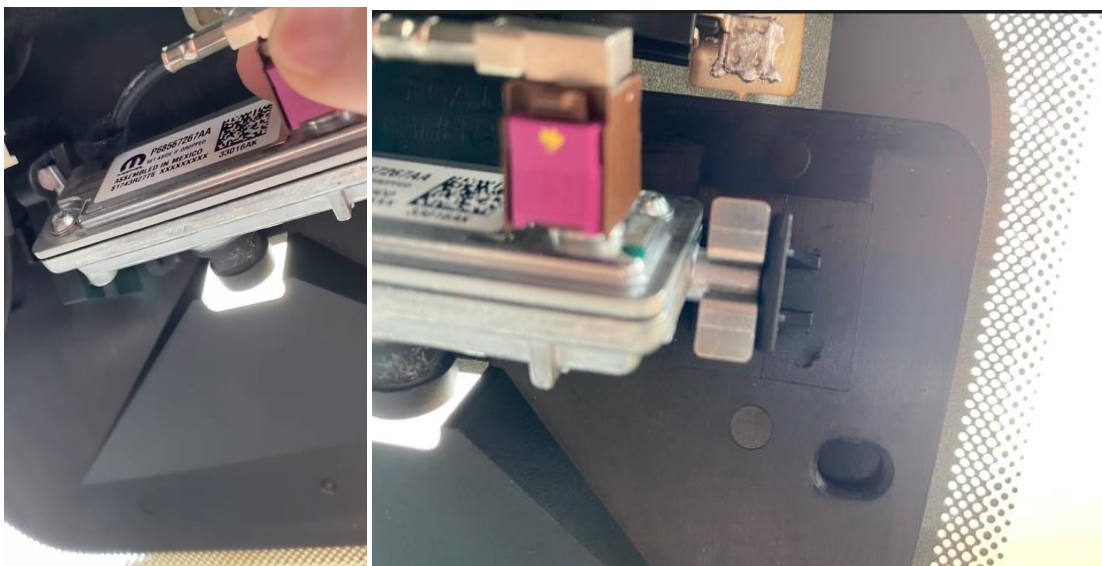
Fig 2: Properly Mounted LRCF

<<<NOTE>>> This issue is caused by a slight degree change in the roll angle of the Long-Range Front Camera (LRCF).

1. Remove the Mirror Cover and Inspect the LRCF.
2. To aid Engineering in the investigation, take a picture of the LRCF mounted in the windshield bracket as shown below and upload as a **DID-I** with the claim.
3. Verify LRCF is not damaged, obscured or out of alignment and is **properly mounted**.
4. Remount the Camera and continue to step 5 below.
