STAR ONLINE PUBLICATION

Case Number: S2405000002 Rev. C

Symptom/Vehicle Issue: Brake Light Switch Service Information.

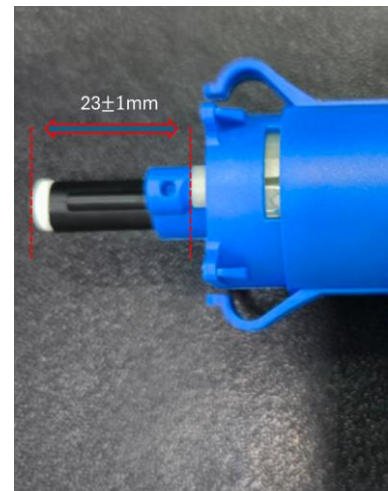
NOTE: If damage to the switch is present for any reason, the switch is to be replaced. If a switch is removed and the plunger length differs from a new switch, the switch should always be replaced and not reinstalled. The nominal height for a new switch (tip of the plunger to the tip of the cam tab) is 23 ± 1 mm (0.90 ± 0.04 inch).

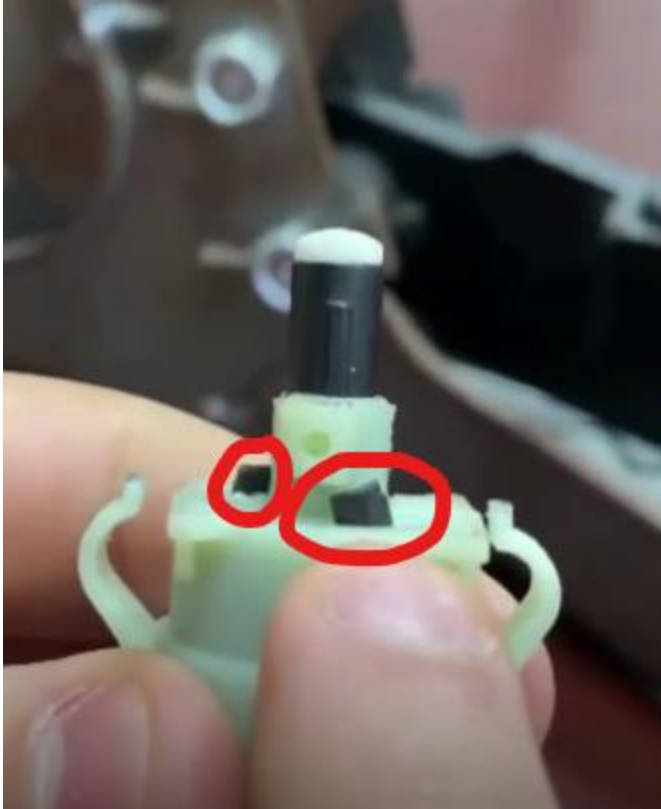
- * Visually verify if brake pedal switch housing is damaged.
- * Check if tabs (small plastic pieces positioned beside the plunger) are damaged or broken. See the below figure red circled plunger tabs. Note the red circled tabs are cocked sideways- "Not OK". Green circle shows "OK" part. See figure below.

Not OK.

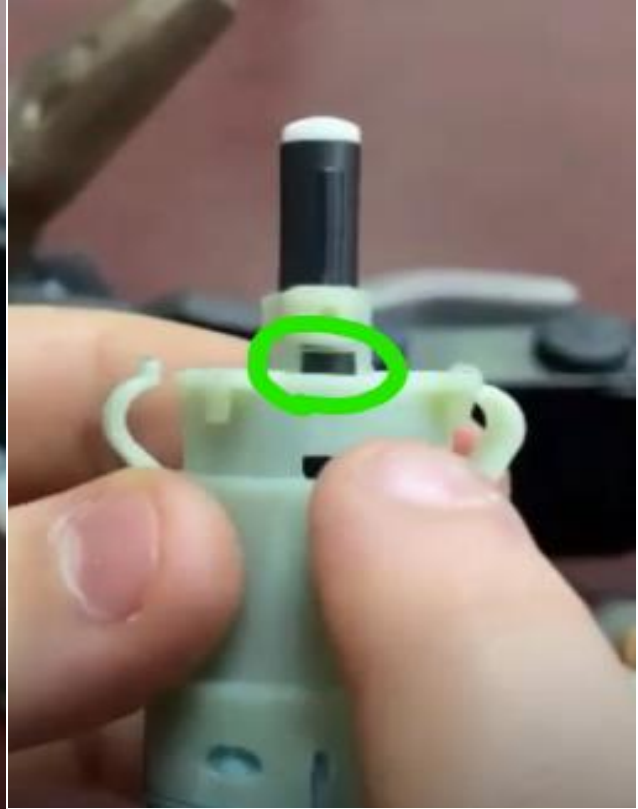
OK.
