## Mitsubishi Radio Displays - Order as NEW for Warranty Repairs

## Chassis/Suspension - Shock Absorbers - Oil Leak Diagnosis

### Shock/Strut Leak Criteria

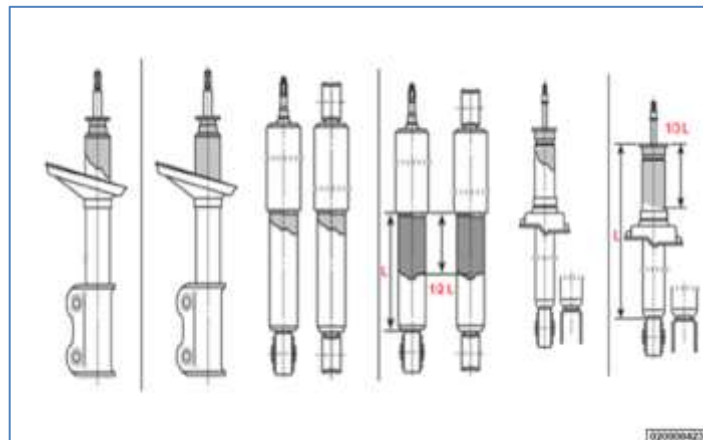
Normal misting of a strut or shock. The reasons misting occurs is usually from evaporation of shock fluid from the rod under heated conditions. The evaporated fluid condenses and forms a mist on the shock body and cover. This is normal because a certain amount of shock oil must stay on the rod to lubricate it. Some misting accumulation is normal and does not degrade ride performance. Misting is most likely to be noticed at higher mileages due to accumulation.

**LIGHT and MEDIUM MISTING STRUTS/SHOCKS (DO NOT REPLACE)**

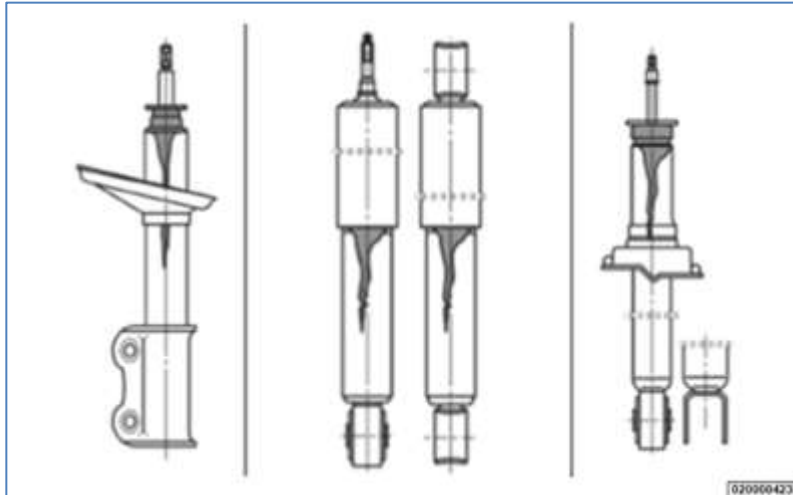
Struts and shocks with an excessive drip or run on one line on the body of the shock or strut. Excessive runs and drips are something different

and likely is caused by damage to the rod or sealing system.

**STRUTS/SHOCKS EXHIBITING AN OIL LEAK/DRIP ON ONE SIDE OF THE TUBE (REPLACE)**

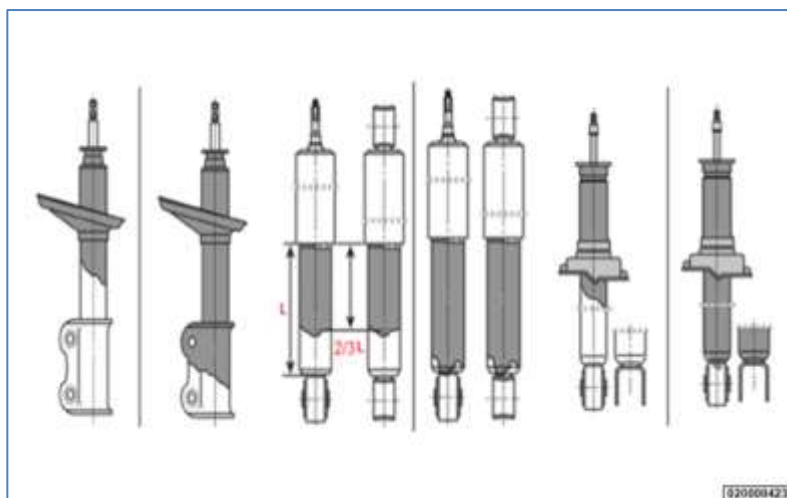
Struts and shocks that exhibit excessive oil leakage. This is determined by oil evenly around the body of the strut or shock that is at passed

the spring seating surface or a strut or shock with spring, or at least 2/3 of the way down the body of a standard shock.

**FAILED LEAKING STRUTS/SHOCKS (REPLACE)**

The shock absorbers are not refillable or adjustable. If a malfunction (excessive leak) occurs, the shock/strut must be replaced.
