Service Campaign Notification

Campaign #	Description	Check Mounting Bracket on Vehicle Underbody
2025070004	25P6190215

CAMPAIGN NO.	2025070004
CAMPAIGN DESC.	25P6190215
SUBJECT	Check Mounting Bracket on Vehicle Underbody
MODEL(S)	GLE and GLS (167 platform)
MODEL YEAR(S)	2024
CAMPAIGN POPULATION	2,844

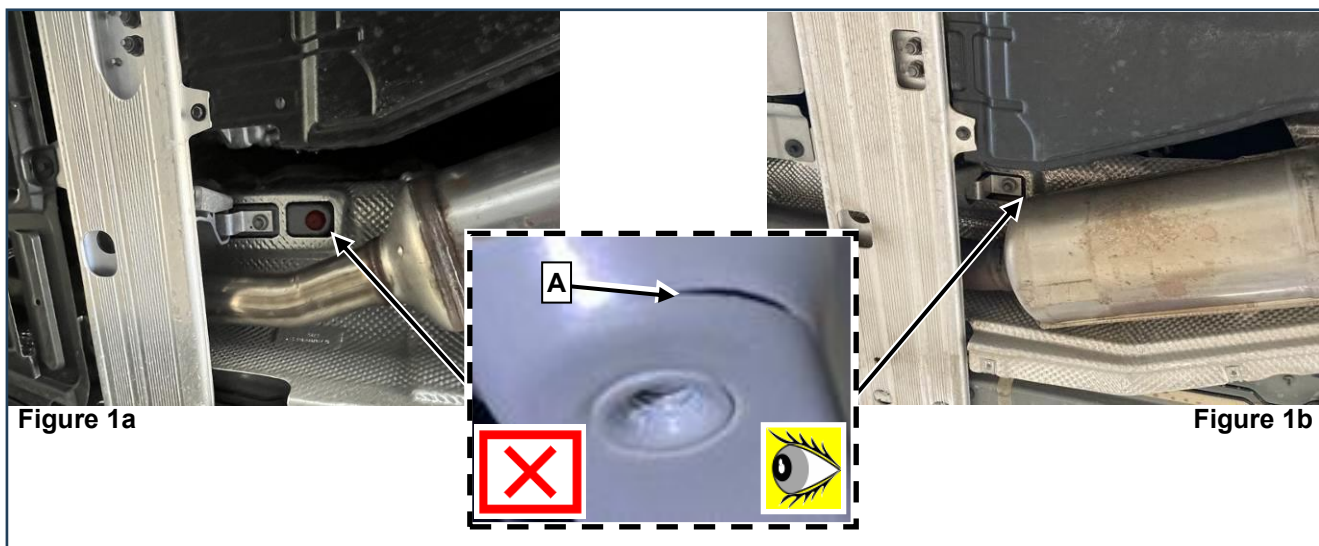
Figure 1

- Lift vehicle on vehicle lift (**AR00.60-P-1006A**).
- Check affected area (**Figure 1a or 1b**, depending on vehicle as-built configuration) for cracking (**Figure 1, A**).
i If the as-built configuration is **Figure 1b**, use a commercially available endoscope to check for cracks.

- If crack (**Figure 1, A**) is present: Carry out **Work Procedure**.
- If crack (**Figure 1, A**) is *not* present: **End measure**.

i The crack in the mounting console will be sealed by welding.
