SIB 41 06 25

DELIVERY STOP: BULKHEAD HEAT INSULATION

E-Series	Model Description	Production Date
G90	M5 Sedan	April 16, 2025
G99	M5 Touring	March 24, 2025

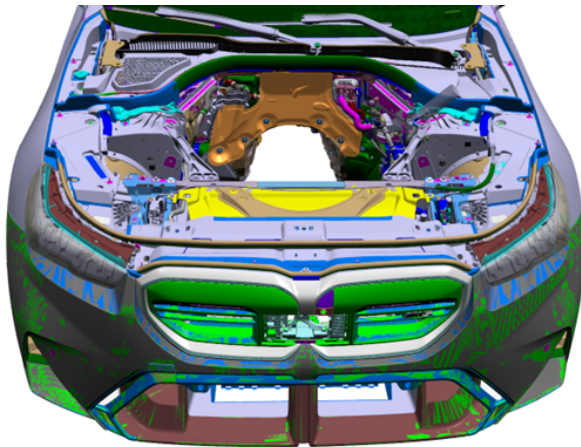
The heat insulator (highlighted in orange) for the bulkhead was not installed. Thermal overload of the components located in the area cannot be ruled out.

Install the heat insulator onto the bulkhead.
