SIB 61 20 24

**DELIVERY STOP: INTERACTION BAR**

E-Series	Model Description	Production Date
G70	7 Series Sedan	November 10, 2022 – March 28, 2023

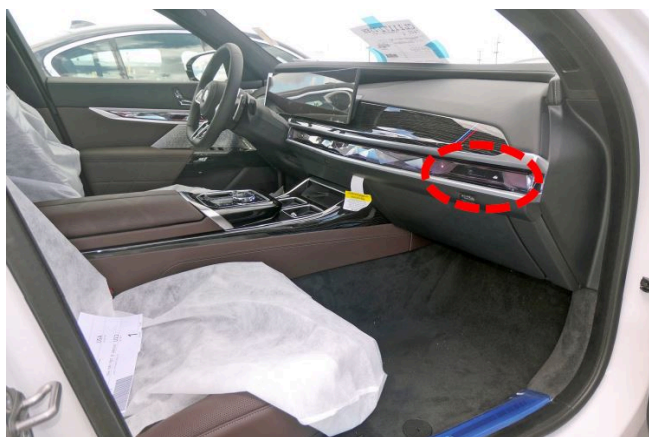
In the event of a voltage drop, comfort functions of the BMW interaction bar may fail and not respond.

Software error in the BMW interaction bar.

This can lead to a failure of the air vent functions on the passenger side of the bar (circled).

Replace the BMW interaction bar.

Replace the BMW interaction bar following the repair instructions listed in ISTA/AIR 61 31 147.
