SIB 64 04 25

SERVICE ACTION: MODIFY HARNESS ROUTING AT THE NEXT NANOFILTER REPLACEMENT

This Service Information Bulletin (Revision 3) replaces SI B64 04 25 **dated July 2025**.

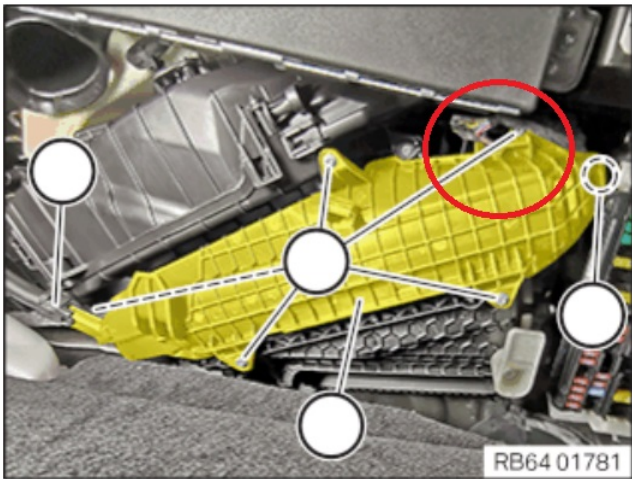
When following Repair Instructions REP 64 31 010 to change the cabin air nanofilter, check the vehicle wiring harness routing (circled) before fastening the plastic cover over the filter.

This is where the harness can be damaged when installing the cabin air filter cover screw.

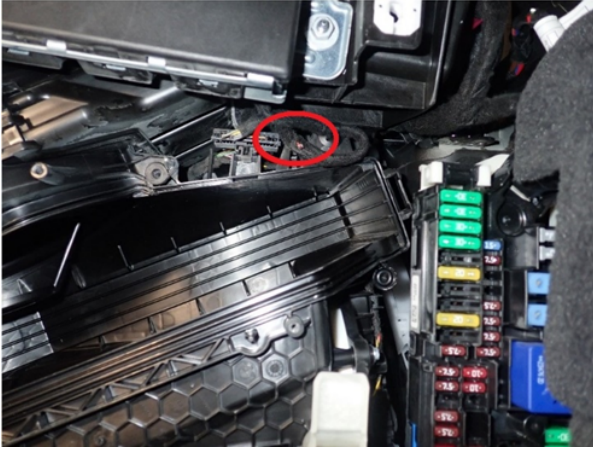
This shows the harness damage; the sheathing has been abraded.

If the wiring harness has already been damaged during the installation of the cabin air filter cover, the damaged section of the wiring harness must be repaired.

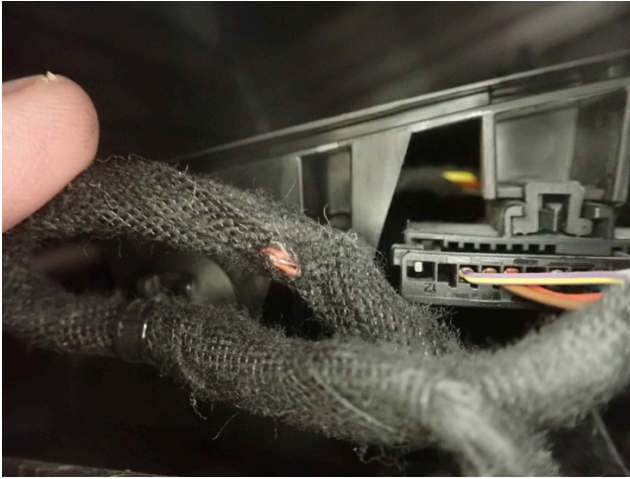
With the harness pulled out of the way, you can see the screw mounting hole for the cabin air filter cover.
