| | BOD | 2024-2025MY<br>EV9 (MV1) |
| | 341 | July 2025 |
| TECHNICAL SERVICE BULLETIN | | |
| SUBJECT: CONSOLE ARMREST LOWER COVER<br>AND BUMPER REPLACEMENT | | |

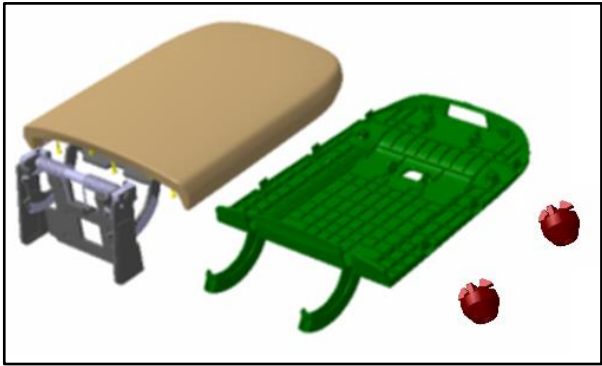
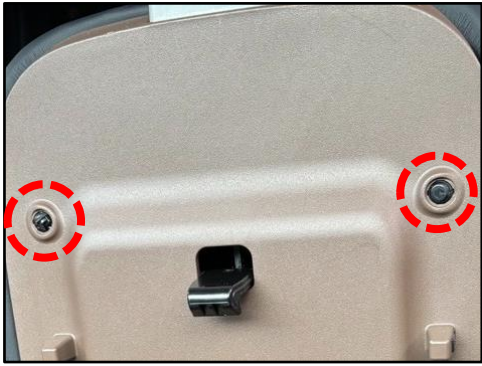
This bulletin provides information to replace the console armrest lower cover and bumpers on some 2024-2025MY EV9 (MV1) vehicles produced from July 27, 2023 through April 26, 2024. The affected vehicles may exhibit console armrest wobbling and/or rattling when closed. One or both bumpers can be missing, broken, and/or shifted out of place creating a gap between the console armrest and the console assembly which causes the console armrest to wobble and/or rattle while closed. To rectify this concern, follow the procedure outlined in this publication to replace the console armrest lower cover and bumpers on the applicable vehicle.
