Service Campaign Notification

Campaign #	Description	Retrofit Heat Shield on Integral Carrier
2025070007	25P4990104

CAMPAIGN NO.	2025070007
CAMPAIGN DESC.	25P4990104
SUBJECT	Retrofit Heat Shield on Integral Carrier
MODEL(S)	CLA, GLA and GLB (118 and 247 platform)
MODEL YEAR(S)	2024
CAMPAIGN POPULATION	5,810

Campaign Technical Instructions

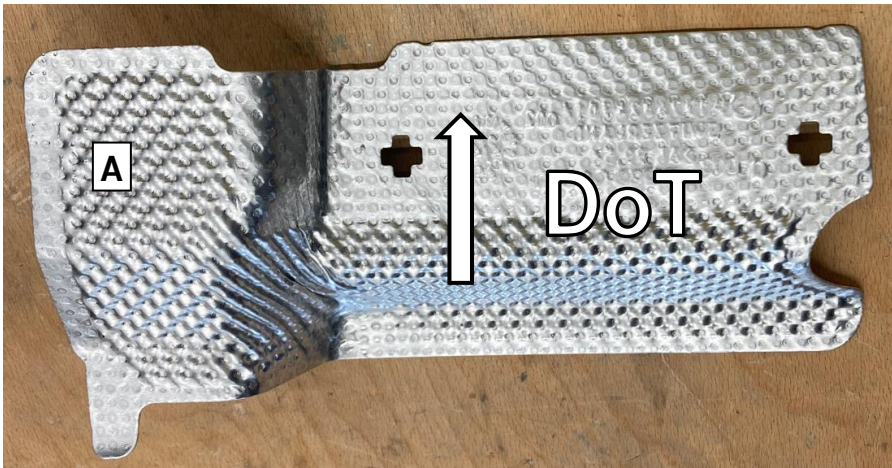
Figure 1 – DoT = Direction of travel (installation position)

Retrofitting heat shield (Figure 1, A) onto the exhaust system integral carrier.
