Diagnostic Sheet

Grecale MHEV Rattle Noise From Turbocharger Area

DATE: JULY 30 2025

Model: Grecale MHEV (All MY)

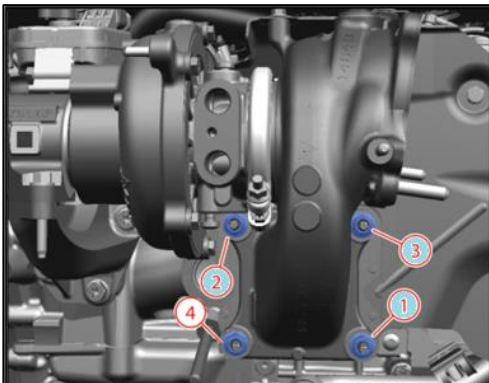
Customer may report a knocking/rattle noise from the turbocharger area. (An example video is included with this bulletin)

- Pre-tighten M8 nuts #1 to #3 to 12 Nm.
- Final tighten M8 nuts #1 to #3 to 25 Nm.
