**Diagnostic Sheet**

# Misfire Warning Light on Single Bank

DATE: JULY 31, 2025

**Models:** Quattroporte (M156), Ghibli (M157), Levante (M161) – V6 and V8 engines (ALL MY)

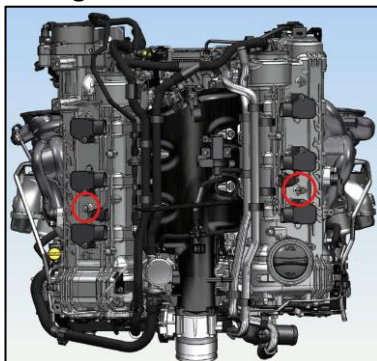
1. Connect the EVO and save the ECM DTC report.
2. Check if the misfire codes are concentrated on one bank (Bank 1 or Bank 2).
3. If so, inspect the ignition coil **ground connections**:
  - o **V6 Engines:**
    - Grounds are located on the cylinder head covers.
    - Remove the engine compartment cover to access them.
    - **Tighten to 10 Nm** if loose.

**Note:** If one or both are loose, tighten them to the correct torque, clear the DTCs, and verify proper operation of the vehicle with a short road test.

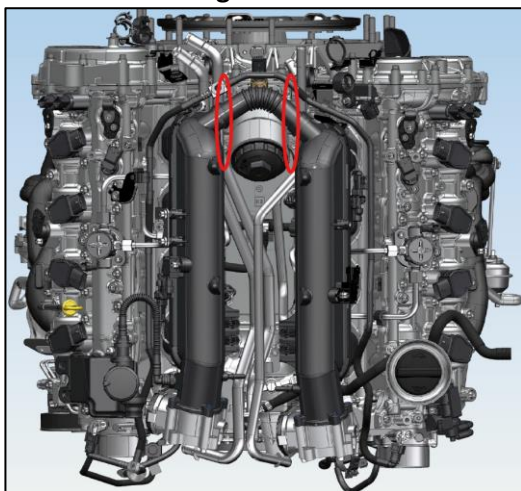
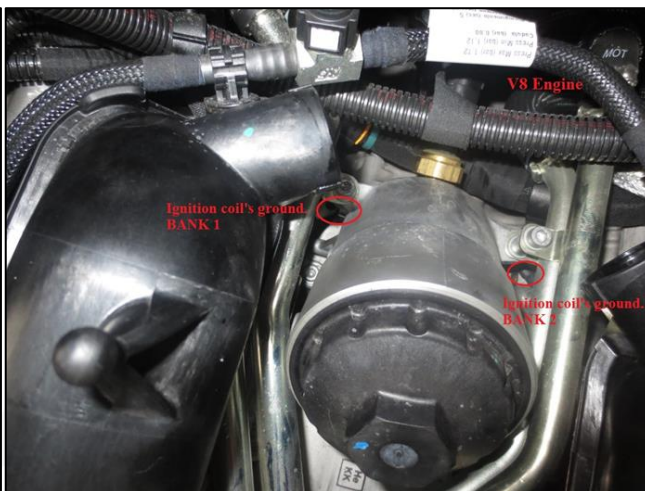
○ **V8 Engines:**

- Grounds are located near the engine oil filter support.
- Follow the specific service procedures for accessing and inspecting the grounds.
- **Tighten to 10 Nm** if loose.

4. Clear DTCs.
5. Perform a short road test to confirm resolution, Open a BOL as Support request if DTCs persist.
