Oil Leak at Crankcase Near the High-pressure Fuel Pump OM654

Topic number	LI07.02-N-079573
Version	1
Function group	07.02 - Injection pump, Plug-in pump, High pressure pump
Date	7/25/25
Validity	Engine OM654.9
Reason for change

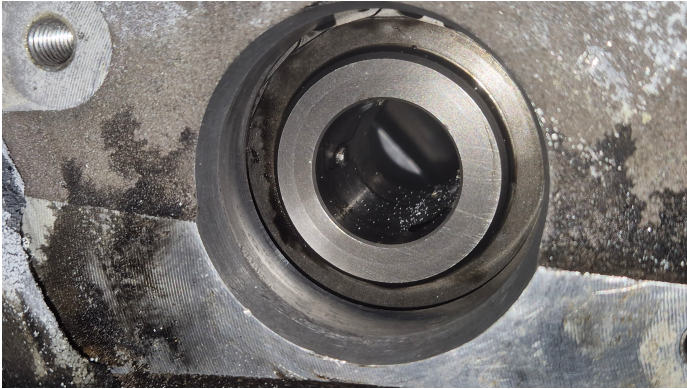
Visible oil leak at the crankcase near the mounting area of the high-pressure fuel pump on OM654 engines.

Attachments	
File	Description
Bohrung HDP im KGH.jpg	Oil leak near mounting hole for high-pressure fuel pump

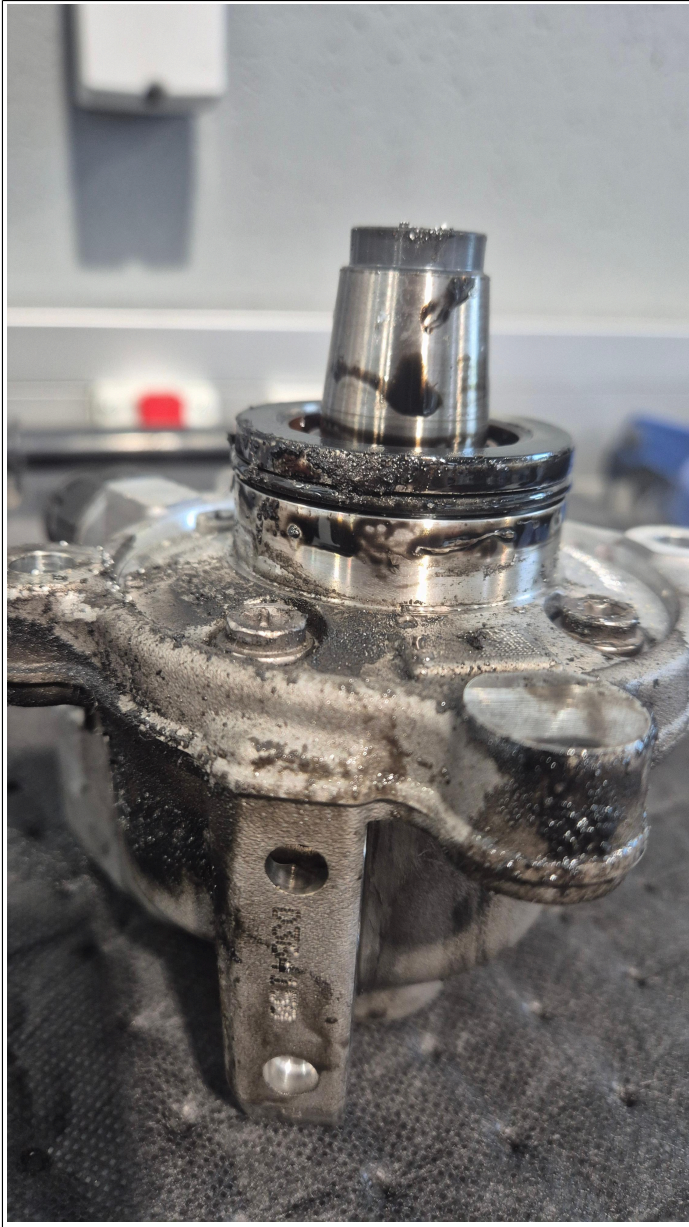
The shaft seal (radial sealing ring) at the high-pressure fuel pump is not leak-tight, resulting in external oil leakage.

Attachments	
File	Description
Radialwellendichtring an der HDP undicht.jpg

Install new high-pressure pump together with design-optimized sealing ring.

1. Replace the high-pressure fuel pump.
2. Discard the 2.5 mm O-ring included with the new pump.
3. Install the updated 2.6 mm O-ring (P/N: A0009973819).
4. Verify the repair using crack detection spray (P/N: A0009890359) around the pump mounting area.
5. If the leak reappears, submit a TIPS case to the Powertrain inbox with reference photos.

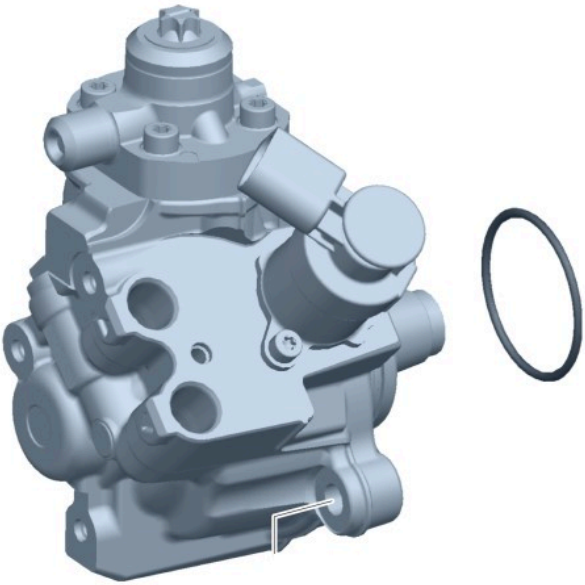
Attachments	
File	Description
Hochdruckpumpe + Dichtring.jpg

High-pressure pump together with design-optimized sealing ring
