eCascadia & eM2 EVDM Connector Plate

Recall Campaign F1017 A

Subject: Electric Vehicle Power Distribution Module

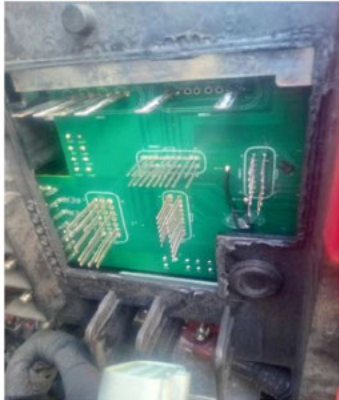
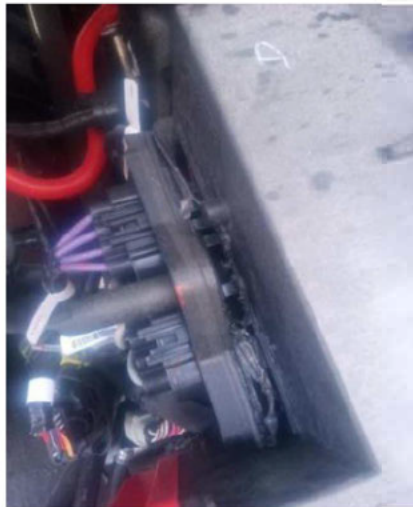
- Connector plate on EVDM may not be properly adhered to housing.
- Disconnected connector may cause different failure effects in the components served by EVDM. Communication disruption in some EVDM components may cause the vehicle to shut down.

- Poor adhesive installation

- Recall Campaign F1017
 - Inspect for connector plate separation; replace EVDM if found.
 - If no visible separation, install retainer brackets to reinforce
