## Nuisance Mirror Adjustment DTC

## Service Solution 785

Published: 06/24/2025

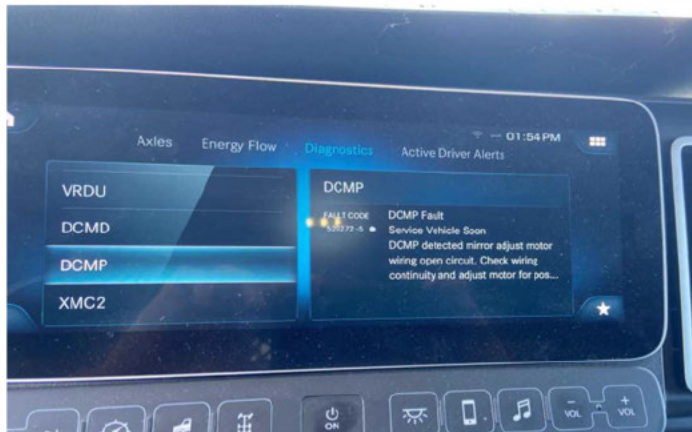
Due to incorrect parametrization the door control module will set DTC 520272-5, when the vertical adjustment button is pressed for the raise or lower position.

The solution is to change parameters "Mirror Y-Axis" in both DCM02T and DCMP02T ECU's from enable to disable

- Change parameters to disable the DTC fault in the door control module
