HVAC Stops Cooling

TSB-83-032-WST

- ▶ 49X
- ▶ 47X
- ▶ 57X

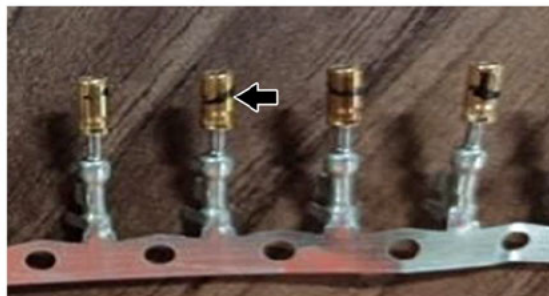
Fig. 1, Terminals with Markings

Starting on November 18, 2024, production started receiving new terminals attached to the harness with A66-14821-000 that addresses the 'loose terminal' issue. Also the aftermarket started receiving updated terminals in Parts Distribution Centers (PDC's) on December 6, 2024. The new terminals may not receive a new part number, however all aftermarket terminals that have been updated, did have the terminals marked with a black marker. See Fig. 1.

➡ **Note:** The terminal markings are only for reference, There can be new terminals which may not have the black markings.

7. Before installing the new terminals, perform a drag test on each terminal using the transducer pins to ensure they are in good condition. If the terminal does not have identifying marks, as shown in Fig. 1, then ensure the new terminal has resistance when installed on the transducer pin.

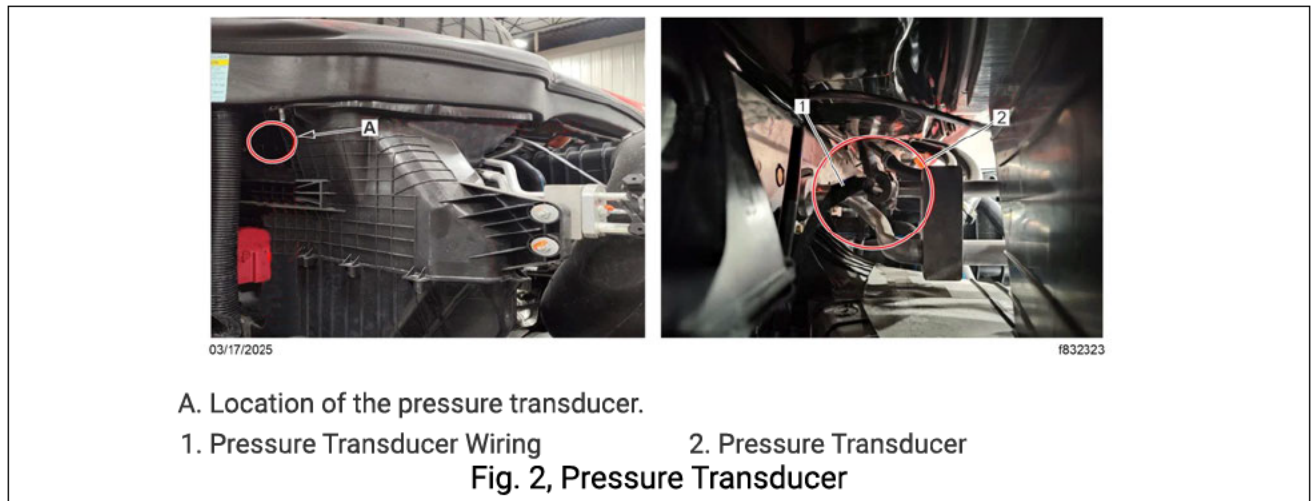
The field received numerous complaints about air conditioning (A/C) systems not cooling. In most cases the fault code 25/522510/3- high side Pressure – Voltage above normal or shorted to the high source or open circuit, is present. After investigation, it has been determined that the terminals (23-13211-440) are loose on the pins of the pressure transducer. Loose terminals at the pressure transducer can affect the A/C functionality, resulting in the A/C not cooling. Vehicles built from June 2022, through December 2024, or any vehicle receiving replacement terminals that do not fit properly on the pressure transducer pins, can be affected.

- While monitoring the A/C pressure in DiagnosticLink®, inspect if wiggling the wires connected to the A/C pressure transducer results in a spike in the pressure transducer high pressure reading, or if the fault code 25/522510/3 is triggered as active. See Fig. 2 for pressure transducer location and the wiring to wiggle.

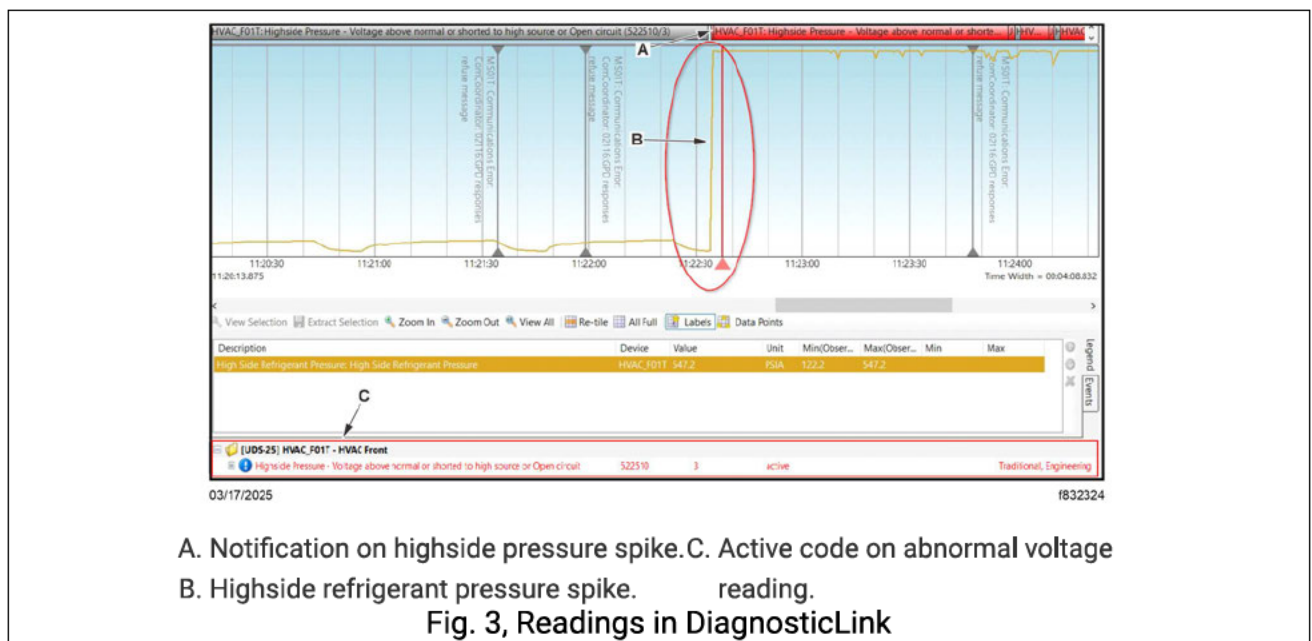
- If a spike is observed in DiagnosticLink, it indicates that one or more of the terminals connected to the pressure transducer may be loose and should be inspected and replaced. See Fig. 3.

3. If wiggling the wires to the pressure transducer causes irregular high-pressure readings, examine the terminals leading to the pressure transducer. With the terminals removed from the pressure transducer connector, there should be some force (drag) required to push/pull the terminal on to the pressure transducer pin.

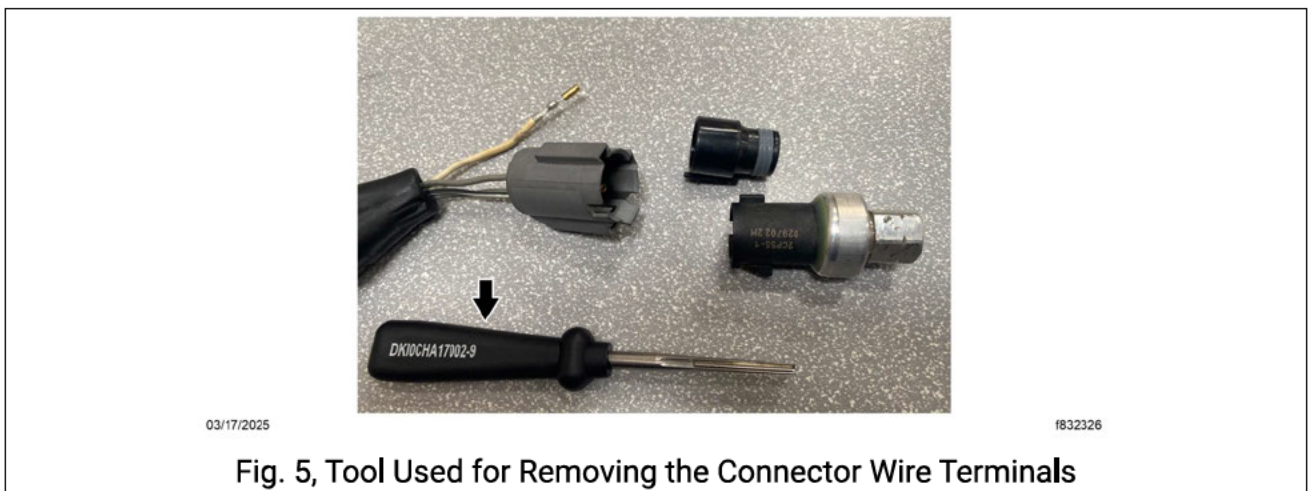
➤ **Note:** A terminal that has become loose on the pressure transducer pin, might cause wear on the pin, resulting in replacement of both the pressure transducer and terminals.

5. To remove the connection wire terminals, press the little tab on the wire insertion end of the connector to remove the black internal secondary lock. Then remove the terminals from the connector using the tool DK10CHA17002-9 or equivalent pick to release the terminals from the connector. See Fig. 5.
