# HVAC Stops Cooling

## TSB-83-163-FTL

### Engine or Vehicle Affected:

► New Cascadia

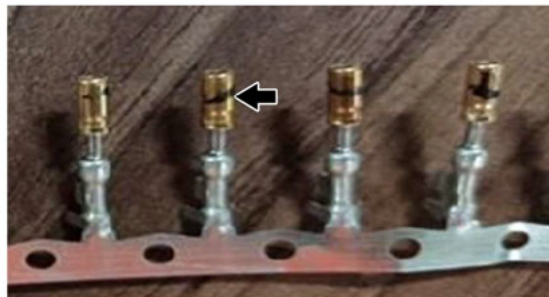
Fig. 1, Terminals with Markings

Starting on November 18, 2024, production started receiving new terminals attached to the harness with A66-14821-000 that addresses the 'loose terminal' issue. Also the aftermarket started receiving updated terminals in Parts Distribution Centers (PDC's) on December 6, 2024. The new terminals may not receive a new part number, however all aftermarket terminals that have been updated, did have the terminals marked with a black marker. See Fig. [1](#).

➦ **Note:** The terminal markings are only for reference, There can be new terminals which may not have the black markings.

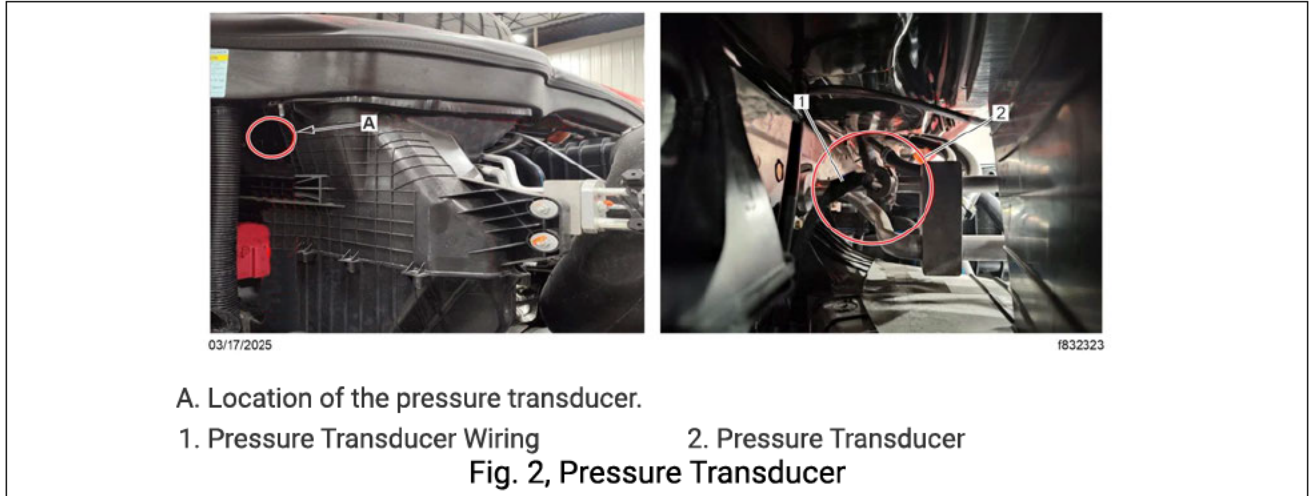
1. While monitoring the A/C pressure in DiagnosticLink®, inspect if wiggling the wires connected to the A/C pressure transducer results in a spike in the pressure transducer high pressure reading, or if the fault code 25/522510/3 is triggered as active. See Fig. 2 for pressure transducer location and the wiring to wiggle.

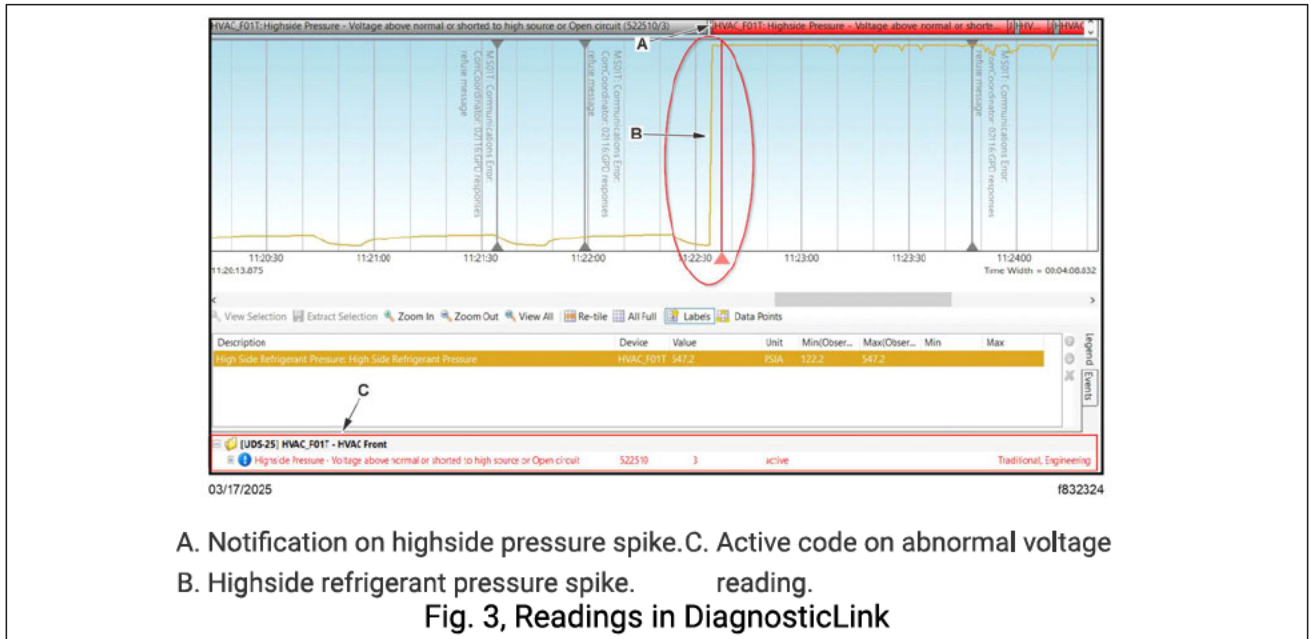
2. If a spike is observed in DiagnosticLink, it indicates that one or more of the terminals connected to the pressure transducer may be loose and should be inspected and replaced. See Fig. 3.

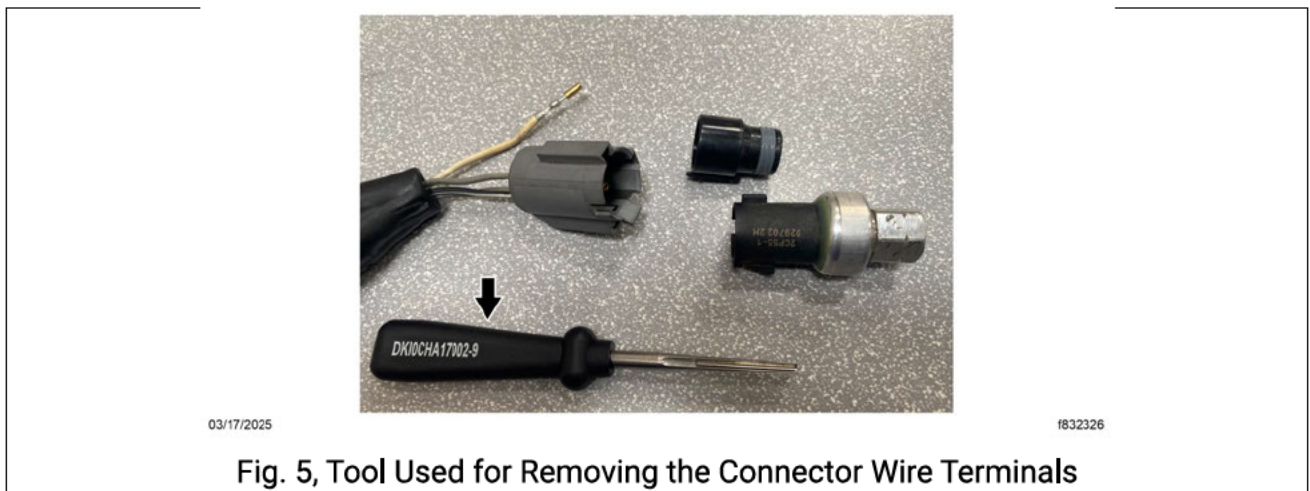
✦ **Note:** A terminal that has become loose on the pressure transducer pin, might cause wear on the pin, resulting in replacement of both the pressure transducer and terminals.

5.  To remove the connection wire terminals, press the little tab on the wire insertion end of the connector to remove the black internal secondary lock. Then remove the terminals from the connector using the tool DK10CHA17002-9 or equivalent pick to release the terminals from the connector. See Fig. [5](#).
