Heater Return Pipe

TSB-83-164-FTL

► New Cascadia

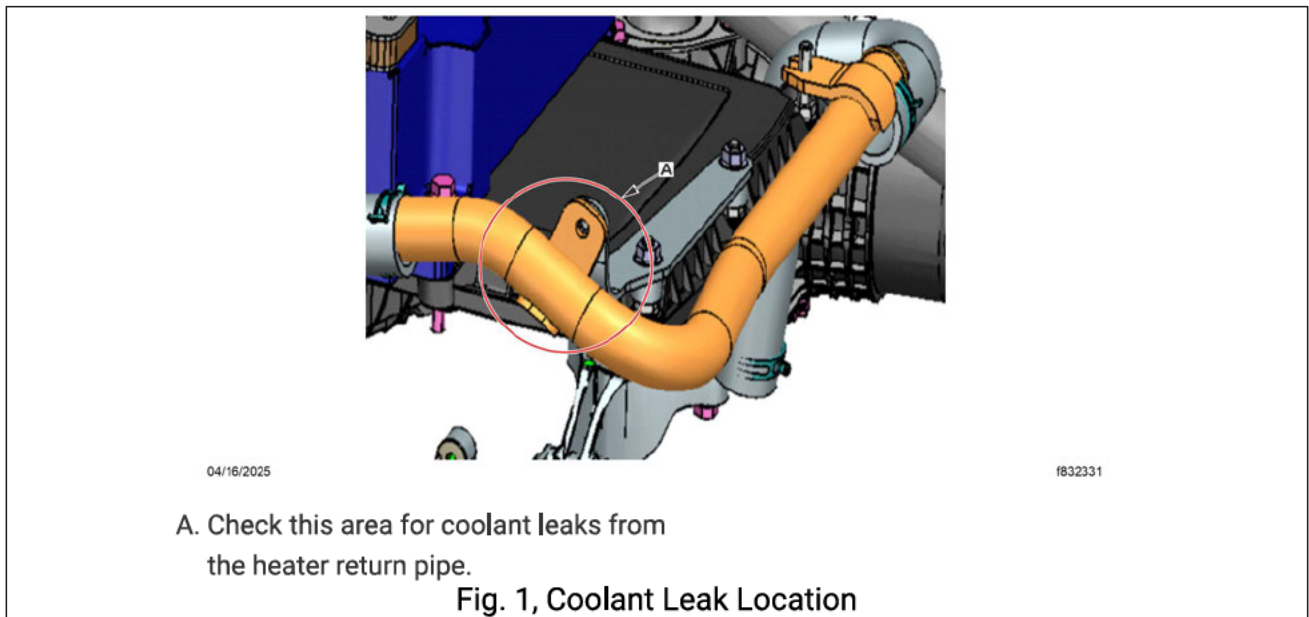
The field received complaints about obvious coolant leaks on the heater return pipe from the weld-on bracket that attaches to the engine bracket. This condition is observed most often on vehicles equipped with DD13 engines. This service bulletin is applicable when there is visible coolant leakage from the tubes and engine side.

1. Inspect the front right-hand side of the DD13 engine heater return pipe for coolant leakage. See Fig. 1.

2. If coolant leaks are found, drain or adjust the coolant level as required.

3. Replace the old heater return pipe with the updated part. **Do not** replace the right-hand side bracket.
4. To replace the welded clamp on the engine, install the P-clamp on the heater return pipe. Fasten the P-clamp at the original mounting point on the engine. See Fig. 2.
