SERVICE BULLETIN

NUMBER: 15-236-18R
DATE: 12/04/18
REVISED: 07/10/25

SUBJECT: Reprogramming File Availability for Optimization of Harman Gen 3.1 and Gen 3.1α Audio and Navigation Head Units

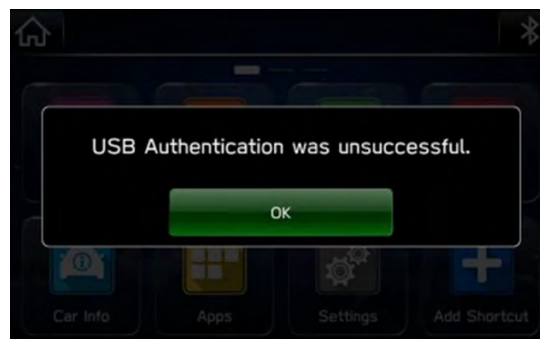
NOTE: If an attempt is made to install the wrong “grade” file into the wrong grade head unit (EXAMPLE: “Base” update file into a “Base Plus or Mid” or “High” head unit), the USB Authentication error screen below will be displayed:

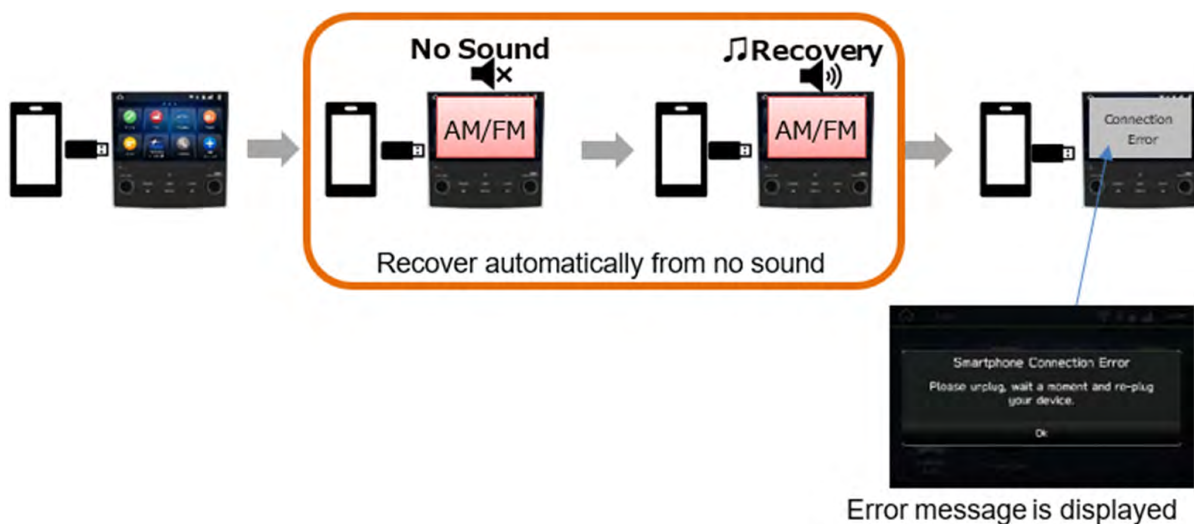
Case1: "Smartphone Connection Error" is displayed

Situation: If an iPhone is already connected via USB when the AM/FM radio automatically recovers from a no sound, a connection error occurs with the iPhone displaying a popup message stating "Smartphone Connection Error". See below.

Countermeasure: Re-connecting the USB cable from the iPhone would restore normal operation.

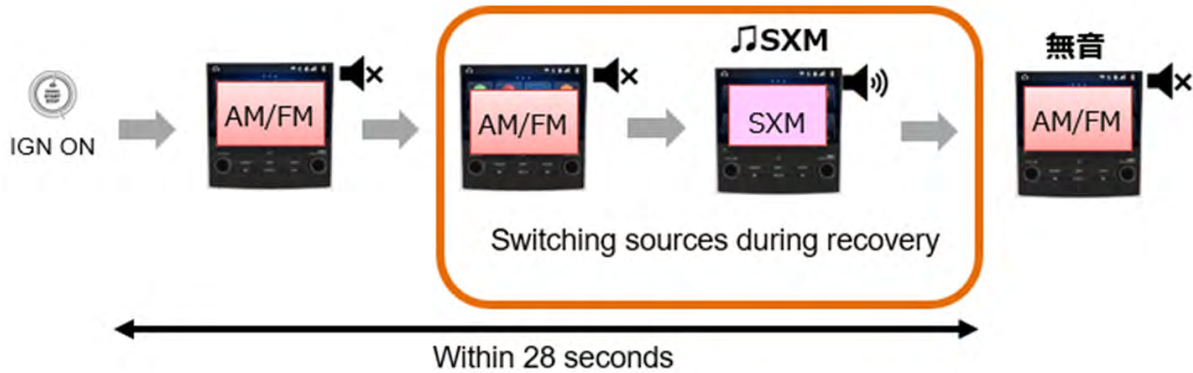
Case2: Continue no AM/FM radio sound due to switching other sources

Situation: If the AM/FM radio experiences a loss of sound after turning the ignition on, it recovers automatically within approximately 28 seconds. However, switching sources (such as to SXM or Bluetooth Audio) during this recovery period prevents the automatic restoration, resulting in continued no AM/FM radio sound. See below.

Countermeasure: Turning the ignition OFF and ON.

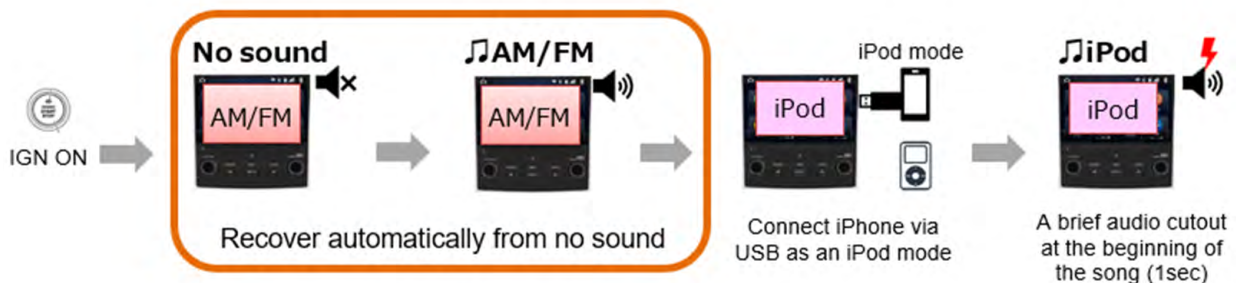
Case3: Audio cutout when playing music from iPhone as iPod (only applicable for the models up to iPhone 13)

Note: Only iPhone models up to iPhone 13 can be connected as an iPod. iPhone 14 and later models do not support iPod mode and only function in charging mode.

Countermeasure: Turning the ignition OFF and ON.

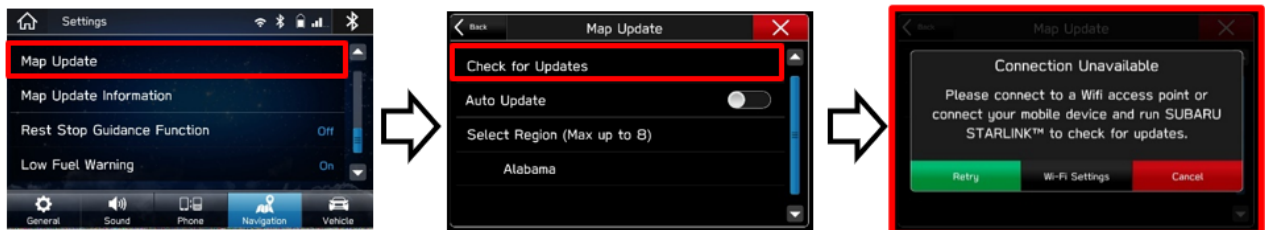
When customer attempts MOTA update after 12/2/2024 on the head with an outdated electronic certificate the following error pop-up will be displayed.

This popup is the same as the one that appears when Wi-fi connection is not available.
