SERVICE PROGRAM BULLETIN

APPLICABILITY: 2017 MY Forester (turbo) **NUMBER:** WRA-25R
 2017 MY WRX **DATE:** 06/27/25

SUBJECT: Rear Catalyst (Center Exhaust Pipe) **REVISED:** 07/31/25
 Non-Compliance

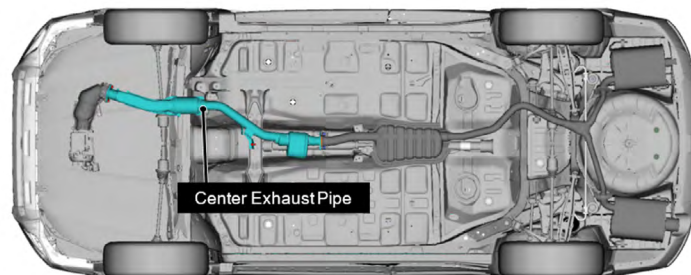
COMPONENT CONFIGURATION:

Defective Part

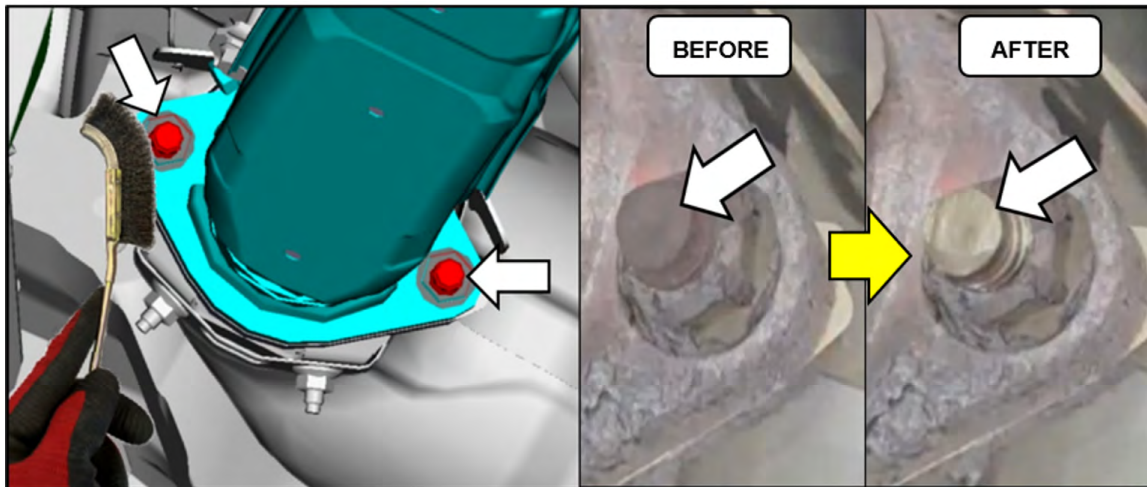
NOTE: The amount of rust may vary depending on the vehicle. The example image below is to be used as reference.

STEP 5: Using a wire brush, remove all rust located on both nuts and studs of the front center exhaust pipe connection.

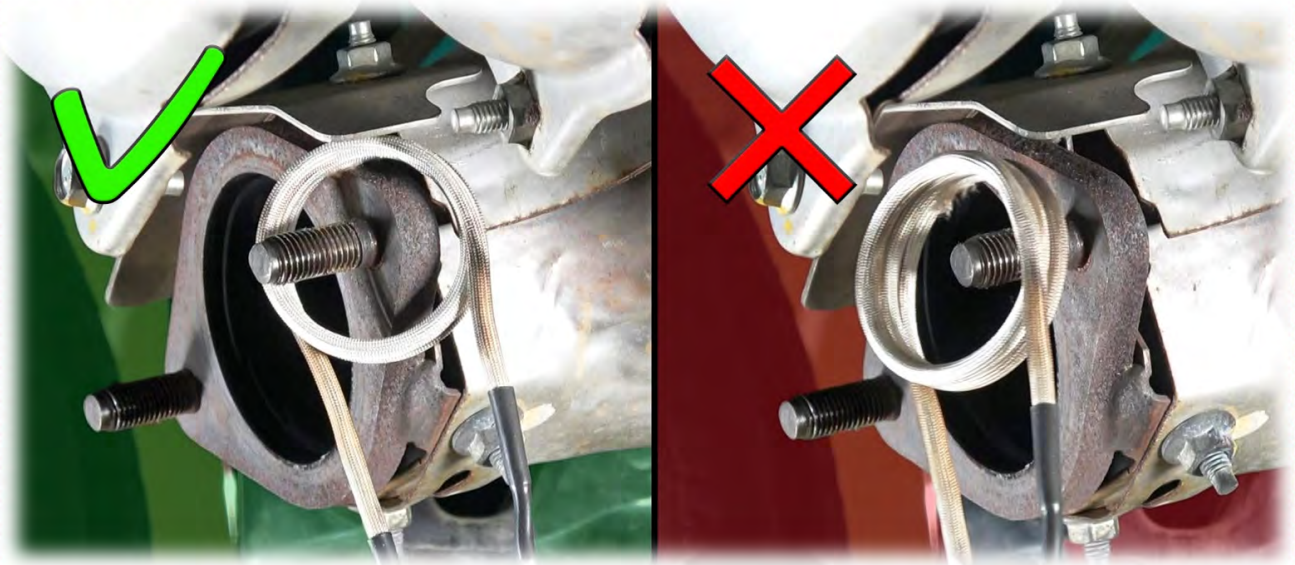
The IH heater coil should be set to heat the base of the stud bolt and the front and back of the flange. If the heating method is incorrect, the target temperature (250° C) will not be reached, and the bolt will not loosen.
