**Thrive Roof Sealant Concern:**

**Thrive Roof Sealant Inspection and Repair**

Technical Service Bulletin # 2025-001

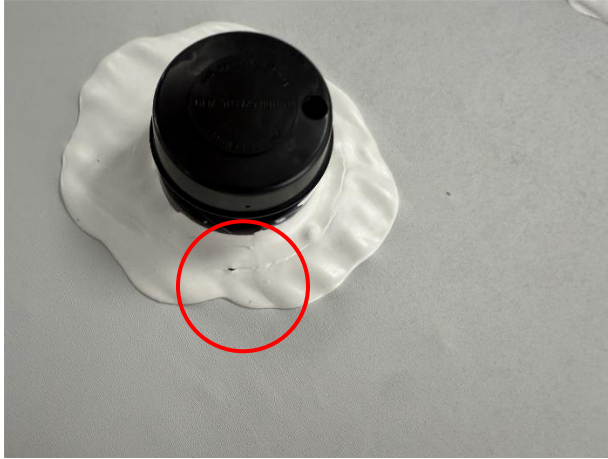
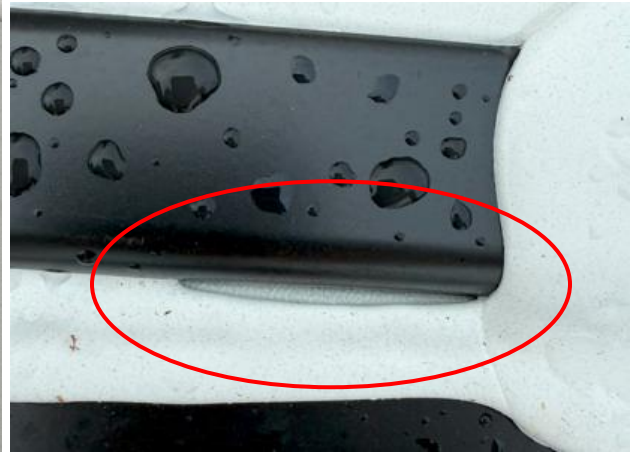
### Voids:

1. Apply Alpha 1010 Non-Sag Sealant to all affected areas as noted in the inspection. Allow to dry and confirm application of the seal has corrected all defects.

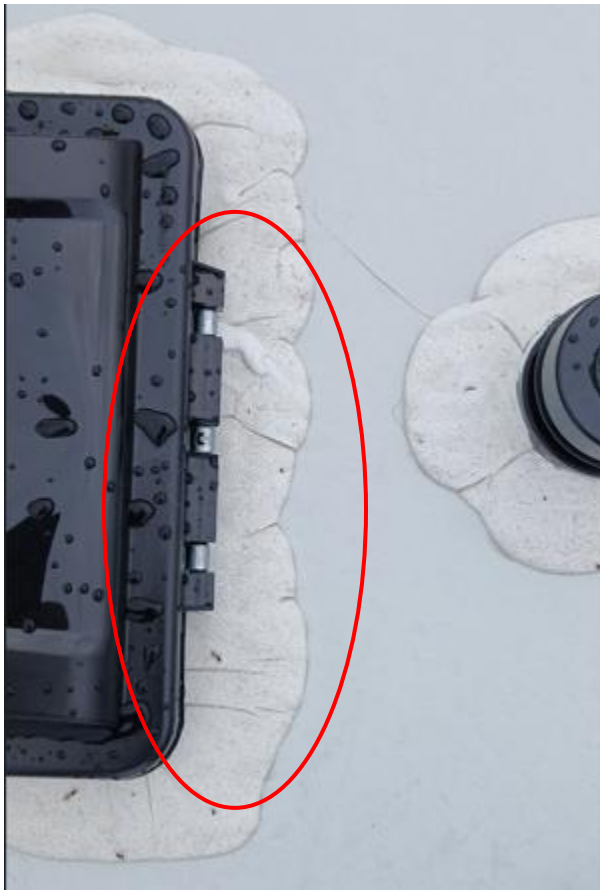
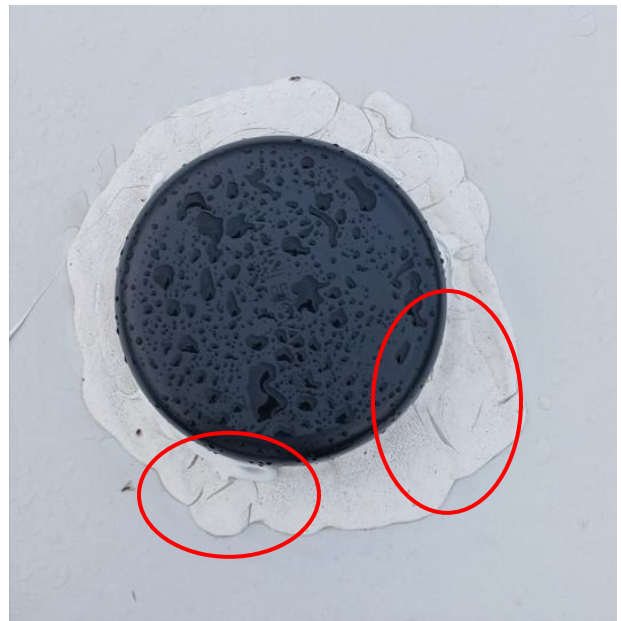
### Cracking
