ID # CBR-2484

Volvo Chassis - Battery Power Management Unit DTC U300049 - VN (4)

The Purpose of this CBR is to assist with diagnostics for fault code U300049 on the Battery Power Management Unit (BPMU).

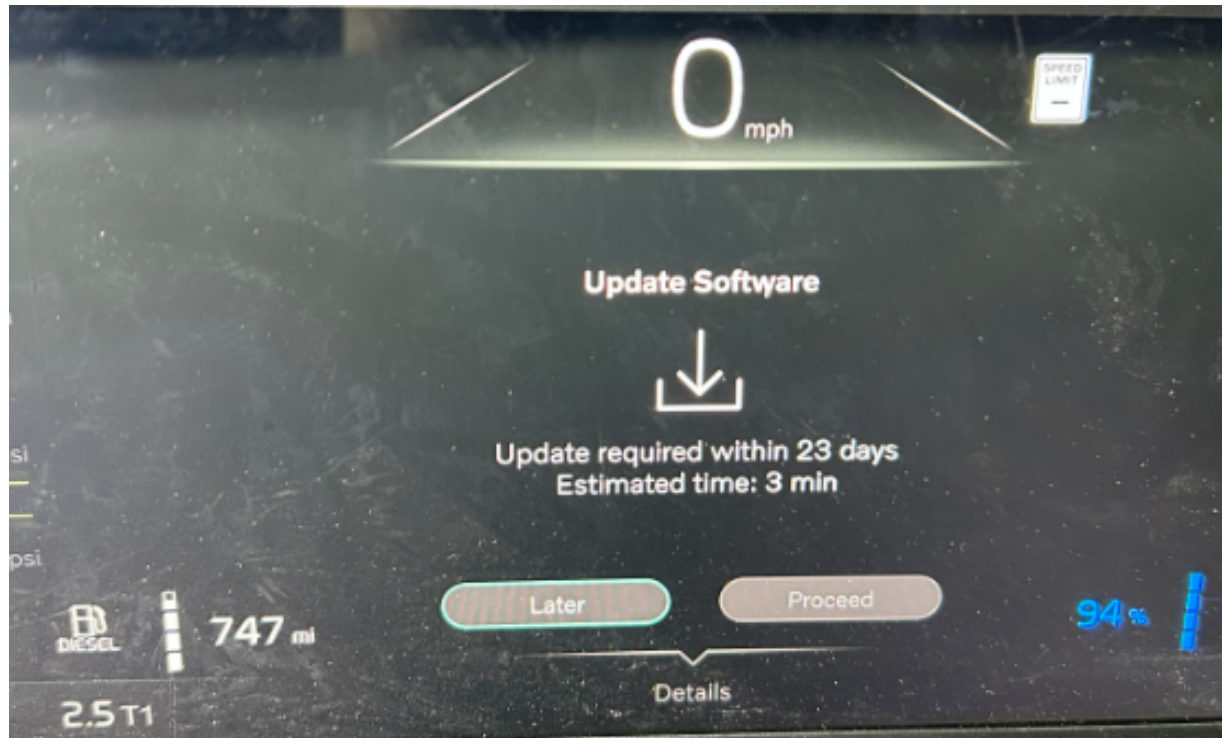
- Check the dash to see if there is Over-The-Air available. If there is one please perform the update through the dash.
  1. Make sure unit is outside and select Proceed in dash.

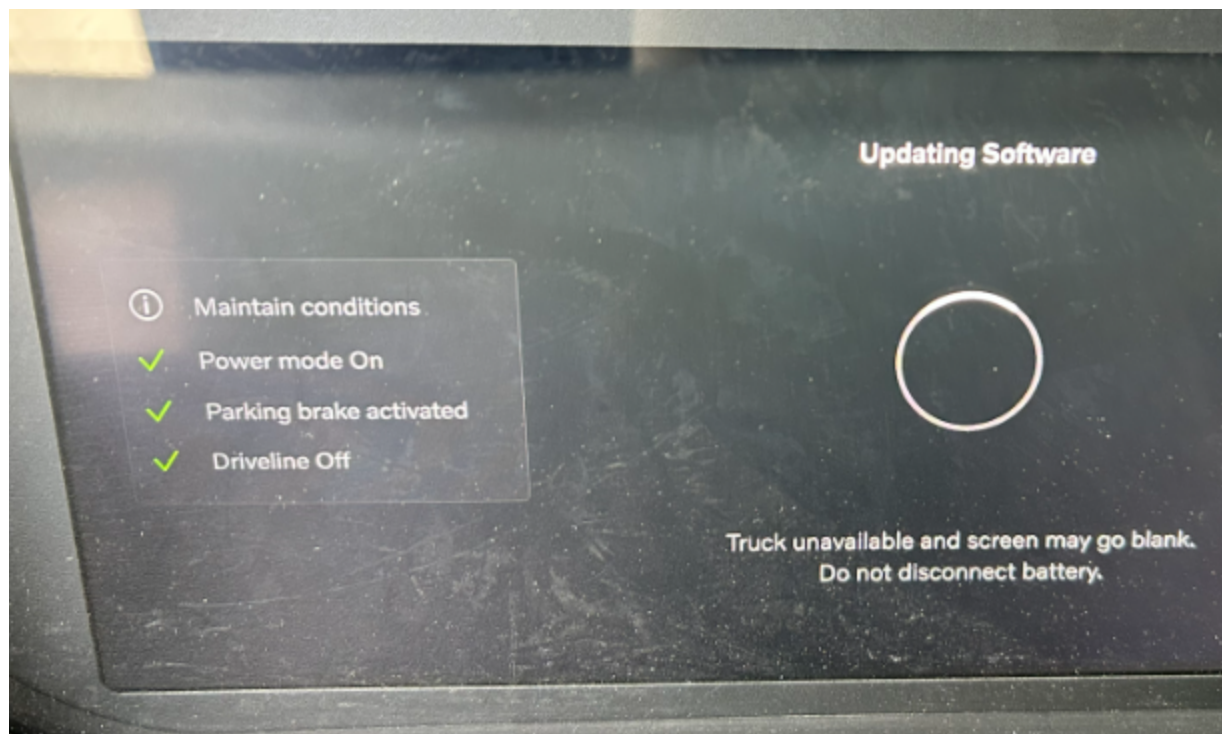
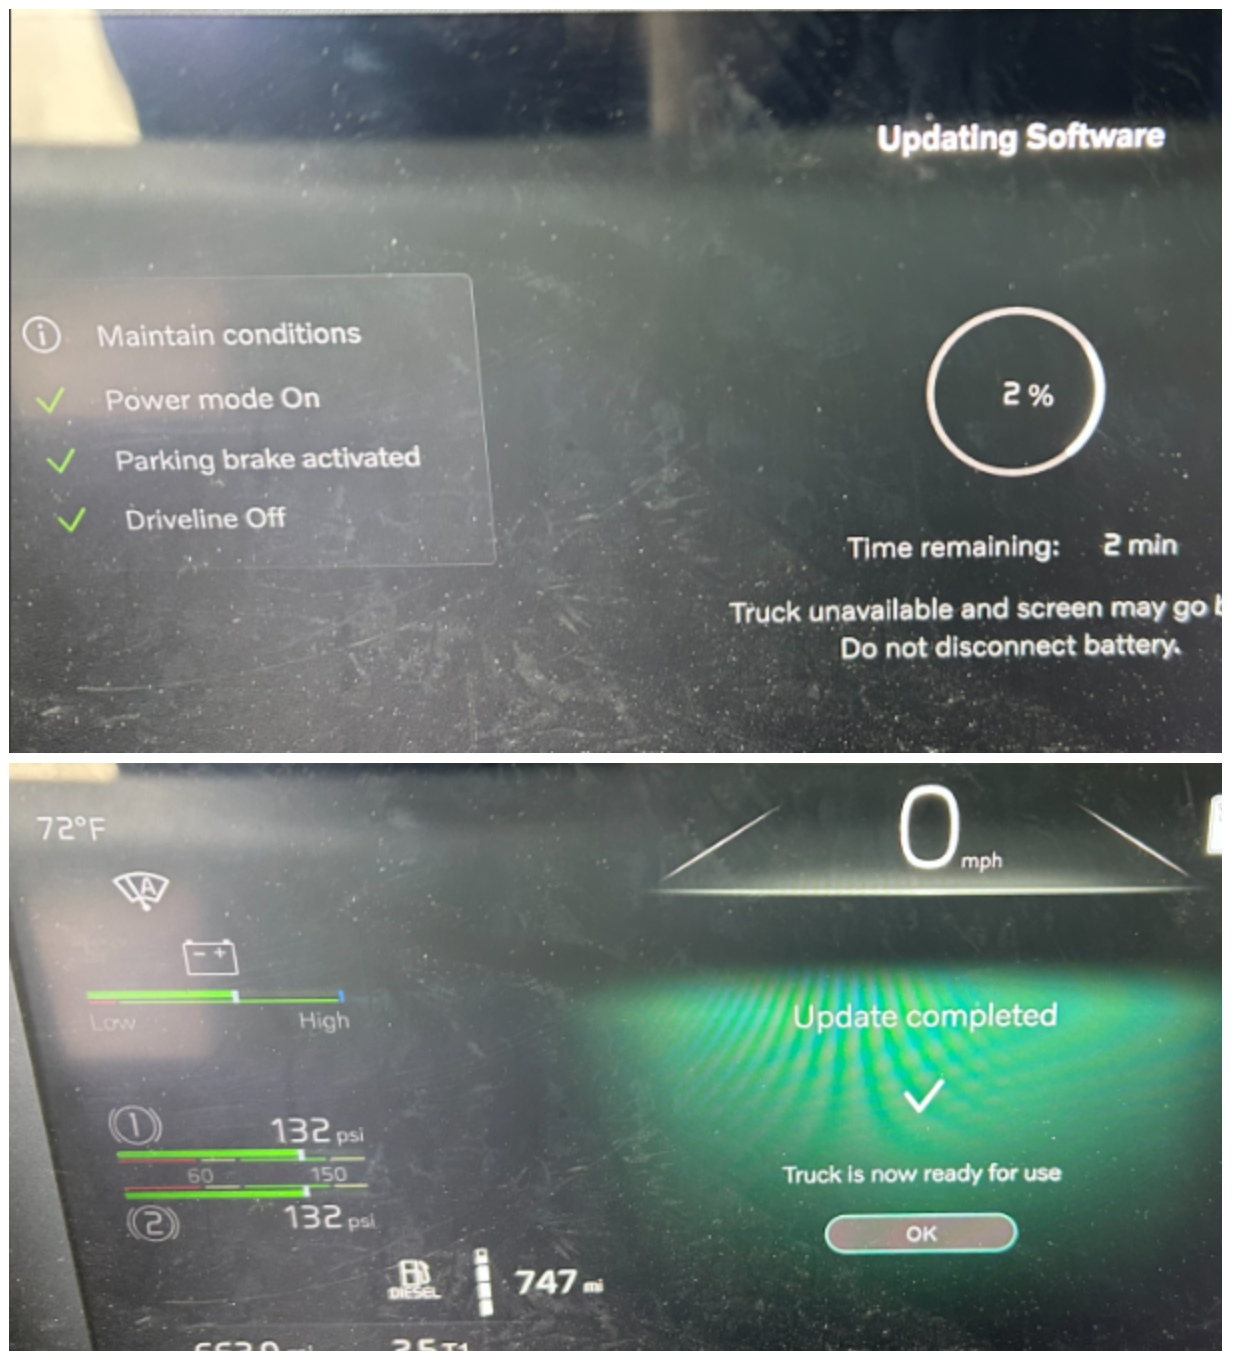
2. Once update starts, wait till the update completes.

3. Once update is completed, clear faults and if U300049 returns please follow PTT.
