**ID #** CBR-2425

Regeneration Failure - VN (4) - PR (4)

Volvo Chassis - VN(4)

Mack Chassis - PR (4)

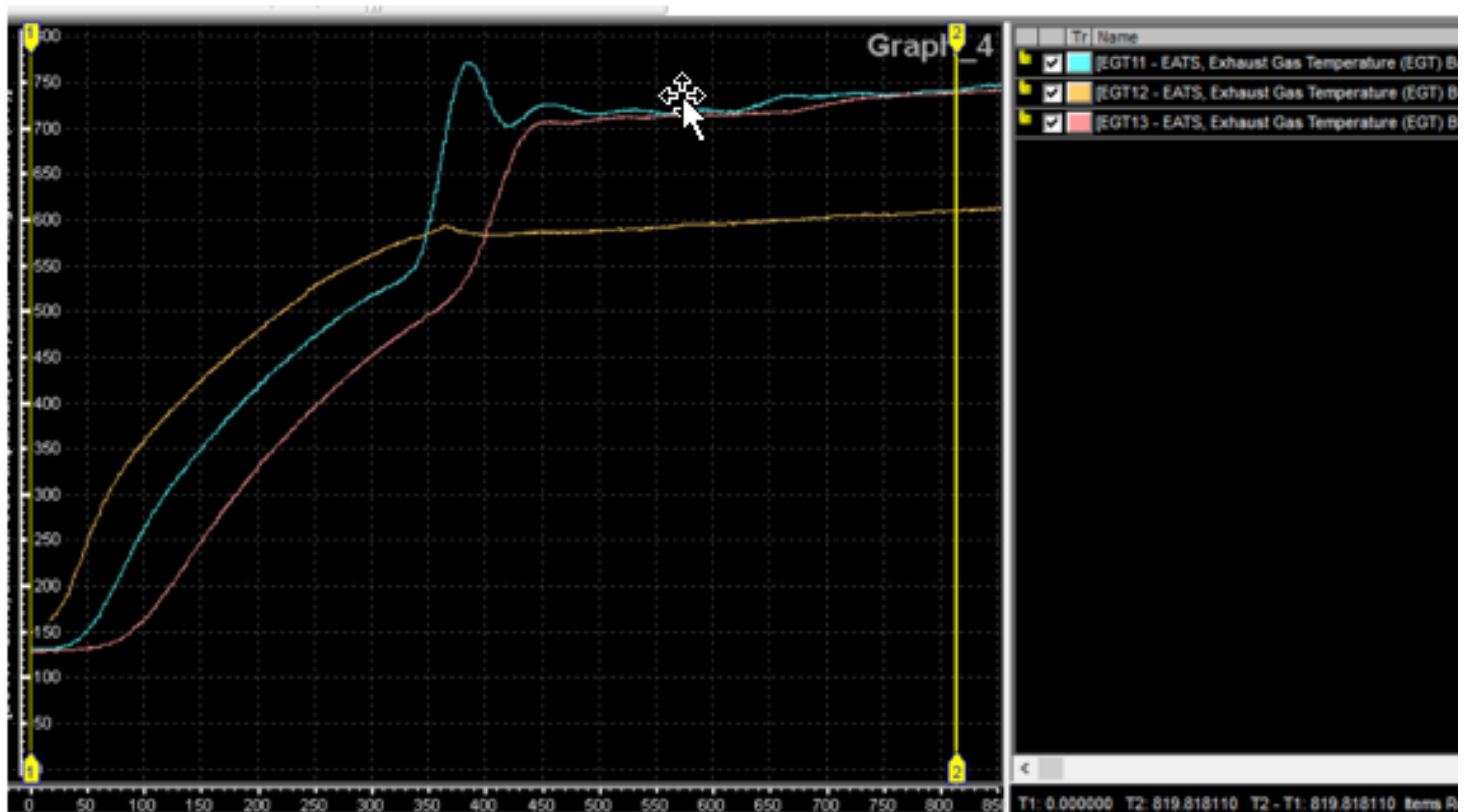
- All sensors (T1, T2, T3) start from almost the same temperature.

- **Order of Temperature Increase:**
  - T2 increases first.
  - T1 follows.
  - T3 increases last.

- **T1:** Exhibits an increase in temperature.
- **T3:** Shows an increase in temperature after T1.
- **T2:** Remains flat with no significant temperature change.

- T1 and T2 increase as described.
- T2 stays flat while T1 and T3 increase post AHI fuel injection.

- Check if sensors T1 and T2 have been swapped.
- Ensure correct sensor positioning.

- Do not replace any other parts until the sensor inspection and swap verification are complete.
