## Mack MMD Fan Hub Bolt Torque

**Revised 7/8/2025 Updated the torque information.**

Mack

| Model Years | Models |
|---|---|
| 2025 | MD6, MD7 |

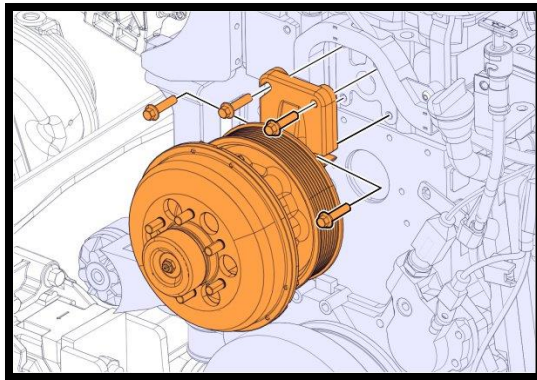
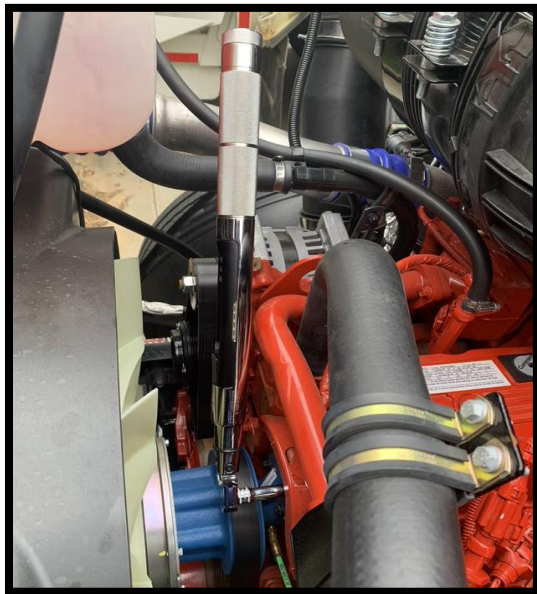
Mack Trucks has identified that certain 2025 model year Mack Medium Duty (MMD) vehicles may have been assembled with insufficient torque on the fan hub retaining hardware. To address this issue and maintain Mack's high-quality standards, please follow the instructions below to properly retorque the fan hub retaining hardware.

If any fan hub mounting bolts are missing or damaged, replace them with new ones as necessary.

7. Using a torque wrench, retorque the 4-fan hub mounting bolts.

| Tightening torque | |
| Fan hub mounting hardware | 24±4Nm (18±3lbf·ft) |
