## Incorrect Interaxle Prop Shaft Hardware

**MACK**

Year	Model
2026	AN, PI, GR, LR

Mack Trucks has identified that certain truck models may have been assembled with incorrectly torqued interaxle prop shaft U-joint hardware. Improper torque can increase the risk of hardware failure. To address this issue, please follow the instructions in this document to replace and correctly torque the interaxle prop shaft U-joint hardware.

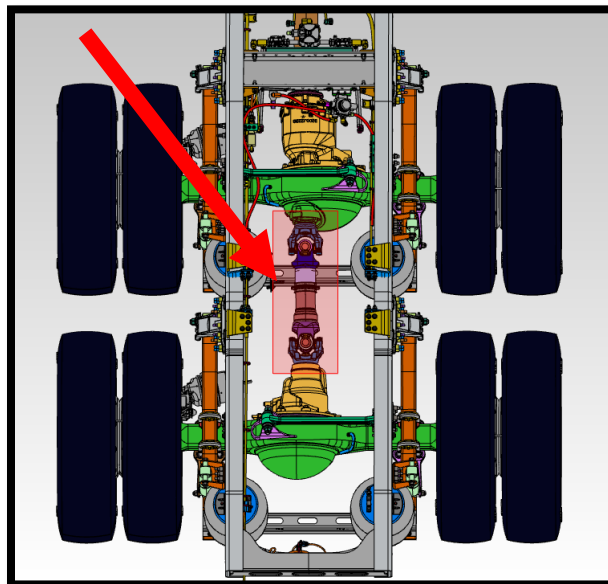
5. Locate the interaxle prop shaft.
