**992 GTS THEV- Fire Hazard Warning in Instrument Cluster**

**Vehicles Affected**

Models	Model Year	Model Type	VIN Range	Vehicle-Specific Equipment
911	2025	992142 992342 992442 992542 992642	N/A	N/A

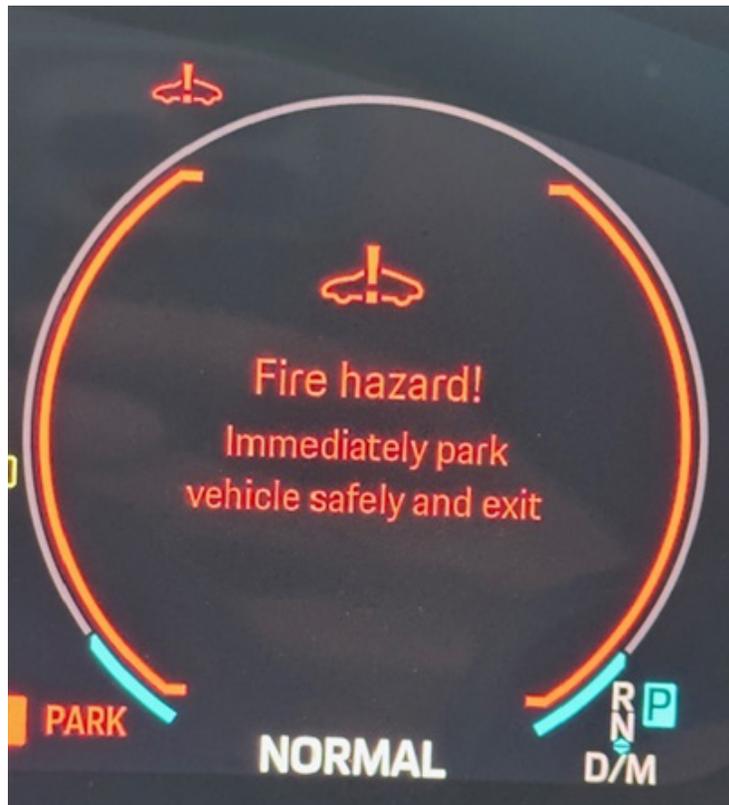
Figure 1

The customer complains of a red Fire Hazard warning in the instrument cluster (Figure 1) and the vehicle will not start.

**P29FF00** - High-voltage battery, thermal run-through detected

**B1C30F0** - Thermal Runaway WarnID-Nr.844 (A00844)

No excessive HV battery surface temperature or odors have been detected in these cases.

Analysis has found that an internal software condition causes communication loss between the HV Battery and the Battery Manager Control Unit (BMC) in some cases. This causes the internal temperature sensors in the HV battery to report implausible signals in these cases. This condition is more likely to occur in colder ambient conditions on start-up.

To restore the drivability of the affected vehicle, update the Software level of the BMC to version 0478 via Automatic Programming with PIWIS Tester SW release 43.500.000 or later.
